FACE Report Number: 2005-05

August 29, 2005

Hispanic Youth Dies in Densifier at a Plastics Recycling Plant - Tennessee

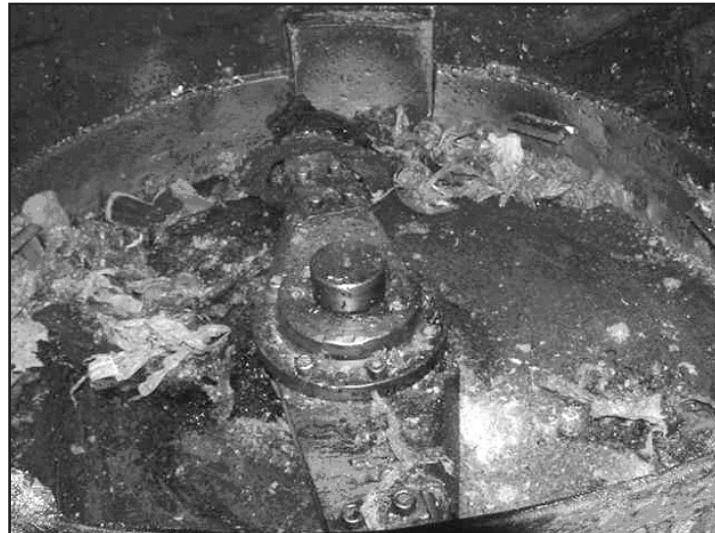
Rotor blade located inside and at the bottom of the Densifier. [Photograph courtesy of TDLWD]

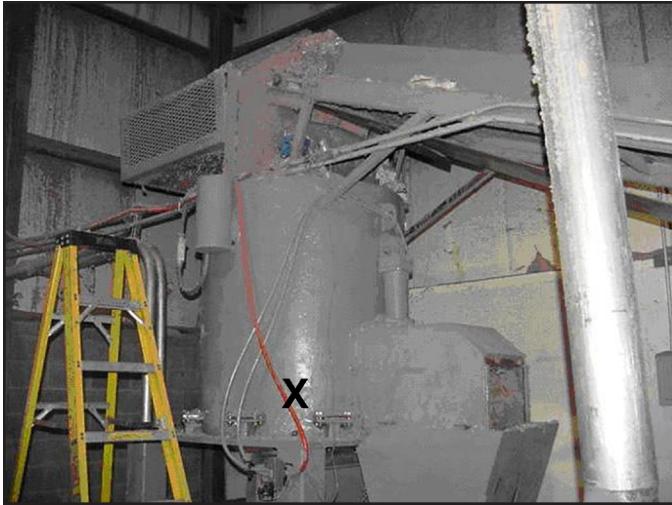
On March 9, 2005, a fourteen-year-old male Hispanic laborer (the victim) died from injuries sustained after coming in contact with the blade inside a Densifier (Photo 1). On March 16, 2005, the U.S. Department of Labor, Wage and Hour Division, notified the National Institute for Occupational Safety and Health (NIOSH), Division of Safety Research (DSR) of the incident. On March 23-24, 2005, a DSR Safety and Occupational Health investigative team met with a compliance officer and an Assistant Director of the U.S. Department of Labor, Wage and Hour Division, Southeast Region; and with a compliance officer of the Tennessee Department of Labor and Workforce Development (TDLWD), Division of Occupational Safety and Health. Findings from the compliance officers' investigations were reviewed, along with the police report of the incident and the assistant coroner's report. On March 23, 2005, the DSR team made a site visit to the plant and discussed the incident with the plant manager and the employer's workers' compensation specialist. None of the coworkers who were working during the incident were available for interview. The DSR team

Photo 1. This photo illustrates the Densifier in which fatality occurred. The rotor blade is located inside the Densifier and its approximate location is marked with an X. [Photograph courtesy of TDLWD].

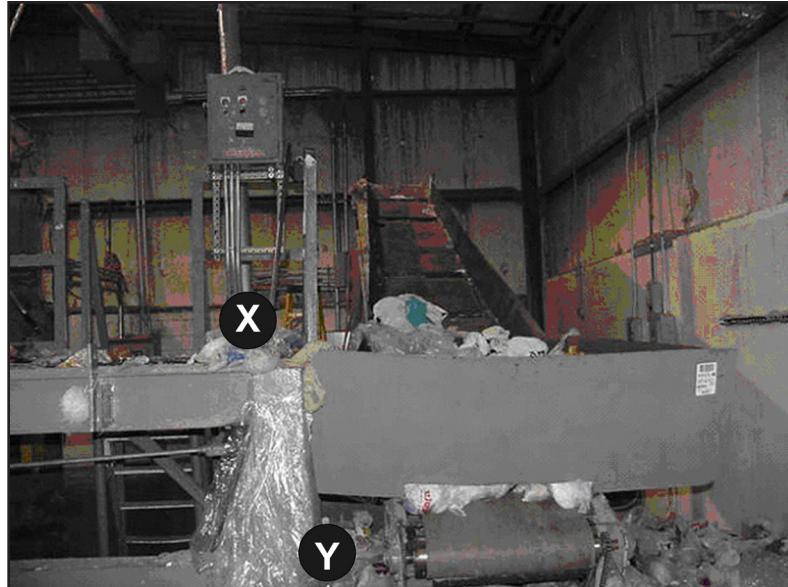
Photo 2. This photo illustrates the operator platform for the Densifier and the conveyor over which plastic bags traveled to enter through the top opening of the Densifier. The Densifier is not visible because it is positioned behind and under the top of the conveyor. An X indicates the platform on which the machine operator stands while operating the machine and monitoring the flow of plastic bags over the conveyor. A Y indicates the usual location of the worker loading the conveyor (victim's usual location). [Photograph courtesy of TDLWD].

3). The machine was designed to be operated by two people. One worker (the loader) stood at the base of the conveyor belt and threw the plastic bags over a guard onto the conveyor belt. The role of the second person (the operator) was to turn the conveyor belt on and off, to push the start and stop buttons that control movement of the blade, and to ensure smooth flow of raw materials into the Densifier. The victim was employed as a loader.

Discussion: Engineering controls are the cornerstone of any safety program. These controls include construction of physical barriers to isolate a hazard, installation of guardrails to mitigate against a fall hazard, and construction of access routes free of obstructions and hazards for safe operation in and around the plant while providing safe accessibility to the work area. This is in keeping with OSHA's General Duty Clause which requires employers to furnish a place of employment which is free of recognized hazards that are causing or likely to cause death or serious physical harm to employees.¹⁴ Areas to consider retrofitting include placing a guard over the opening at the top of the Densifier to prohibit an employee from entering the Densifier from above. Also, consideration should be given to installing guardrails for fall protection around the operator platform and installing standard railings along the stairway leading to the Densifier's side access hatch.

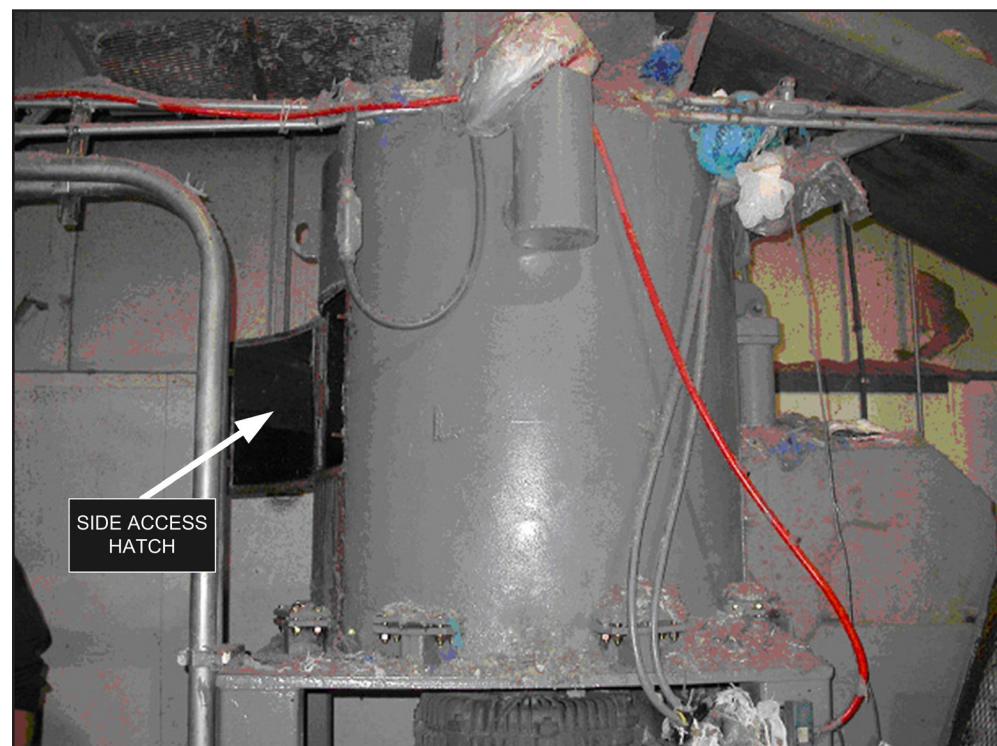
There was a side access hatch leading to the interior of the Densifier that was covered and secured with bolts (Photo 4). There were no signs or placards observed on the Densifier warning that it was a permit-required confined space and that special operating procedures were required for authorized entrance. According to the company's mechanic, this side opening was designed as a sole entrance into the Densifier for its

Photo 4. This photo illustrates the side access hatch that should have been used by appropriately trained workers to gain access to the interior of the Densifier to perform maintenance and repair. [Photograph courtesy of TDLWD].

maintenance, but it was frequently entered from the top when the rotor blade jammed. According to the TDLWD compliance officer, there was a 4 riser stairway at the rear of the Densifier leading to this hatch. Standard railings were not installed on the stairway.
