Fatality Assessment and Control Evaluation Program

FACE Report Number: 2004-10

Hispanic Flagger Dies After Being Run Over by a Dump Truck - North Carolina

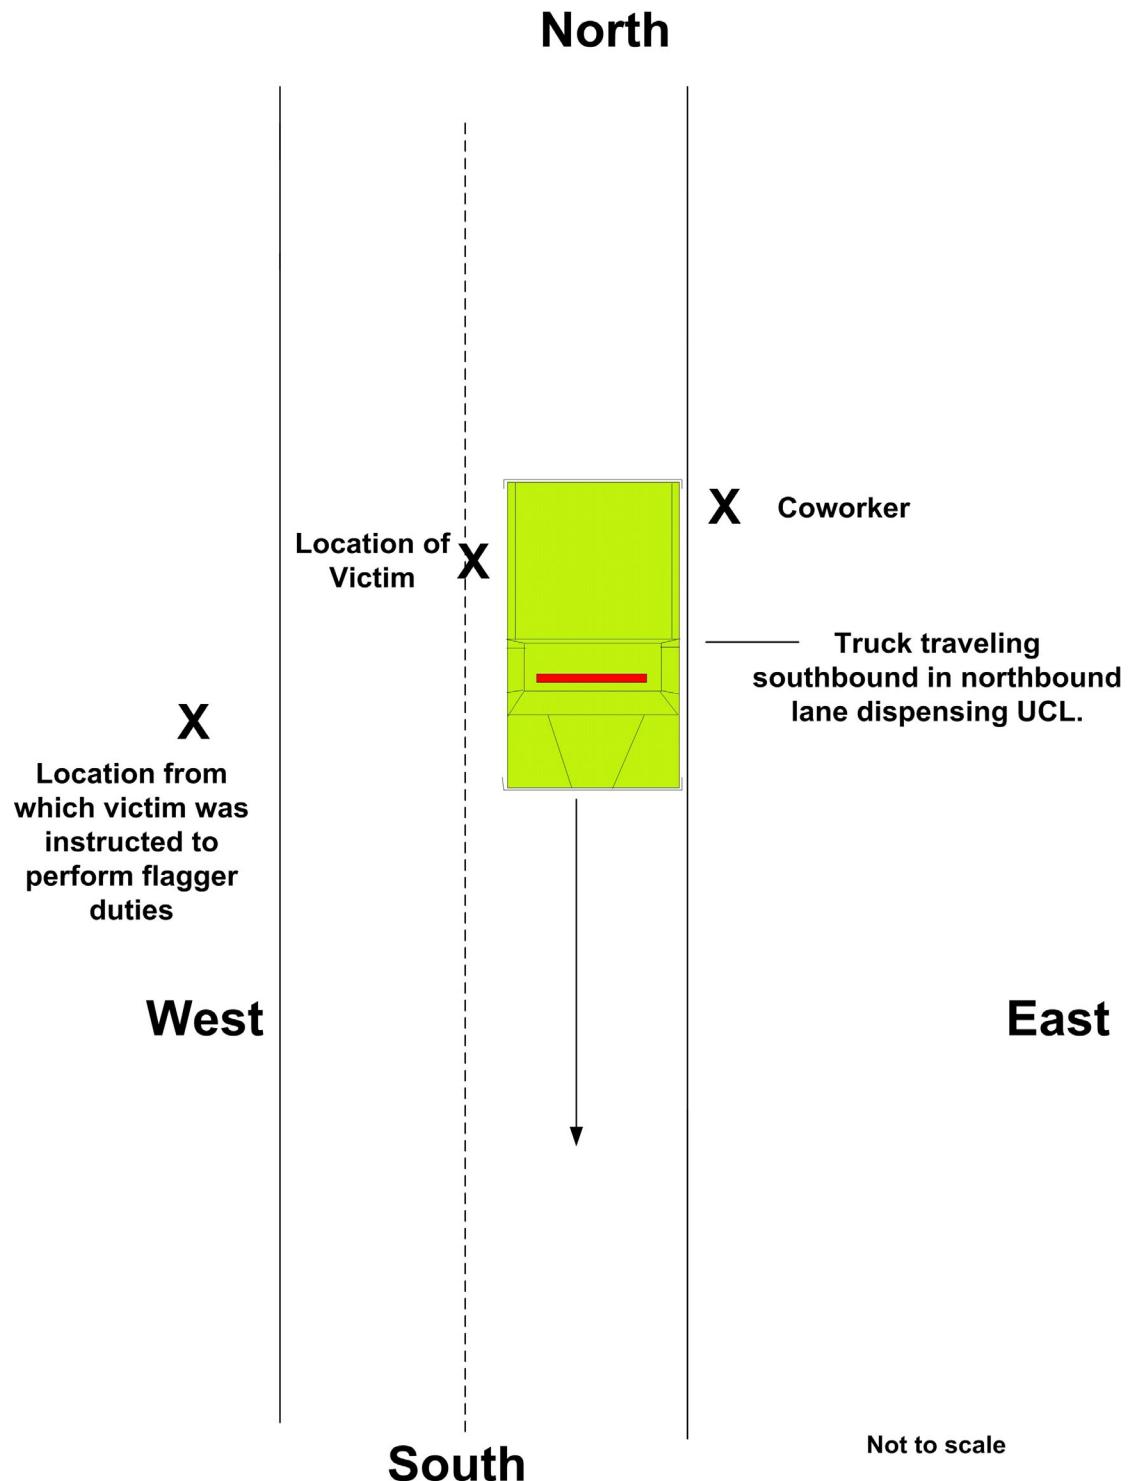
Diagram. Overhead view of the shoulder-rutting operation

Work started at 7:00 a.m. on the day of the incident. The crew was working in a southbound direction in the northbound lane of a five-mile stretch of road (Diagram). The crew consisted of a truck driver/crew leader, a worker positioned on the driver side of the truck with a rake to smooth the fill mixture as it was dispensed from the rear of the truck, and the victim, positioned on the opposite shoulder of the road with his flag. The ten-wheel dump truck blocked the northbound lane of the road. Work on the southbound lane had been completed the previous day. The workers were wearing hard hats and reflective vests. The workers were equipped with two-way radios that they wore at their waists. The noise level at the rear of the truck was measured at 90 dba by the OSHA compliance officer. The noise level in the truck cab was measured at 76 dba with the truck idling. This would have made it very difficult for the workers to hear any radio signals during normal operations with the position of the radios.

As the truck bed was raised, UCL would slide into a hopper at the rear of the truck. It would then be dispensed onto a conveyor that would deposit it on the northbound lane shoulder where a coworker would smooth it with a rake. The victim had been instructed by the truck driver/crew leader to stand on the shoulder of the southbound lane to serve as a flagger to direct traffic around the truck as work progressed (Diagram).

Discussion: Section 6E.05 of the MUTCD states that at a spot lane closure where adequate sight distance is available for the safe handling of traffic, the use of one flagger may be sufficient. At a spot lane constriction, the flagger may have to take a position on the shoulder opposite the closed section in order to operate effectively. The victim reportedly had been instructed by the crew leader to position himself on the opposite shoulder of the road to perform his flagging duties, and to stay in that position as the work zone progressed. Although the NCDOT said that two flaggers could be used on the job, a verbal agreement between the NCDOT and the employer allowed compensation for only one flagger. Both parties felt that with the low volume of traffic on the road, one flagger would be sufficient. After the incident, the agreement was amended to require two flaggers on the job. Whenever possible, two flaggers should be used. This would allow the flaggers to be positioned well in front of and behind the truck, eliminating the workers' exposure to moving equipment.
