Hispanic Laborer Electrocuted After Boom Truck Contacts Overhead Power Line - North Carolina

Fatality Assessment and Control Evaluation (FACE) Program

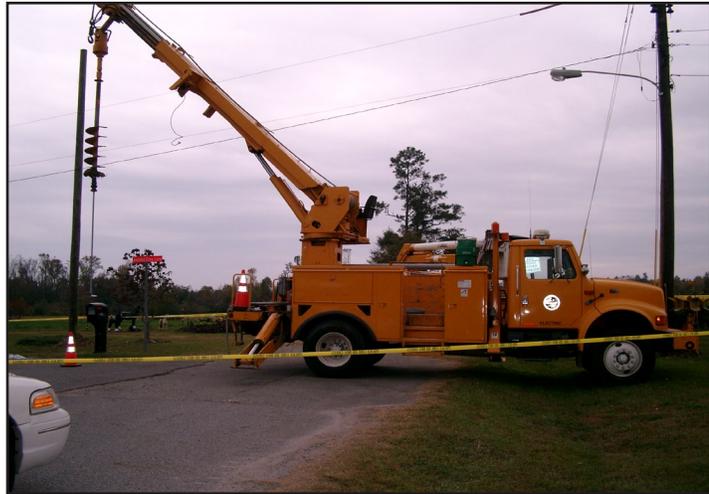
On November 3, 2004, a 44 year-old Hispanic laborer (the victim) was fatally injured after being electrocuted through indirect contact with a 7,200 volt overhead power line. A boom truck with an auger attached (Photo 1) was turning a utility pole anchor in an anchor-setting process in preparation for a utility pole replacement. During the process, the anchor began to wobble and the extended boom contacted the overhead power line. Apparently unaware that the boom was in contact with the overhead power line, the victim grabbed the energized anchor with both hands in an attempt to stabilize it and remained in contact with the energized anchor until the boom was moved away

Boom truck involved in the incident

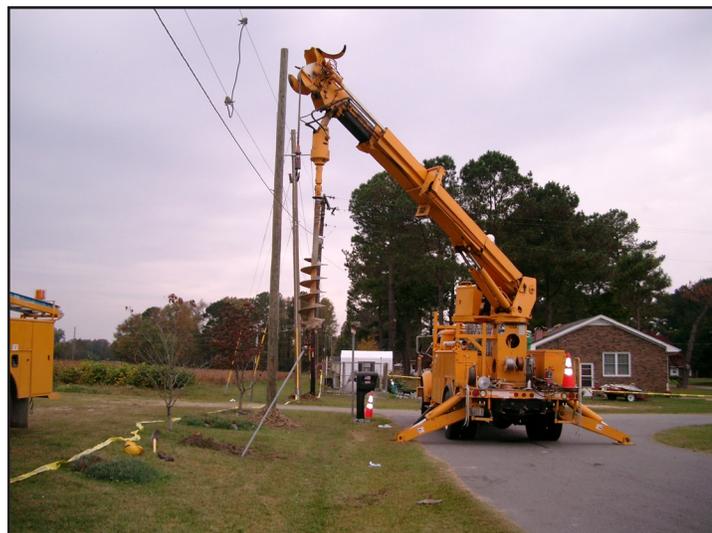
At about 9:50 a.m., the ground crew connected the anchor to the end of the auger and placed the anchor into the hole. A few minutes later the boom truck operator began turning the boom auger and setting the anchor. Because of the angle of the required hole (see Photo 1) the rotating auger/anchor pivot point began to wobble, causing the boom to sway. The victim went over to the anchor and grasped it with both hands to likely try to stabilize it. The boom truck operator saw the victim approach the anchor and called to the victim to stop. The victim, despite the boom truck operator's attempt to warn him, reached for the anchor at the same time the boom operator heard

Photo 1. Illustrates the angle of the anchor. Photo courtesy of NCOSH.

Discussion: The boom of the truck was in a position that may have obscured the operator’s view of the power line. Also, the operator was preoccupied with positioning the anchor, which was having difficulty in being set because of the angle of the required hole. The rotating auger/anchor pivot point began to wobble, causing the boom to sway. If an observer had been present or utilized, he/she could have quickly warned the operator and other workers of the equipments’ proximity or contact with the power line, and the incident may have been avoided. This is required by OSHA Standard 29CFR 1926.550(a)(15)(iv)⁴, which states: “A person shall be designated to observe clearance of the equipment and give timely warning for all operations where it is difficult for the operator to maintain the desired clearance by visual means.”

In this incident, appropriate control measures may have included designating a safe area at the work site where the employees should remain until the hazard was mitigated and disconnecting the power to the lines. Alternatively, the procedure could have been modified, such as digging a larger and deeper pilot hole to accommodate the longer anchor and ensure proper clearance with the power line. Regardless, equipment should be located in a manner which does not create a hazard at the jobsite. Additionally, an area should be designated and marked (perhaps with barricades) at the worksite to provide the safest location for employees to remain while the auger was rotating and the boom of the truck was in close proximity to the power line.
