Hispanic Sawmill Worker Dies Inside Storage Silo After Being Engulfed In Sawdust - North Carolina

Fatality Assessment and Control Evaluation (FACE) Program

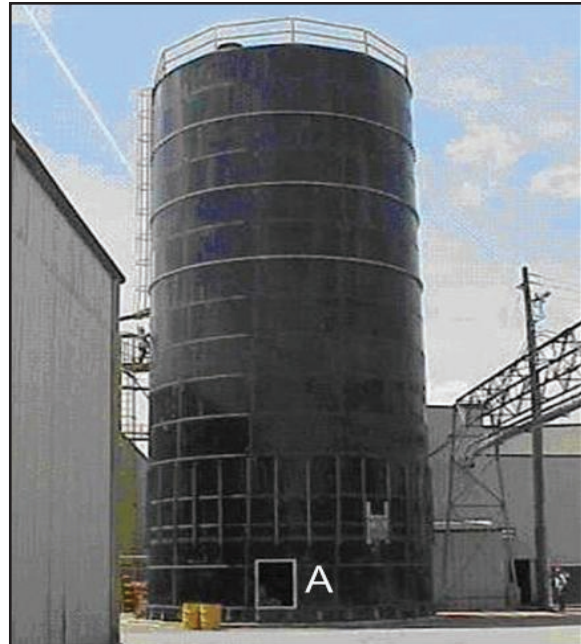
The incident took place at a sawmill that produced over 35 million board-feet of saw lumber per year. On site were three silos that were used to store sawdust, a by-product of lumber processing. Two of these silos, including the one involved in the incident, were flat-bottomed silos (photo 1). They had been purchased used at an auction, and were installed approximately one year prior to the incident. The third silo was an older hopper-bottomed design and had been manufactured by a different manufacturer (photo 2).

Photo 1. Silo in which fatality occurred.
A) Door into the silo machinery room.

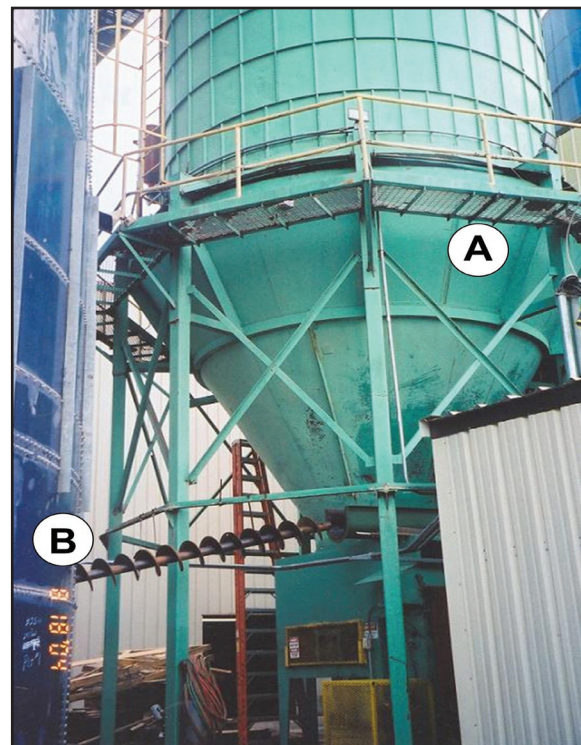
Photo 2. A) Hopper-bottomed silo model stored and transferred the sawdust without clogging. B) Flat-bottomed silo with exposed, partially disassembled, transfer unloader auger.

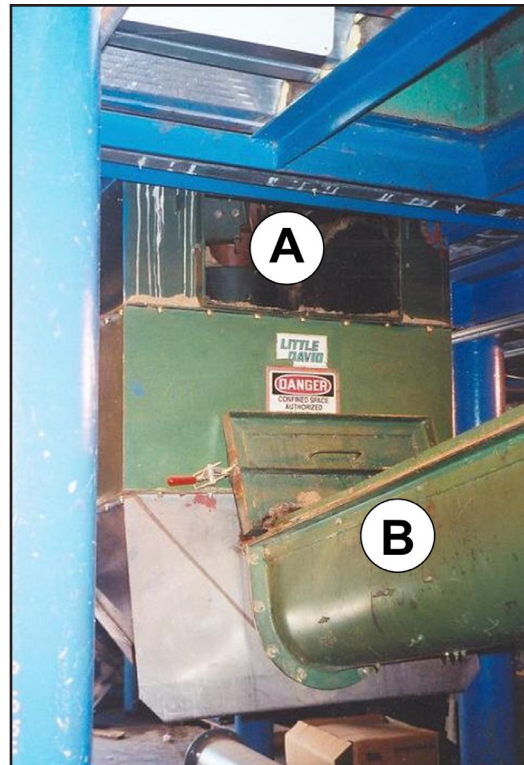
installed on the silo floor was used to funnel the stored sawdust through an opening in the middle of the silo floor. The sawdust would then fall down to another auger called a transfer unloader located below the silo floor in the machine room (photos 3 & 4). The transfer unloader auger would then funnel the sawdust through a series of pipes to the boilers (photo 5). The machine room contained the power equipment to operate the augers and serves as a storage site for other pieces of equipment.

Photo 3. Power unit for augers. A) Sweep auger axle: note that the cover plate is removed and placed below the opening. B) Pipe enclosing transfer unloader auger.

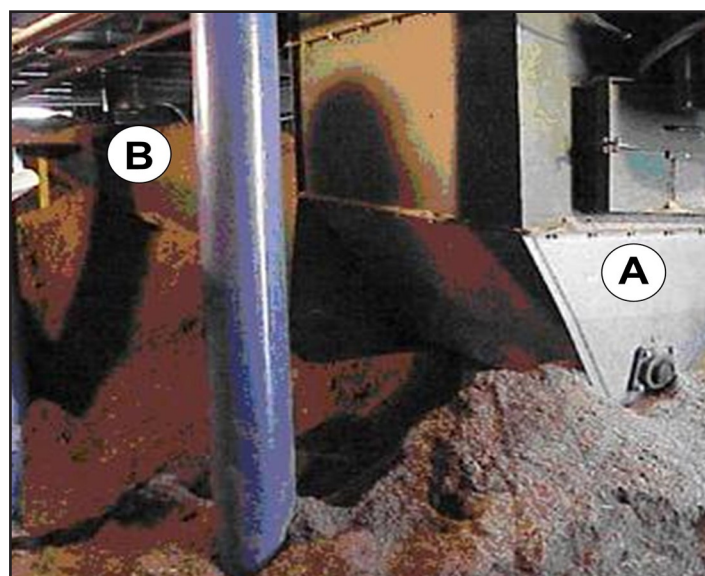
Photo 4. A) Sweep and transfer unloader auger power unit. B) Transfer unloader auger, top plates removed, loaded with sawdust.

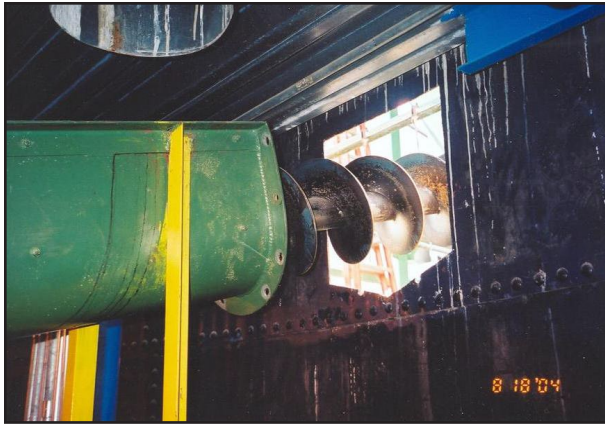
Photo 5. Partially disassembled transfer unloader auger system exiting the silo

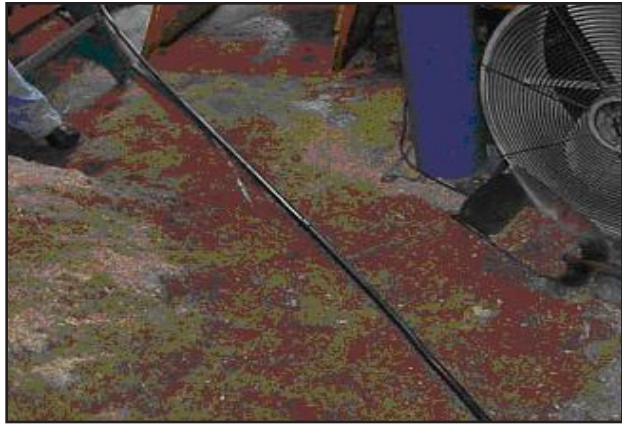
1. Remove 3 12x24" access doors.
2. Chip away card board at the access door.
3. Take poles and rakes and chip away at the saw dust. (Photo 6)
4. Repeat step #3 until saw dust is below the first ring level before entering into upper level of silo.
5. Lockout disconnect and finish cleaning out silo from inside.
6. Repair and test.

Photo 6. Long-handled tool used by laborers to chip cardboard and “rake down” sawdust from the silo directly onto the uncovered transfer auger.

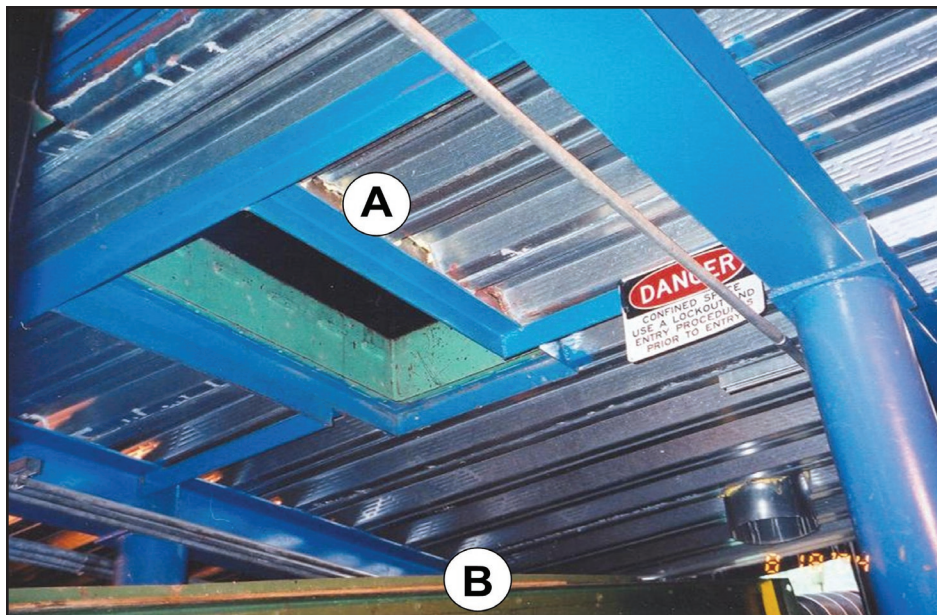
On the day of the incident, sawdust in the storage silo was to be removed in order to unclog the sweep auger located on the silo floor. One Hispanic laborer entered the silo from the machine room directly below the silo floor through the access opening (photos 7 & 8), but quickly exited after determining that the conditions were unsafe inside the silo

Photo 7. Silo floor as seen from the machinery room. A) Overhead entry portal into the silo with cover plate removed. B) Transfer unloader auger.

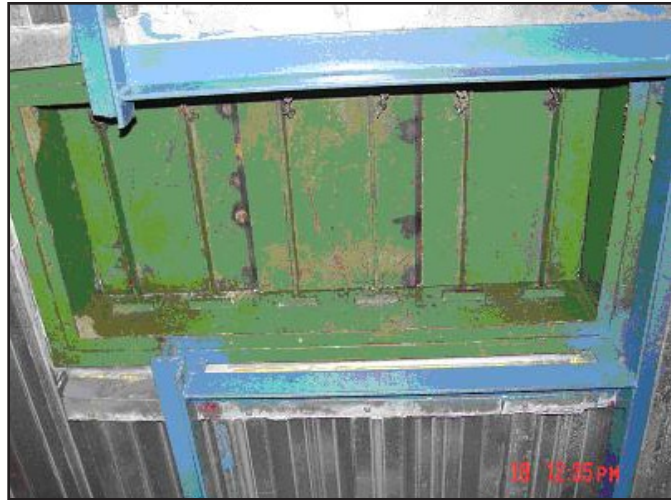
Photo 8. Overhead entry portal with cover in place.
