FACE 92-16

Textile Worker (Machine Operator) Electrocuted After Contacting an Energized Conductor--South Carolina

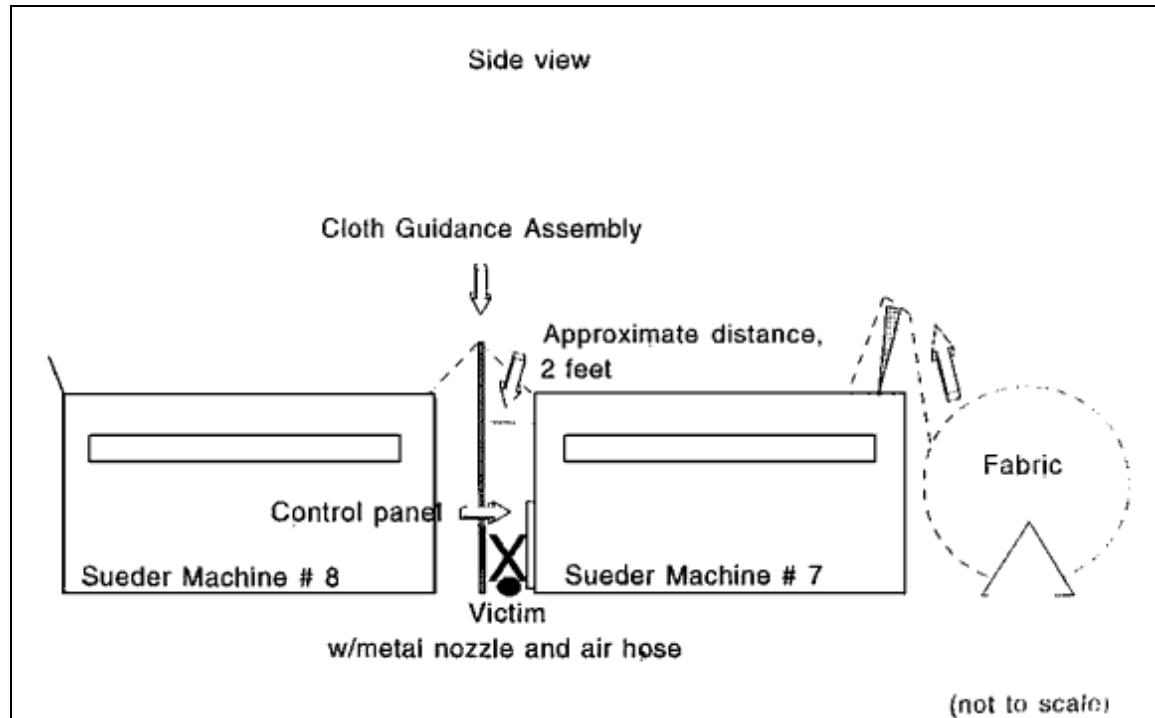
Figure.

the machines, which guided the cloth from one machine to the other. The opening between the control panel and the cloth guidance assembly was about 2 feet (Figure).

Discussion: The control panel was located between the two sueder machines at the bottom left front of machine # 7. The control panel, equipped with two covers that could not be locked, were accessible to anyone within the building. When the control panel covers were removed by an unauthorized person (another operator) and not replaced, the victim may have assumed that using the aluminum nozzle to cool the conductors was a safe and accepted practice. If the covers had been locked the unauthorized worker or victim could not have accessed the energized components of the control panel enclosure. Qualified/designated personnel would be more likely to understand the hazards of

Recommendation #1: Employers should ensure that all electrical control panel covers are secured (locked) against unauthorized removal, and only qualified/designated personnel have access to the control panel.
