## FACE 92-13

### Bulldozer Operator Crushed by Bulldozer During Construction of Oil Exploration Island-Alaska

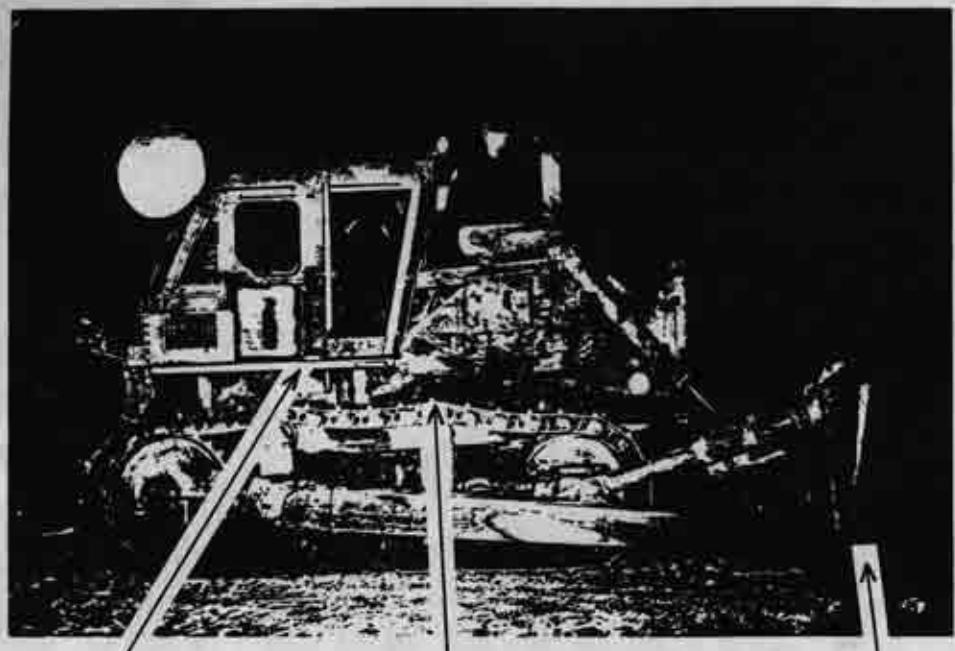
FIGURE 3

- Extended fenders or boarding platforms having non-skid surfaces which cover the entire top of the track. This would prevent an operator from standing or falling on the track, and would further prevent him from being pulled between machine parts by the track as it moved. As shown in Figures 2 and 3, the fender or boarding platform (which is the same on both sides of the cab) does not have a non-skid surface and only covers a small portion of the track.
