## FACE 92-06

### Roofing Mechanic Trainee Electrocuted in South Carolina

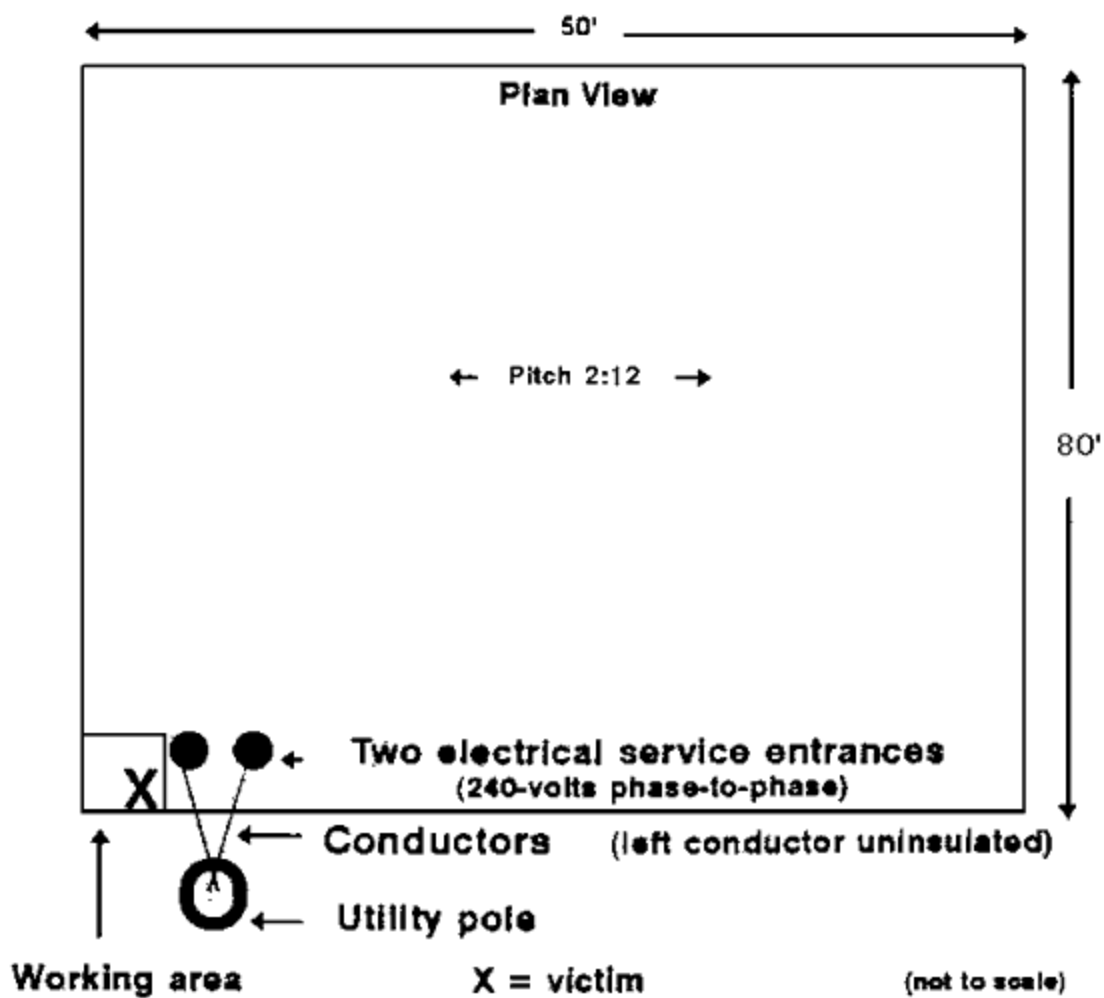
electrical service entrances had insulated conductors while the other did not. The roof had a 2:12 pitch (i.e., the roof rose 2 feet for every 12 feet in width.) ([Figure](#)).

**Discussion:** Two electrical service entrance conductors were attached to the service head and conduit located at the corner of the warehouse roof. One set of conductors was insulated while the other was not. Employers should comply with the National Electrical Code Article 230-41 which states that service entrance conductors entering or on the exterior of buildings or other structures shall be insulated.

Figure. Warehouse Roof and Utility Pole with Service Entrances

***Recommendation #3: Employers should ensure that service entrance conductors are insulated.***

***Recommendation #6: When circumstances offer no alternative to working in close proximity to energized conductors, employers should contact the local utility company to de-energize or insulate the conductors before the start of any work.***
