FACE 92-04

Steel Connector Dies After Falling 19 Feet From a Bridge Under Construction to the Highway Below in Indiana

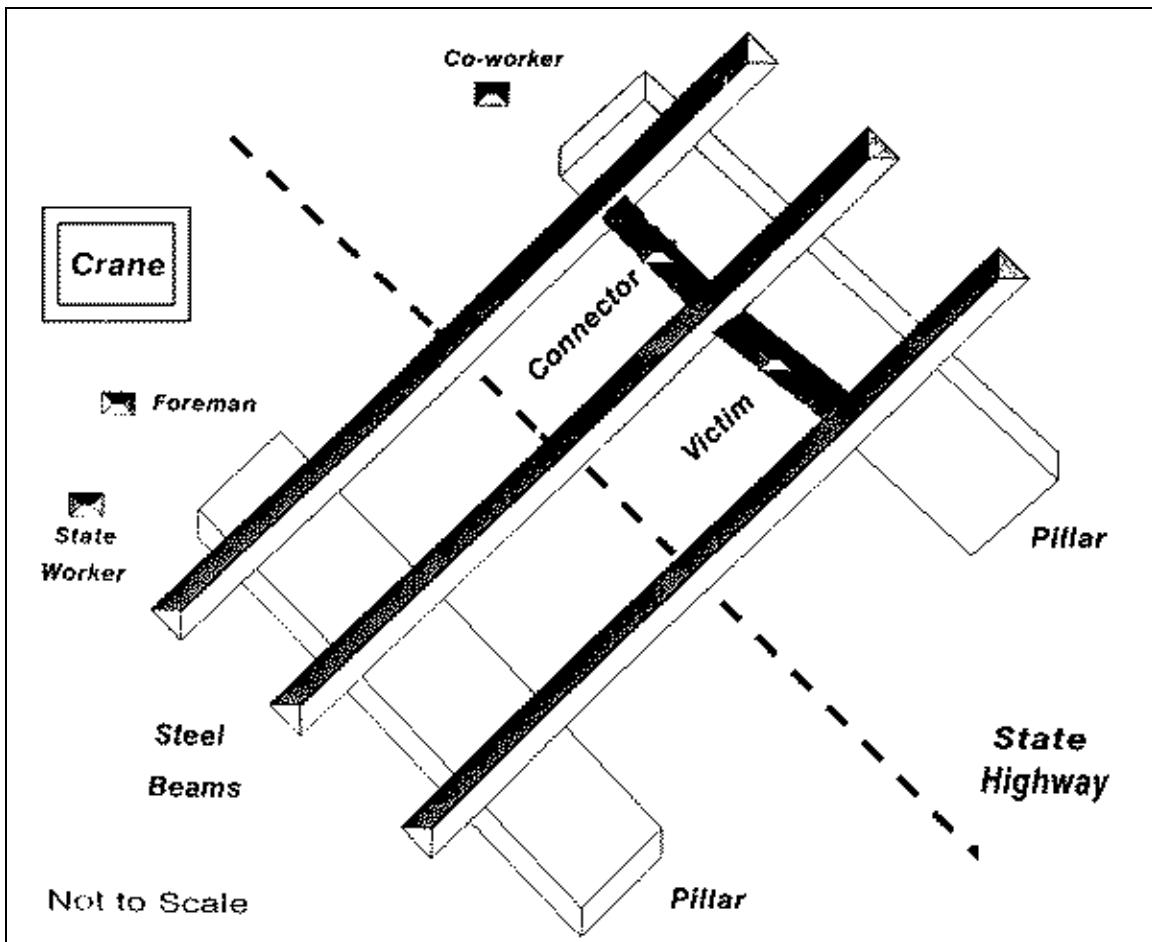
Figure.

The two connectors and the laborer (guiding the beams with a tagline) were working near one pillar, while the supervisor and the state employee were standing in the vicinity of the other pillar. The crane operator was receiving hand signals from the supervisor (Figure).

Investigation revealed that bolts protruding upward from a flange plate (connecting two sections of beam) on the beam's lower flange limited the platform's bearing surface (overlap) to 2 inches. As the victim pushed against the beam, the platform slid away from him and off the flange, causing the fall.

Recommendation #2: Employers should always secure temporary flooring from displacement during steel erection.

Discussion: During bolting, riveting, fitting up, or plumbing up operations, 29 CFR 1926.752 (i) requires that provisions be made to secure temporary flooring from displacement. In this instance, this requirement was not satisfied.
