FACE 92-02

Lineman Electrocuted After Contacting Energized Conductor While Working From the Bucket of an Aerial Lift Truck in Virginia

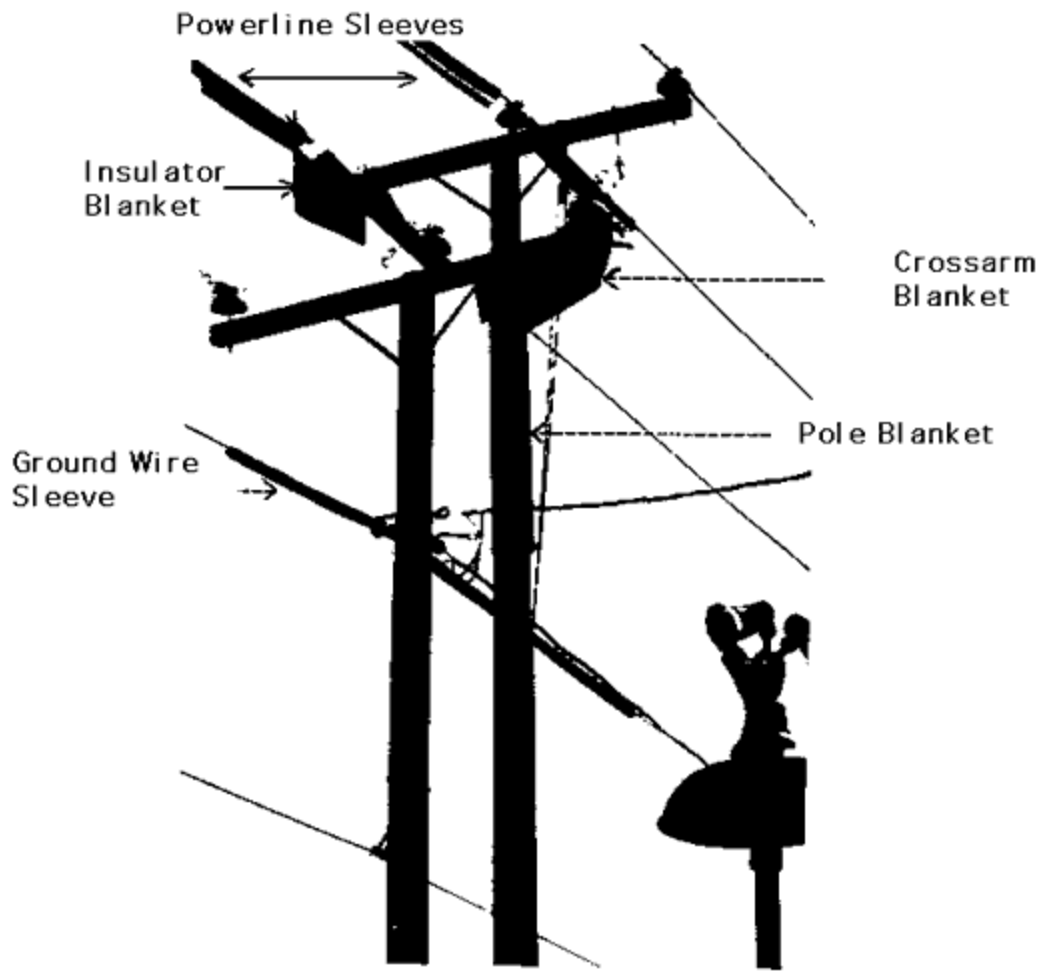
Figure 1. Insulating Materials

On the morning of the incident, a pole crew arrived at the job site, erected a taller utility pole about 4 feet away from the existing pole, and moved to the next job site. Later that morning a five-man crew consisting of a job site foreman, two linemen (including the victim), a lead lineman, and a groundsman arrived at the job site to make the transfer of the powerlines. Insulating line sleeves and blankets were positioned over the energized powerlines, ground wire, and insulators, and also over the crossarm attached to the shorter pole. The top section of the taller pole was further protected with an insulating blanket ([Figure 1](#)).

Discussion: Safe work procedures regarding the removal of the insulating blanket from the crossarm before the removal of the line sleeves and insulator blankets should be reviewed and revised, where appropriate. A work procedure which specifies leaving the crossarm insulating blanket in place until after the removal of line sleeves and insulator blankets may help to reduce inadvertent contact with energized conductors. Safe work procedures regarding the positioning and repositioning of the aerial bucket should be periodically reviewed and revised where indicated, to assure the procedure is appropriate in providing access to the middle powerline sleeves, while allowing adequate clearances from ground potential items. The procedure used in securing powerlines to utility pole insulators should be reviewed and revised, where applicable, to ensure the procedure adequately addresses the appropriate manner in which the powerline is secured to the insulator. The tie down (i.e., a piece of wire used to secure the powerline to the insulator), should be fastened to the powerline in such a manner that the ends of the tie down do not protrude from the powerline. This would minimize any snagging hazard.
