Emergency Medical Technician Dies In Ambulance Crash - New York**SUMMARY**

Fatality Assessment and Control Evaluation (FACE) Program

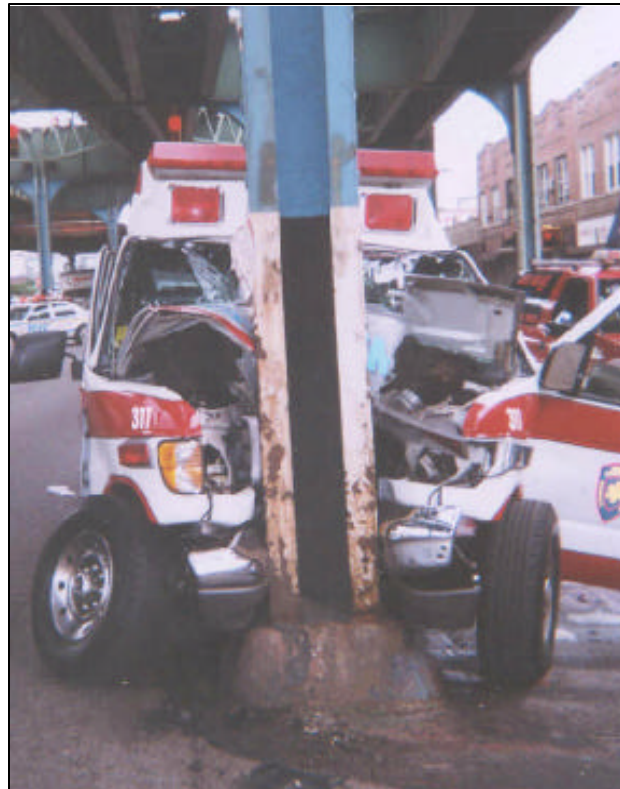
On July 13, 2001, a 27-year-old female Emergency Medical Technician (EMT) [the victim] died when the ambulance she was working in struck a support column for an elevated train track. (Photo 1) The victim had been riding unrestrained in the patient compartment while attending to a patient during a non-emergency medical transport. The ambulance was traveling along a two-lane city street when it drifted across the roadway through an oncoming traffic lane and struck the support column. During the collision, the EMT/driver who was also riding unrestrained, sustained minor injuries from contact with the dashboard and deployed air bag. The victim and the patient struck the front of the patient compartment. The EMT/driver and the patient were transported by ambulances to a hospital where they were admitted. The victim was transported by ambulance to a hospital where she was pronounced dead.

Photo 1. Ambulance after collision with elevated train track support

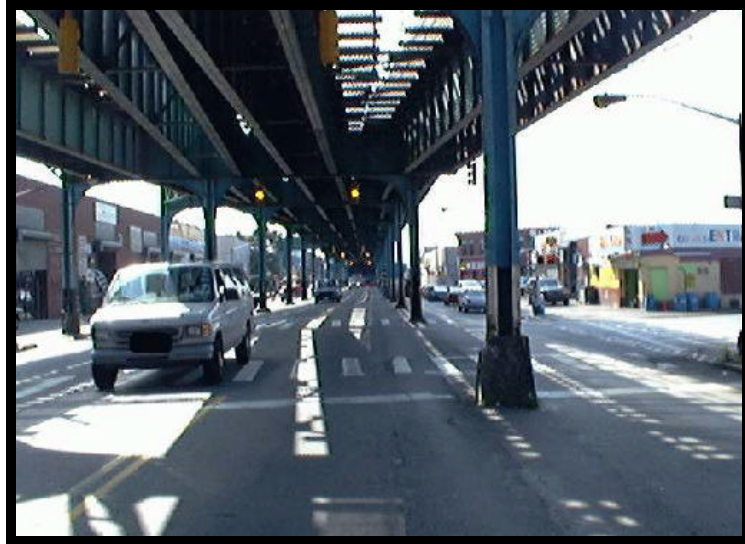
Photo 2. Northern approach to crash site showing track support columns (source, National Automotive Sampling System)

At approximately 12:15 pm., 1½ miles from the hospital, the ambulance drifted through the northbound lane toward oncoming traffic and struck the elevated train track support column at an estimated speed of 26 mph. (Photo 2 and Figure 2) The ambulance came to rest with the front against the track support column. (Photo 1) During the collision, the victim continued moving forward, contacted and broke a hand rail located at the forward end of the squad bench and struck the cabinet at the front of the patient compartment. (Photos 3 and 4) The patient was partially ejected from the cot restraints and struck the rear-facing captain's chair located at the front of the patient compartment before coming to rest partially off the cot. (Photo 5)

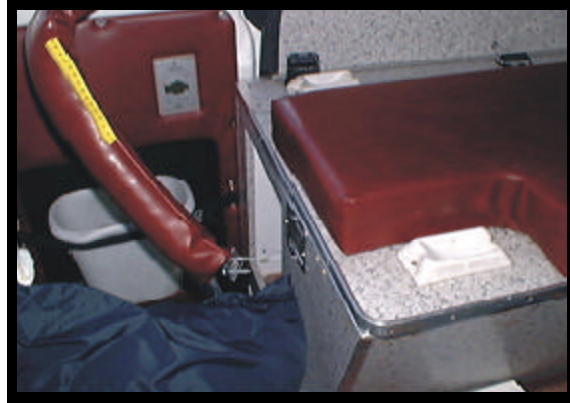
Photo 3. Victim contacted and broke a handrail at forward end of squad bench (source, National Automotive Sampling System)

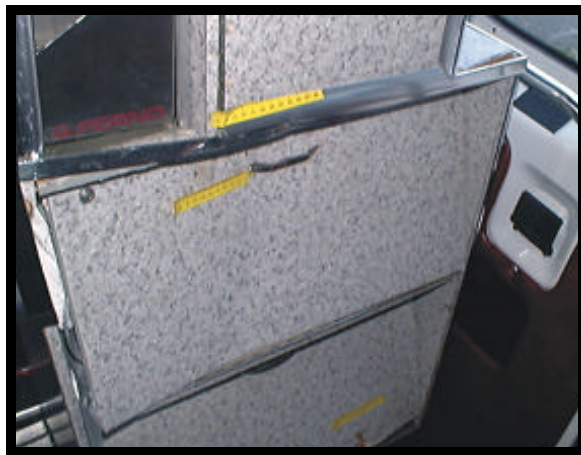
These injuries were attributed to direct contact with the bulkhead/cabinet separating the patient compartment from the driver's cab.

Photo 4. Victim contacted cabinet at the front of the patient compartment (source, National Automotive Sampling System)

Recommendation #1: *Employers should ensure that emergency service workers use the patient compartment vehicle occupant restraints whenever possible.*

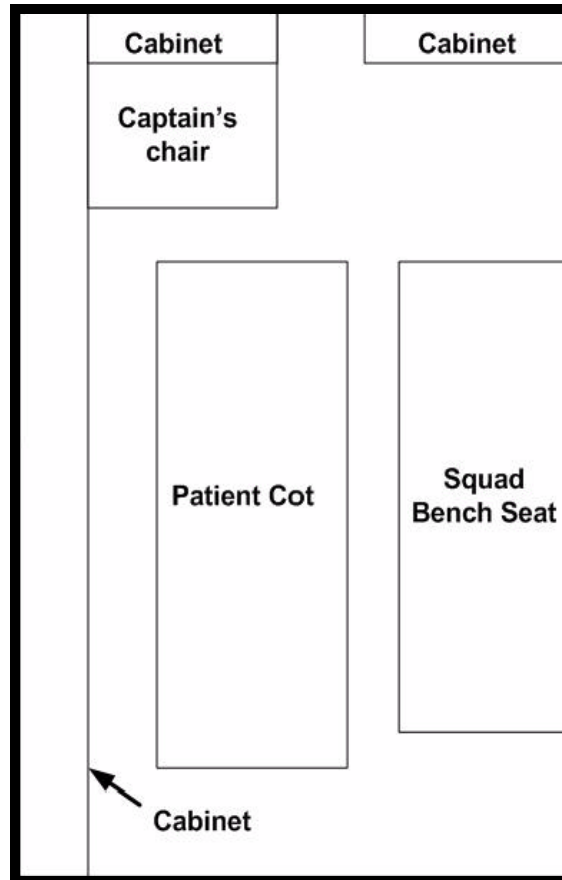
Figure 1. Type II Ambulance Patient Compartment

On the day of the incident, the ambulance crew, an EMT/driver and an EMT (the victim), had been assigned to transport a 74-year-old male patient from a hospital to his residence. The crew departed the hospital with the patient at approximately 11:56 am. The patient had been placed on the patient cot, secured with lap-belt type leg and hip restraints and loaded into the ambulance. The ambulance was traveling southbound and without lights and sirens on a two-lane city street. The EMT/driver was unrestrained, while the EMT (victim) was located unrestrained on the left-facing squad bench seat attending the patient. (Figure 1)

Discussion: The patient compartment of the ambulance involved in this incident was configured with four seating locations each equipped with two-point lap belt type restraints. These positions included a rear-facing high-backed captain's chair and a squad bench with accommodation for three persons. (Figure 1)

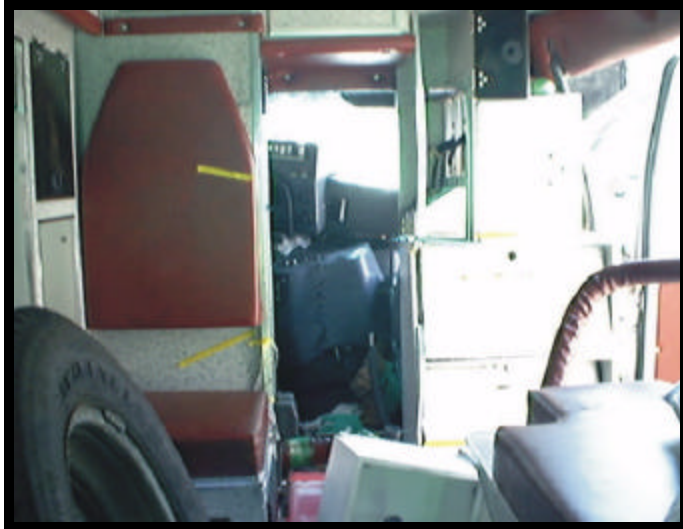
Discussion: During the collision, the patient was partially ejected from the cot and contacted the seat back of the captain's chair at the front bulkhead. [Photo 5] As previously stated, the patient had been secured to the cot with hip and leg straps. Strap type restraints across a patient's lower body offer little or no resistance to forward movement induced from frontal collision. Patient restraint systems are available that include shoulder and chest straps in addition to the hip and leg restraints. Had the patient's restraints included shoulder straps he may not have contacted the captain's chair seat back.

Photo 5. View of patient compartment after the vehicle was recovered from site. Patient contacted seat back at upper location, cot contacted at lower location. Contact indicated by yellow markers (source, National Automotive Sampling System)

Recommendation #2: Employers should ensure that patient cots are equipped with upper body safety restraints for use during emergency and non-emergency transports.
