Hispanic Painter Electrocuted When the Metal Ladder He was Repositioning Contacted an Overhead Powerline - North Carolina**SUMMARY**

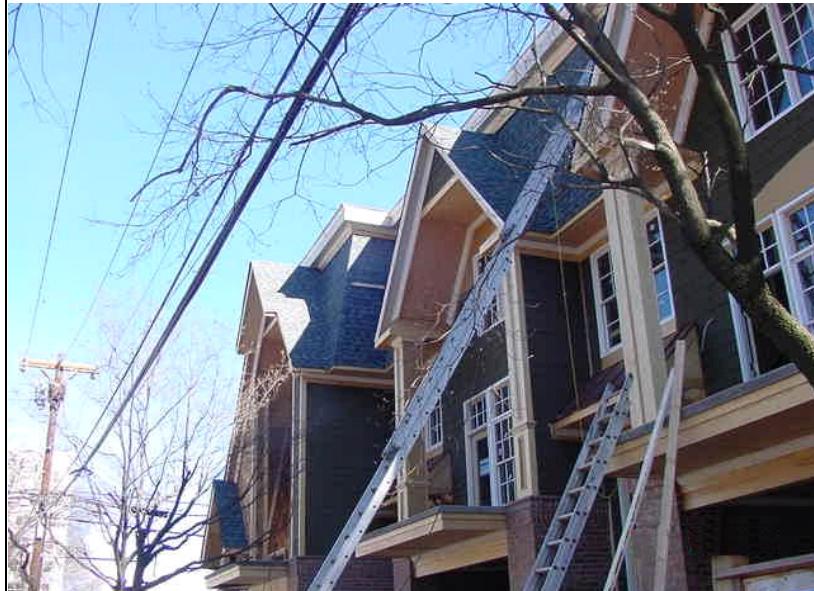
*Incident Scene***Fatality Assessment and Control Evaluation (FACE) Program**

On February 13, 2003, a 24-year-old Hispanic painter (the victim) was electrocuted when the metal ladder he was repositioning contacted an overhead powerline. The victim and his co-workers were painting several two-story townhouses. The victim attempted to reposition the 28-foot-aluminum extension ladder he was using. Several seconds later, the foreman heard a buzzing sound and observed the victim gripping his ladder before falling to the ground. The co-workers ran to help the victim while the foreman called 911. The employees performed cardiopulmonary resuscitation (CPR) on the victim, who had no pulse and was not breathing. Emergency Medical Services (EMS) and police personnel responded within 5 minutes. EMS personnel continued CPR on the victim while transporting him to the local hospital. The victim was pronounced dead in the hospital emergency room.

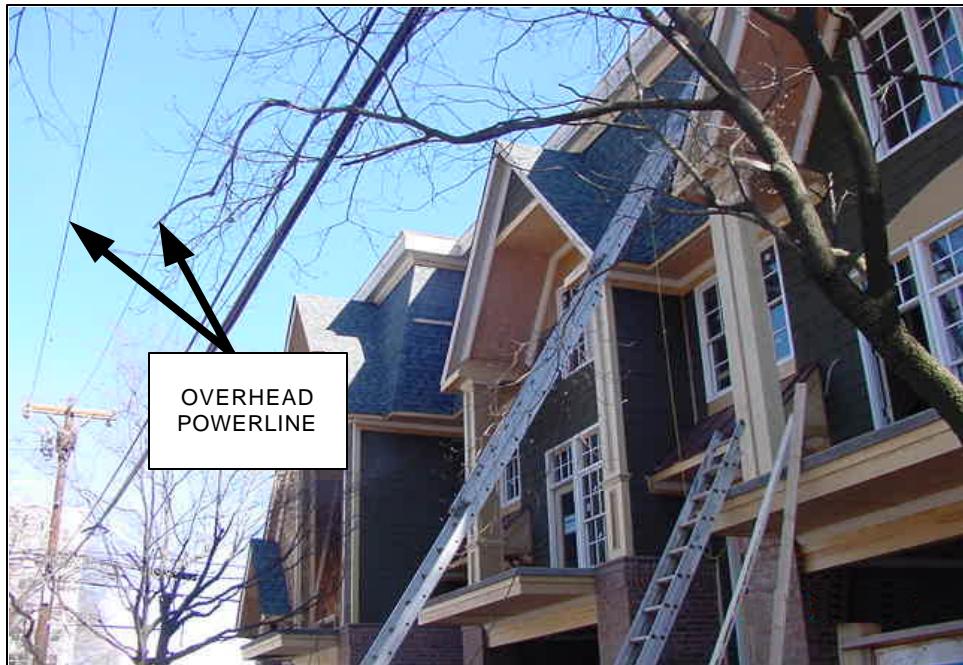
Incident Scene. The employer was subcontracted to paint the exterior of the two-story townhouses that were under construction and unoccupied. The townhouses were brick with wood shingle exterior siding. A three-phase 24-Kilovolt^a, overhead powerline was located approximately 21 feet above the ground level at the site. In addition, there were also three lower telecommunication lines underneath the powerlines. The powerlines and the telecommunication lines were approximately 16 feet from the front of the townhouses (Photo1).

At approximately 12:30 p.m., the victim carried a two-section, 28-foot-aluminum extension ladder that had been extended approximately 26 feet and positioned it on the front of the structure. At the time of the incident, there were two other ladders near the victim, one which was unattended and the other which was being used by the foreman. The ladder being used by the foreman was approximately 30 feet away from the ladder being used by the victim. The victim decided to reposition his ladder by picking it up and stepping around the base of the unattended ladder. While holding his ladder, he stepped back and the top of the ladder contacted the overhead powerline.

Photo 1. Photo of the incident scene. Photograph courtesy of the NCOSHA

Recommendation #1: *Employers should eliminate the use of conductive ladders in proximity to energized overhead powerlines.^{1,2}*

Discussion: Energized overhead powerlines in proximity to a work area constitute a significant safety hazard. Extra caution must be exercised when working near energized powerlines. Metal ladders should not be used for electrical work or where a possibility of contact with electrical conductors exists. Ladders made of non-conductive materials, such as fiberglass, should be substituted for work near energized electrical conductors. The powerlines in this incident were approximately 16 feet from the front of the structure.

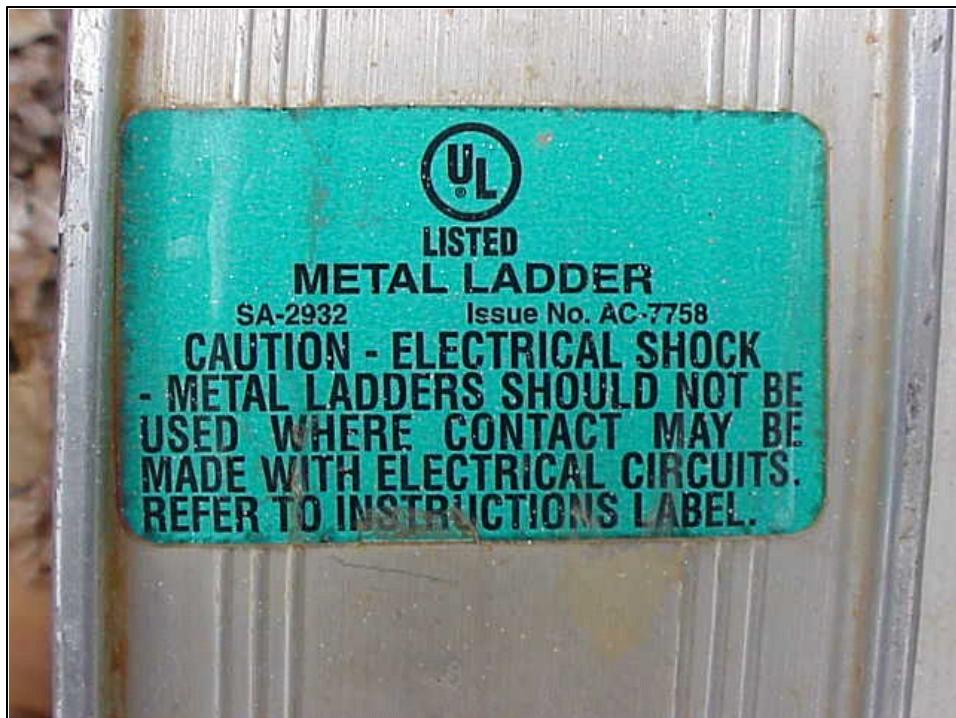
Ladder. The victim was using an 28-foot aluminum, two-section, Type II-Medium Duty/Commercial use ladder at the time of the incident. During the incident, the ladder was extended approximately 26-feet when it made contact with the powerline. The labels on the ladder were written in English and consisted of the manufacturer's name and use specifications.

Photo 2. Photo illustrates an example of the type of instructions and hazard warnings on ladders.

Ladder manufacturers should consider affixing dual language labels with graphics to provide hazard warnings and instructions for safe use of equipment.⁵⁻⁸

Having employees who speak limited or no English presents unique challenges. It is important for Spanish-speaking employees to be able to interpret instruction and warning labels on work equipment such as ladders. While some equipment is bought or shipped with manufacturers' documentation in at least one language other than English, many instruction and warning labels on the equipment are only in English (Photo 2). A dual language label with a graphic or picture label could offer an additional warning to workers of potential hazards.
