***Hispanic Painter Electrocuted When The Ladder He Was Carrying Contacted a 13,200 Volt Overhead Powerline - North Carolina*****SUMMARY**

**Fatality Assessment and Control Evaluation (FACE) Program**

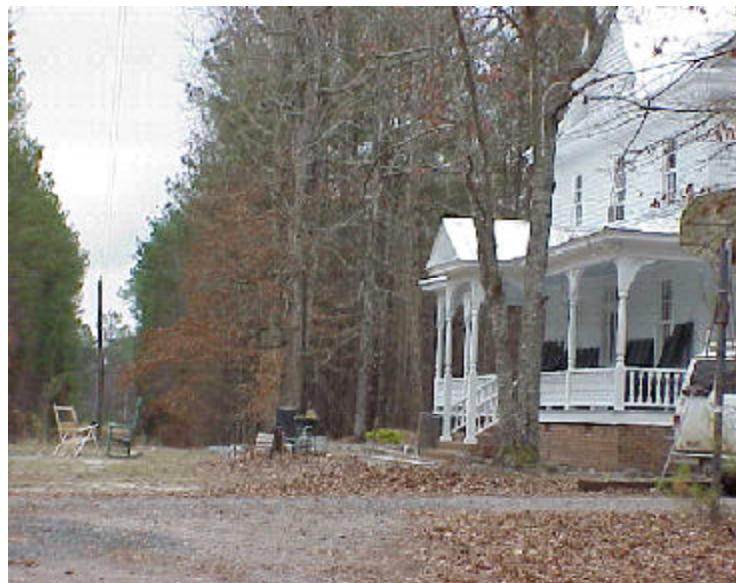
*Photo 1. Incident Scene. Photograph courtesy of the NCOSHA.*

Incident Scene. The employer was contracted to re-paint a 100-year-old, 2-story wood-frame house (approximately 2,000 square feet) that had been moved from its original location to the cleared property where the incident occurred (Photo 1). The house was occupied, however the homeowner was not present when the incident occurred. An energized 13,200-volt overhead powerline was located approximately 26 feet in distance from the front of the house. The primary conductor (top line) was approximately 21 feet above the ground level and the neutral/ground wire (bottom line) was approximately 17 feet above the ground (Diagram).

Prior to beginning the job, the home owner reportedly verbally warned the painting contractor and the workers of the nearby overhead powerline. The foreman and crew arrived on site at approximately 8:00 a.m. on the day of the incident and parked a work van under the overhead powerlines in front of the house (Photo1). The workers unloaded equipment and ladders from racks on top of the van. The foreman and the crew placed ladders and equipment at various locations around the house and began painting.

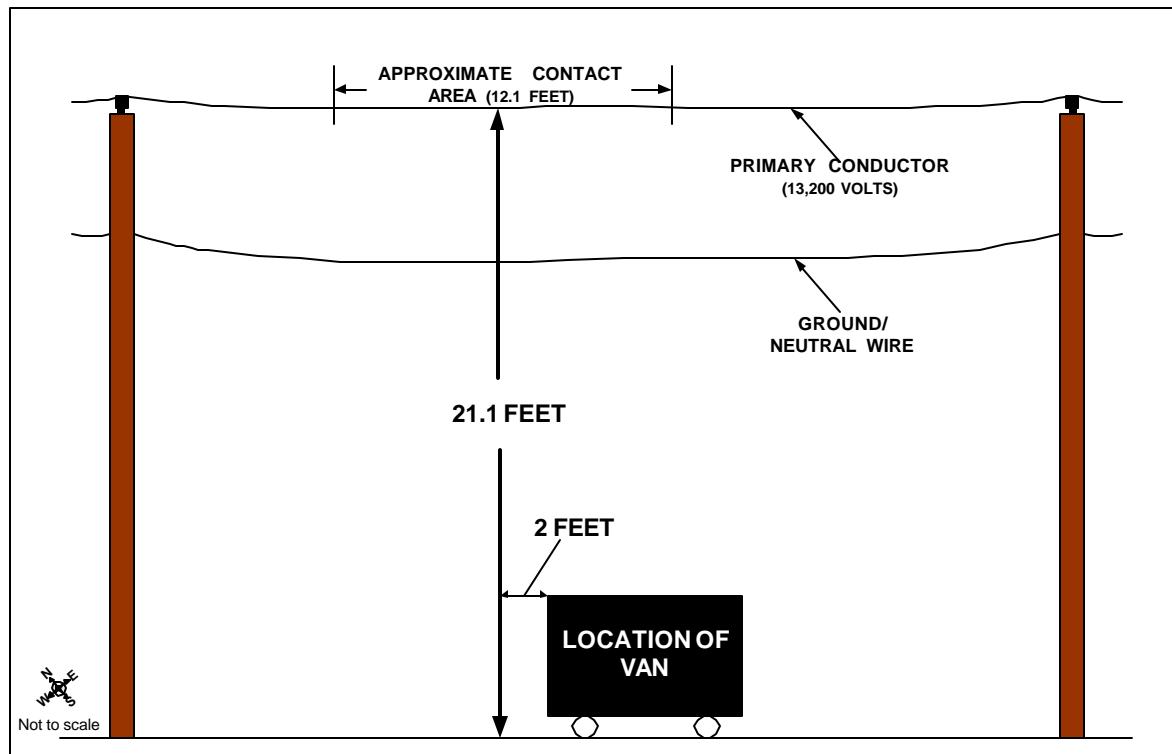
*Diagram. The overhead powerlines layout at the incident scene*

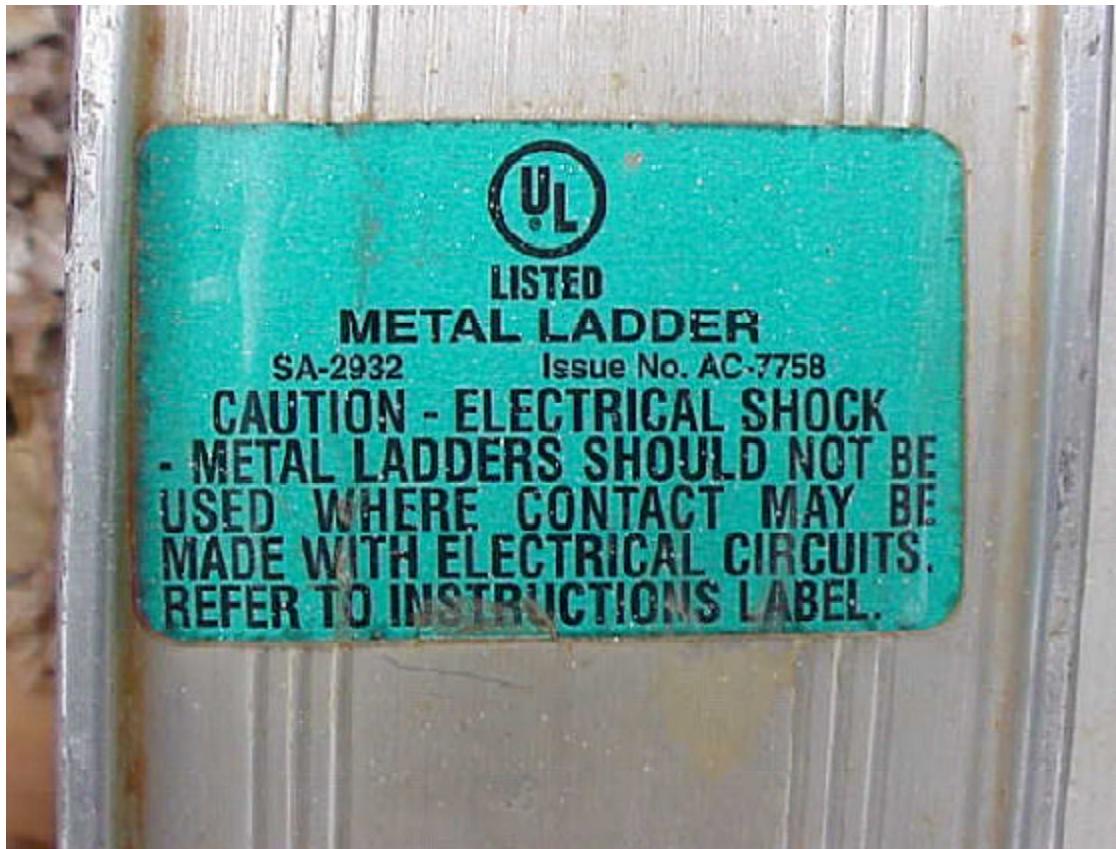
Having employees who speak limited or no English presents unique challenges. It is important for Spanish-speaking employees to be able to interpret instruction and warning labels on work equipment, such as ladders. While some equipment is bought or shipped with manufacturers' documentation in at least one other language other than English, many instruction and warning labels are only in English (Photo 2). A dual language label with a graphic or picture label could offer an additional warning to workers of potential hazards.

*Photo 2. Hazard warning on the ladder used in this incident*

***Consider affixing dual language labels with graphics to provide hazard warnings and instructions for safe use of equipment.<sup>6-9</sup>***
