***Part-time Laborer Pinned Between Scissor Lift Work Platform Railing and Doorway Header - Virginia*****SUMMARY**

Fatality Assessment and Control Evaluation Program  
Investigative Report #2003-01

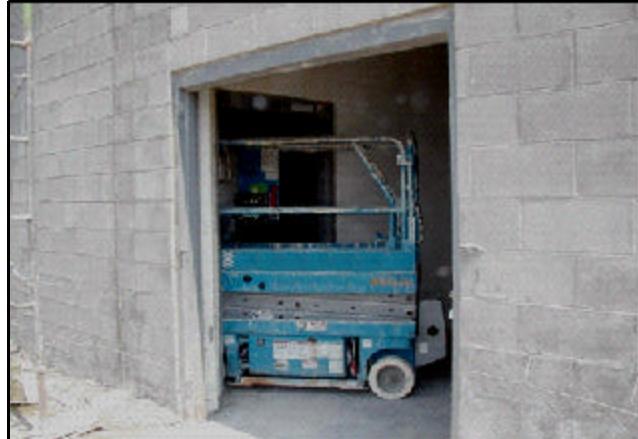
On August 11, 2002, a 42-year-old part-time laborer (the victim) was killed when the scissor lift he was operating elevated and pinned him against the header of an interior doorway. The victim had been working during a weekend performing touch-up painting at a newly constructed day care center. Around midmorning, two coworkers left the jobsite while the victim continued to work alone, using a scissor lift to access the ceiling areas of the structure. Later, between 9:30 and 10:00 pm., one of the coworkers discovered the victim located on the scissor lift platform. The lift was positioned partway through an interior doorway with the platform elevated. [Photo 1]

1] The victim was pinned between the top rail of the work platform and the head jamb of the doorway. The coworker exited the building and called 911 for assistance. Emergency medical service (EMS) personnel and local police responded and arrived at about 10:00 pm. The victim was pronounced dead at the scene. Later examination by the medical examiner's office revealed that the victim had been dead for several hours.

*Photo 1. Scissor lift entering classroom doorway*

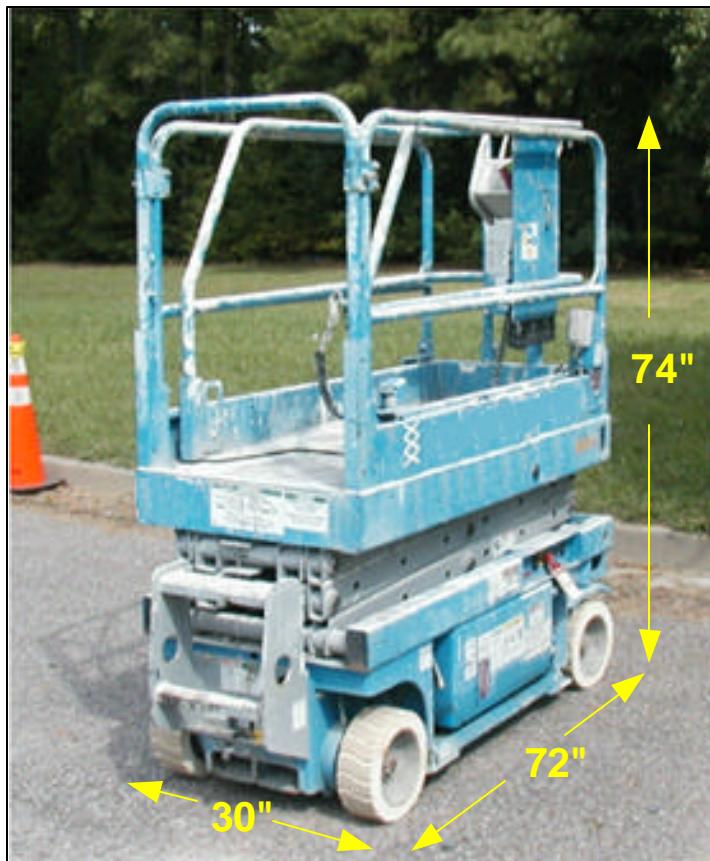
*Photo 2. Scissor lift in lowered position*

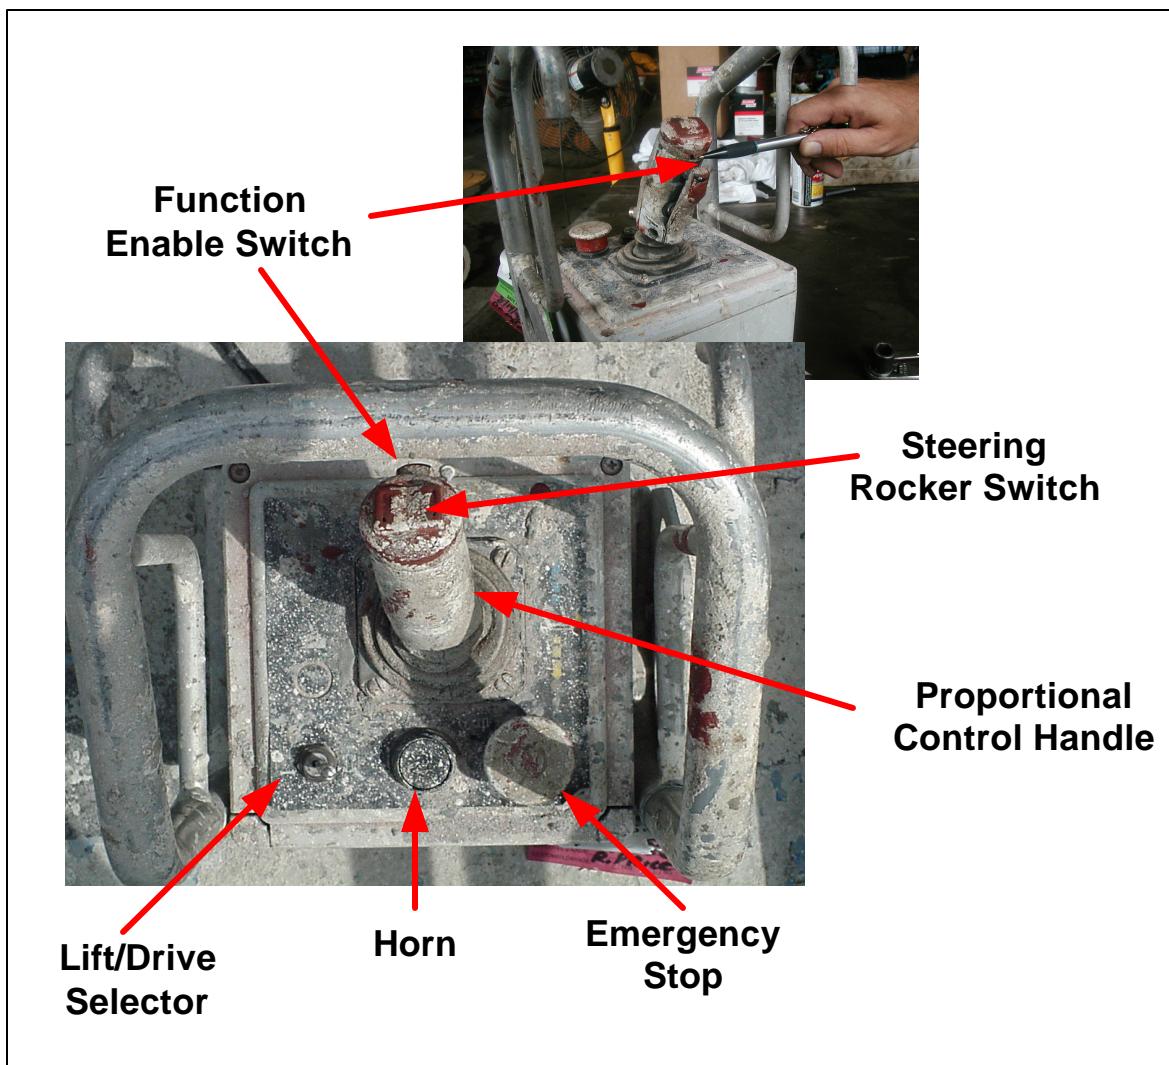
drive the lift from place to place, the lift/drive function selector switch is moved to the drive position, the function enable paddle switch located on the proportional control handle is squeezed, and the control handle is pushed for forward motion, and pulled for rearward motion. [Photo 3] To elevate the work platform, the lift/drive function selector switch is moved to the lift position, the function enable paddle switch is squeezed, and the proportional control handle is pushed to elevate the platform and pulled to lower it. To steer left or right, the steering rocker switch on top of the proportional control is moved right or left to direct the wheels on the steering axle and the proportional control is used to drive forward or back. A set of ground operating controls is located on the side of the machine base. This set of controls contains the on/off switch for the machine, an emergency stop button, and platform elevation controls. No drive controls are located at this panel.

*Photo 3. Control box operating switches*

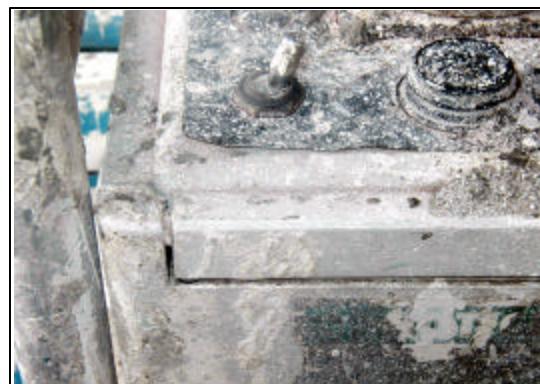
Discussion: The control system for the lift involved in the incident used a single proportional control handle to control both drive and lift functions. A two-position toggle-type switch was used to select the desired function. When the selector switch was placed in the lift position, the proportional control handle was used to raise or lower the work platform. When the switch was placed in the drive position, the proportional control handle was used to move the machine forward and backward. After the incident, the lift/drive selector switch was found in the lift position. The lift/drive selector switch is located on the lower left quadrant of the control panel and enclosed under a weatherproof rubber boot when manufactured. However, the switch lever protrudes from the control panel unprotected. (Photo 4) It is possible that the victim inadvertently moved the selector switch from drive to lift mode when he reached through the platform rails to grasp the proportional control. Pulling the control forward, would then have raised the platform, pinning him against the head jamb of the doorway. It should be noted that the rubber boot had been damaged and/or removed from the switch in the incident. To protect against inadvertent activation of the selector switch, it could be enclosed in a switch guard or alternatively, the lift/drive mode could be selected by use of a recessed button or rocker switch.

*Photo 4. Unguarded lift/drive toggle switch*

***Recommendation 1: Manufacturers of self-propelled elevating work platforms should ensure that selector switches used to change the operating mode of single lever control systems are guarded against inadvertent activation.***

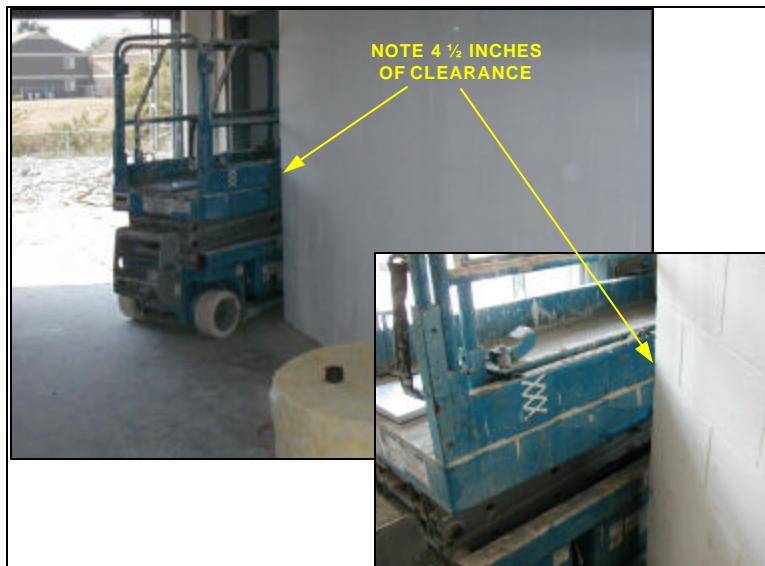
Discussion: As previously noted, the clearance between the machine and the doorway was limited. Further, to access the room through the doorway while avoiding collision with a closet inside the room, the machine had to negotiate a tight turn from the hall way. There was just over 9 inches of clearance between the machine's frame and the doorway, about 4 ½ inches on each side. [Photo 5] Also, when fully lowered, there would have been only 9 inches of clearance between the platform top rail and the head jamb of the doorway. Although the machine in question moves slowly, when clearances are tight, workers can be caught between structures or objects as a result of only minimal unexpected machine movement. OSHA regulation 29 CFR 1926.21 (b) (2) requires employers to instruct workers in recognition and avoidance of unsafe acts.\* The circumstances surrounding this incident suggest that the victim may not have fully appreciated the risks of operating the machine in tight clearances. The machine's control box was

*Photo 5. Doorway to classroom from hall*

***Recommendation #3: Employers should ensure that workers are trained to recognize the hazards of operating self-propelled elevating work platforms in tight quarters.***
