FACE 90-02

Tree Trimmer Crew Leader Dies When He Contacts Energized Powerline in Puerto Rico

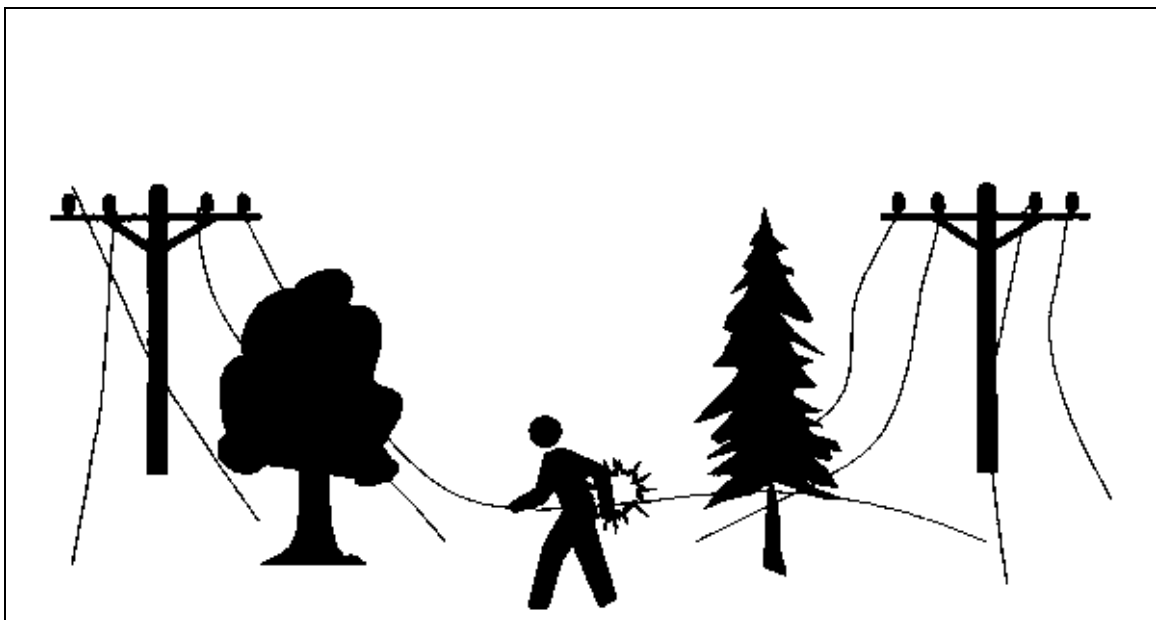
Figure. Tree Trimmer Electrocution

Investigation by power company officials revealed that the lines had been de-energized a day prior to the incident when power company linemen had opened the breaker for the line on an emergency generator which was in use to supply power to the city's public works department. However, on the day of the incident, a gas station between the public works department and the worksite was using a portable gas-powered electric generator to supply electrical power to the gas pumps. Since the main circuit breaker at the gas station had not been opened, electrical current from the portable generator flowed back

through the transformer and energized the powerline at the work area. When the victim contacted the powerline, his body provided a path to ground and he was electrocuted. The medical examiner's report identified an entrance wound in the lower left back region, which indicated where the victim contacted the line (Figure). Tests performed on the powerline by power company workers indicated that the powerline contacted by the victim carried 2400 volts.

Recommendation #1: Workers assigned the task of clearing debris from downed power lines should be instructed to inspect their worksite to identify all downed powerlines prior to the start of work. These powerlines and any debris in contact with these powerlines should be treated as energized until these lines are tested and grounded on both sides of the work area by qualified workers to control the hazard of feedback electrical energy.

Discussion: Workers should be instructed to conduct an inspection of the entire jobsite prior to the start of work to identify all downed power lines. These lines, and any debris in contact with these lines, should be treated as energized. Because of the ever-present danger of feedback electrical energy, these powerlines should be grounded on both sides of the work area and tested by qualified personnel, even though they have been verified as de-energized (1). These precautions are especially important during restoration operations, when the use of portable electric generators is very likely. If these precautions had been taken in this instance, this fatality might have been prevented.
