FACE 90-03

Lineman Dies When He Contacts Energized PowerLine in Puerto Rico

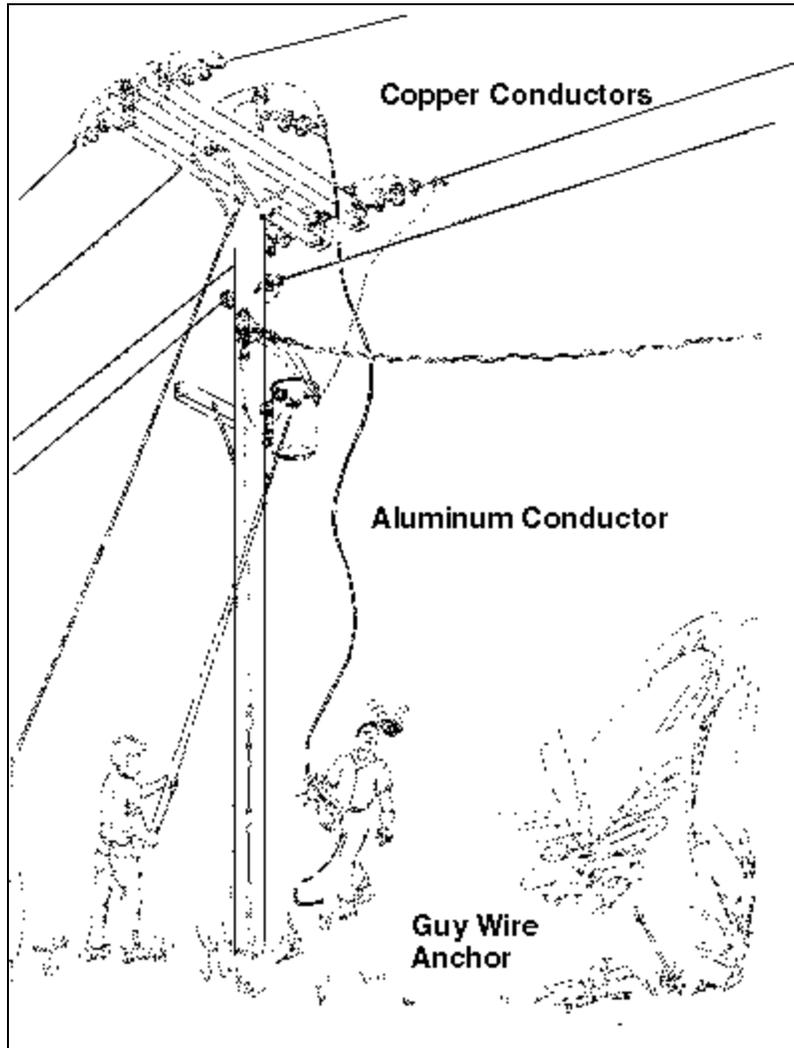
Figure.

Examination of the incident site revealed that six 4800-volt phases were attached to the crossarm above the transformer, three phases on each side of the pole. On one side, however, the middle phase was dangling down from the crossarm to the ground. The phases on both sides of the pole were connected by wire jumpers. The dangling phase was aluminum, while all other phases attached to the pole were copper. A guy wire anchor was buried in the ground approximately 20 feet from the pole, but no guy wire was attached (Figure). It is assumed that the victim either did not see the wire because of the darkness or thought that it was a guy wire because of its color (and therefore not energized).
