## Lineman Dies When He Contacts Energized Power Line in Puerto Rico

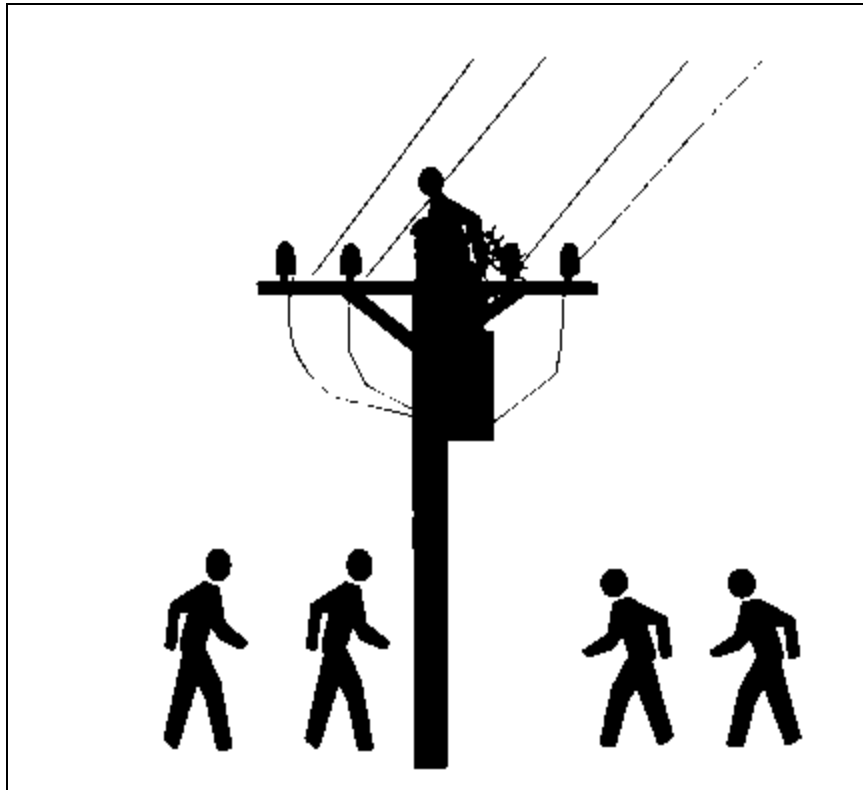
Figure. Lineman Electrocution

Power company investigators discovered that the lines had been de-energized at a pole-mounted service transformer. However, incorrect connections at this transformer established a path for current energy from another circuit to travel back (backfeed) through the transformer, energizing the line that the victim had contacted. Tests determined that 2400 volts were present on the line.

Recommendation #1: Employers must ensure that established safety procedures are followed at all times.

Discussion: Company policy requires linemen to verify that powerlines are de-energized, grounded, and tested before starting work on the lines. The victim accepted the word of his supervisor that someone else had de-energized the lines. The supervisor allowed the victim to proceed without following established procedures. Had the victim or the supervisor verified that the lines were de-energized, grounded, and tested, this incident might have been prevented.

Recommendation #2: Special precautions should be taken to guard against feedback electrical energy.

Discussion: The potential for electrocution due to feedback energy should not be underestimated. This is especially true in this case, where massive damage was inflicted on the area's electrical system by the hurricane. To protect against the hazard of electrical feedback energy, linemen must verify that powerlines have been de-energized. De-energized lines must also be properly grounded to the system neutral. Grounds must be attached to the system neutral first and removed from the system neutral last. If work is being performed on a multi-phase system, grounds must be placed on all lines, and should be grounded in sight of the work area, with work being performed between the grounds whenever possible. If work is to be performed out of sight of the point where the line has been de-energized, an additional ground should be placed on the source side of the work area. Unless a power line is effectively grounded on both sides of a work area, it must be considered energized even though the line has been de-energized. Linemen should also be instructed to always wear the appropriate personal protective equipment (NIOSH 88-104).
