FACE 90-04

Meter Reader Dies When He Contacts Energized Clothesline Wire in Puerto Rico

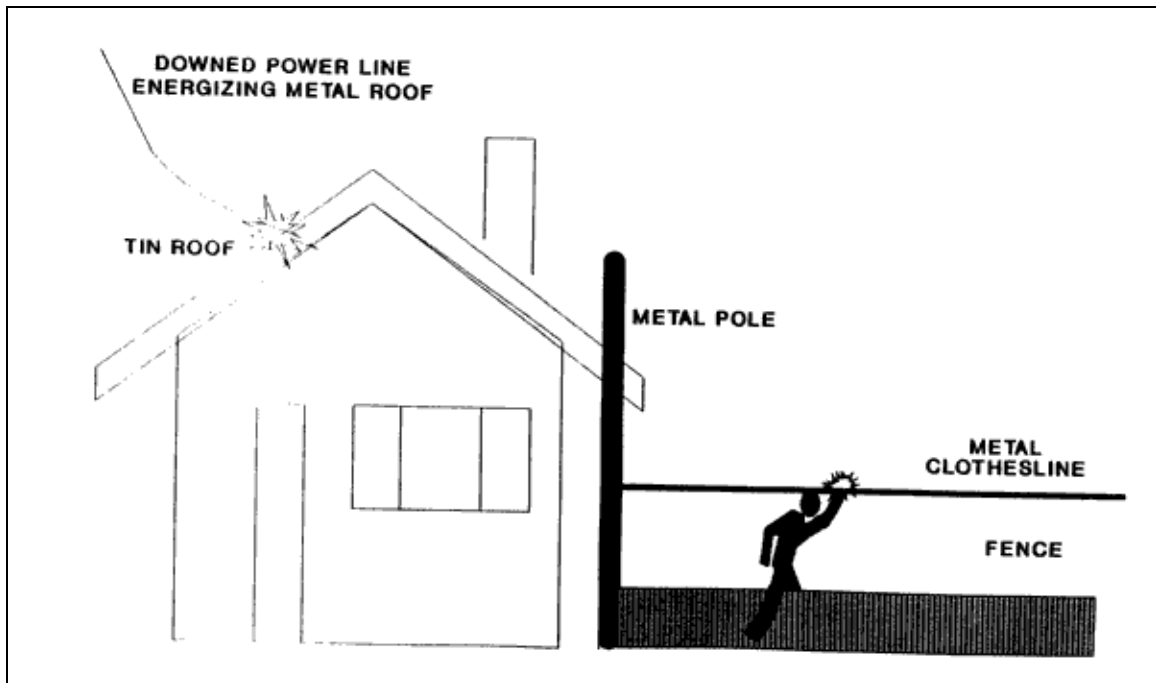
Figure. Meter Reader Electrocution

Investigation of the incident site by power company officials revealed that the wire clothesline was attached to a metal pole that supported the tin roof of the residence. An

energized secondary service line from a nearby residence had been torn loose from its connection and was lying across and energizing the tin roof at 110 volts (Figure). This action, in turn, energized the metal pole and clothesline at 110 volts. When the victim grabbed the wire clothesline, his body provided a path to ground, causing his electrocution.

Recommendation #1: A comprehensive jobsite survey should be conducted prior to the start of work to identify all potential hazards that workers might encounter during the performance of their duties.

Recommendation #2: Adequate lighting should be provided and utilized while performing work place safety inspections prior to the start of work and during powerline repair work at night.

Recommendation #3: Workers should be instructed to treat all conductive components in their work area with extreme caution, especially when the electrical system in their work area has suffered extensive damage, and wear appropriate personal protective equipment when necessary.
