***Three Ironworkers Die After Heavy-lift Crane Tips Over-Wisconsin*****SUMMARY**

**Fatality Assessment and Control Evaluation (FACE) Project**

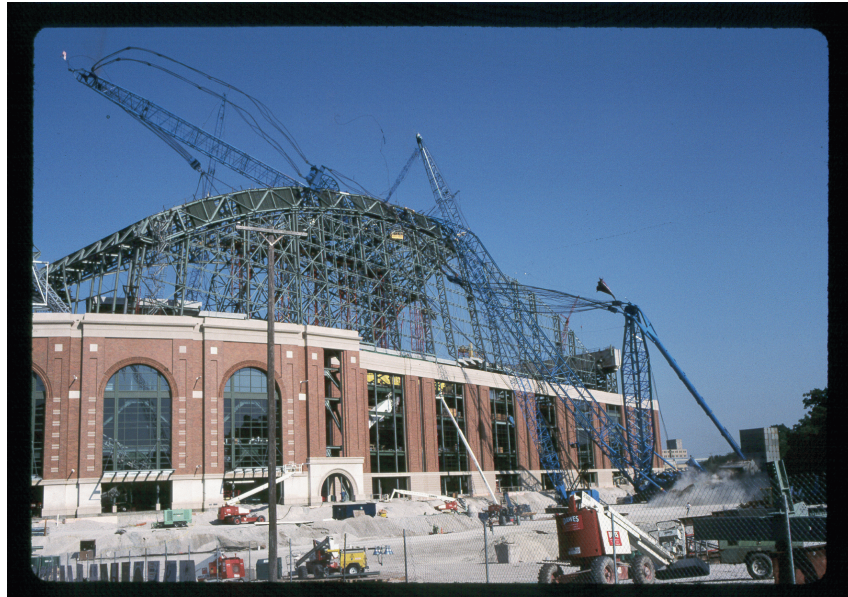
*Photo 1: Heavy-lift crane during tipover at stadium  
(Photo courtesy of John A. Thraen)*

to observe the hoisting of a 450-ton roof section. The roof section had been hoisted to about 330 feet and transported over its connection location by the heavy-lift crane crew. As the roof section was being lowered into place, the heavy-lift crane began to tip over. The crane continued tipping, and the roof section collided with the personnel platform, knocking it and the victims to the ground. Fire department and emergency medical personnel were immediately notified and responded within 5 minutes. The victims were pronounced dead on site by the county medical examiner.

Evaluation of information gathered during the investigation indicates that the weight of the hoisted load, side loads from wind forces on the crane and roof section, out-of-level ground conditions, and the pendulum motion of the roof section combined to tip the crane to the north. This combined load exceeded either the crane's resistance to overturning or its structural strength, causing the incident. Consequently, the hoisted load moved northward, uncontrolled, and collided with the crane and personnel platform of the victims.

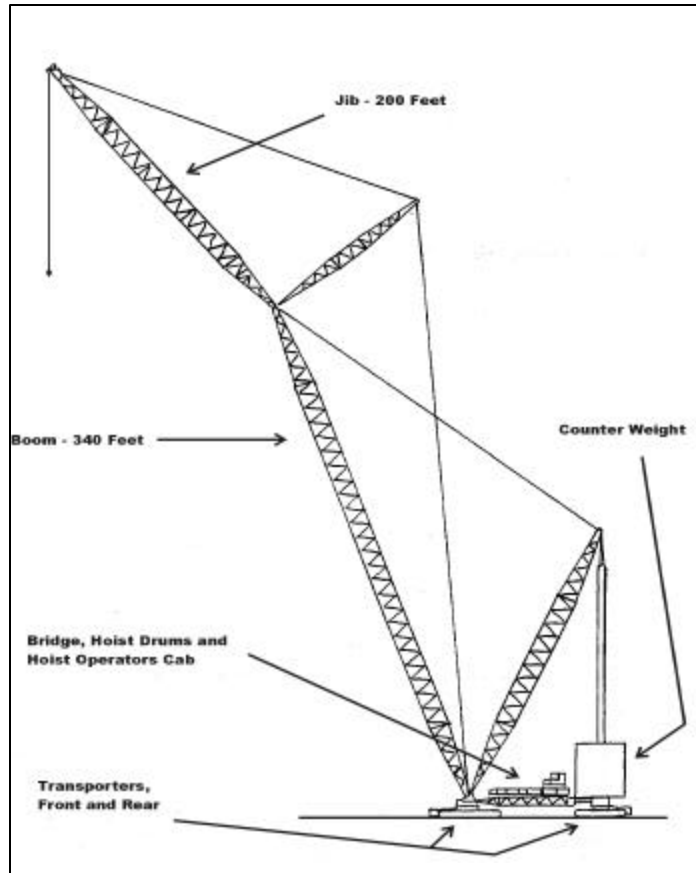
Figure 1. Side view of heavy-lift crane.

The heavy-lift crane was owned by a crane rental and heavy rigging business with over 20 years experience. The business employed 250 people worldwide. It had been at the stadium construction site for 11 months before the incident and had been used to successfully hoist 10 roof sections into place. The heavy-lift crane, of a unique design, was operated by a 5-member crew under the direction of a lift superintendent (Figure 1). Its upper-works consisted of a bridge with five hoisting drums, a hoist operator's cab, and a 340-foot lattice boom with a 200-foot jib. The upper-works was supported by two crawler-tracked transporters and was attached to the front transporter by a center pin located between the boom heel pins. The rear transporter carried a 2,400-kip (1 kip = 1,000 pounds) counterweight and was connected to the bridge by an articulated joint behind the hoist operator's cab. In this configuration, the heavy-lift crane had a maximum capacity of 1,040 kips. Each diesel-powered transporter had its own operator. Two individually operated tugger winches, used to control lines attached to the hoisted load, were mounted on the bridge near the boom heel pins. Crane travel and boom swing

were accomplished by the coordinated movement of the transporters under the direction of the lift superintendent. For example, to swing the boom, the transporters would be rotated at angle to the bridge. While the front transporter remained stationary, the rear transporter would continue traveling, moving the rear of the bridge and thus swinging the boom. Moving both transporters in the same direction along parallel paths moved the crane sideways. To move the crane forward or backward, the transporters would be rotated in-line with the bridge, one transporter traveling in trail with the other. Along with the heavy-lift crane, the crane rental company had supplied the services of a lift superintendent, a hoist operator, and a mechanic/transporter operator who operated the rear transporter. The remaining crew members, two tugger winch operators and the front transporter operator, were employees of the steel erection firm.

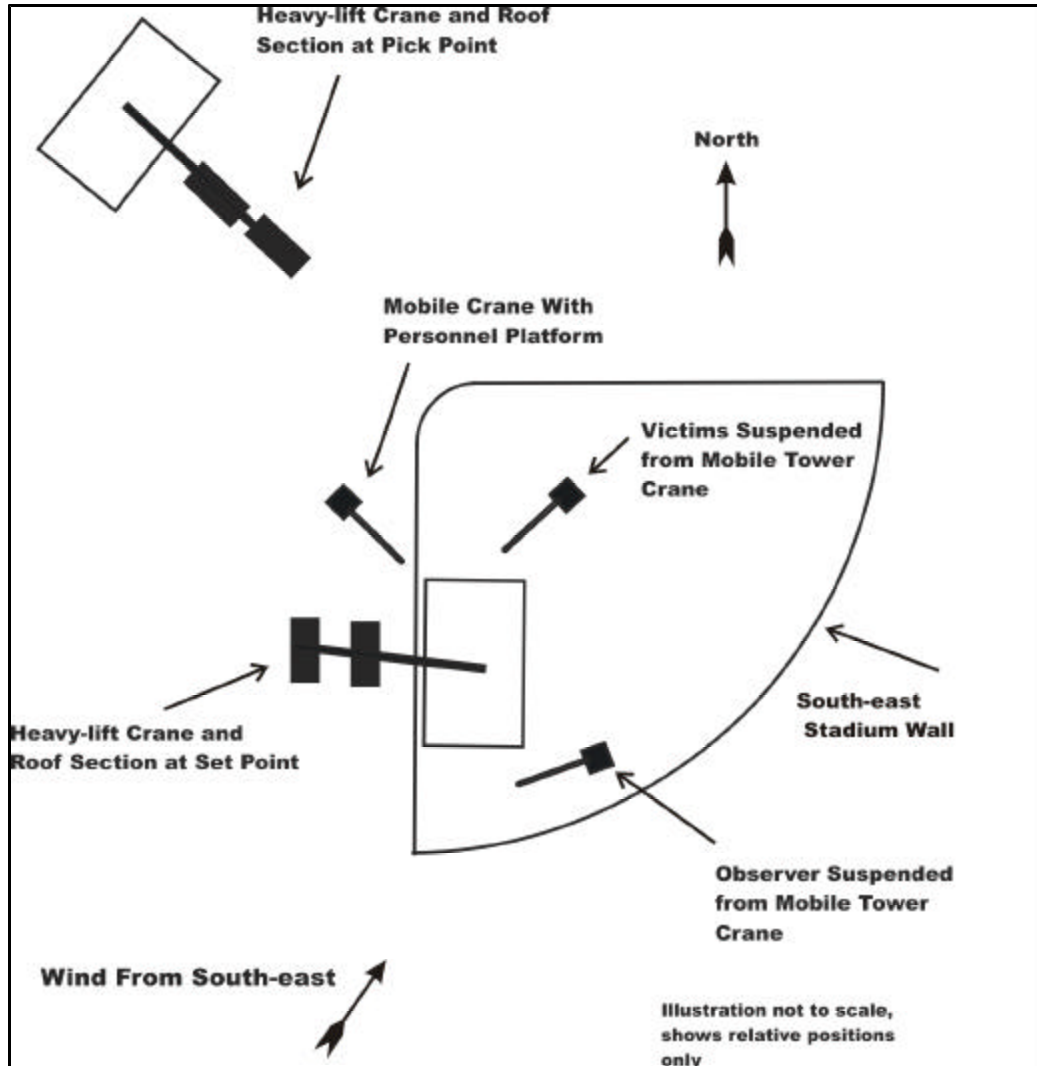
*Figure 2. Plan view, heavy-lift crane and stadium.*

Discussion: At the time of the incident, there were four observers located in two personnel platforms suspended from cranes located inside the stadium (Figure 2). Three of the observers (the victims) were occupying a personnel platform to the northeast of the heavy-lift crane. One observer was in a personnel platform southeast of the heavy-lift crane. When the heavy-lift crane tipped over to the north, the roof section swung into the victims' platform, severing the load line and collapsing the boom of the crane suspending them. The victims fell to the ground along with the personnel platform. Additionally, the lift supervisor was preparing to relocate to the personnel platform located north of the heavy-lift crane near the west face of the stadium. When the heavy-lift crane tipped over, it struck and collapsed the boom of the crane intended for hoisting this platform. Had the incident occurred a few minutes later, it most likely would have struck this platform and injured the lift supervisor. Use of new technology such as strategically located television cameras could eliminate the need for hoisted observers or decrease the amount of time necessary for them to be in the air. The use of distance- and position-measuring instruments, such as laser theodolites, during hoist operations similar to those of the incident could further reduce the need for hoisted observers.

***Recommendation No. 4: Employers should consider alternative methods of observation when landing locations are not readily visible to ground level observers during hoisting operations.***

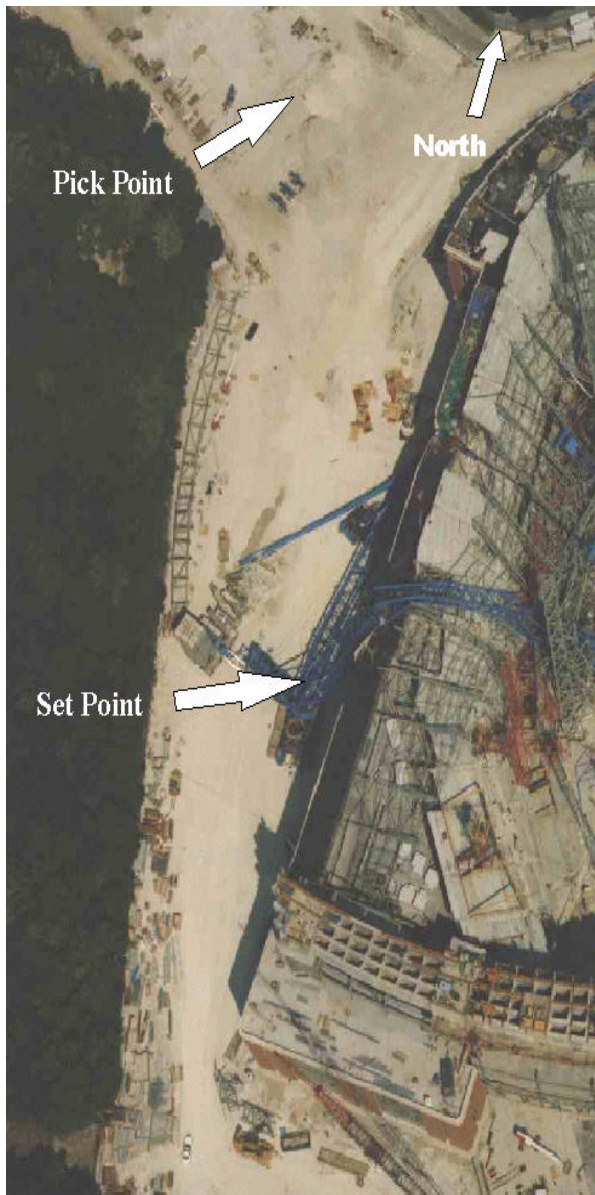
*Photo 2. Travel route from pick point to set point.*

heavy-lift crane into position. At 5 a.m. on July 14, 1999, the lift superintendent completed the lift plan. The crane crew arrived for work at 5:30 a.m. and performed routine daily crane maintenance. Other workers who would be involved in the lift arrived on site around 6 a.m. At 6:30 a.m., a prelift meeting was held which was attended by approximately 40 workers from the various employers involved in the lift. During the meeting, the lift superintendent briefed the crane operators and observers on the procedures to be used during the lift and the directions in which the crane and its load would be maneuvered. The lift would be directed by the lift superintendent while located on the ground near the heavy-lift crane. It would begin at the "pick point" (Photo 2) near the north end of

the stadium where the roof section would be hoisted and checks made to be sure it was properly suspended. The roof section would then be swung to the west, hoisted over the south end of the stadium, and moved to the "set point" near the south end, where the roof section would be lowered into place. The lift superintendent would then direct the final positioning and connection while suspended from the third personnel platform. At 7 a.m., the lift superintendent examined the load and rigging and established radio communication with the crane crews and observers. Hoisting operations were begun and the 176- by 200- by 16-foot roof section, which had been resting on support blocks, was picked up. At about 9:30 a.m., after the roof section had been raised 6 to 8 feet above the blocks, the lift was halted so that the attitude of the roof section (i.e., the orientation at which the hoisted load hangs suspended) could be determined by survey. Since the roof was curved, the connections between the roof sections were at differing elevations on the stadium structure (Photo 3). To successfully connect the roof sections together, it was necessary to hoist them into place at nearly the same attitude as they would be connected. For the roof section being lifted, the south-end connections were at a lower elevation than the north-end connections. The attitude at which a suspended object hangs depends on the location of the object's center of gravity in relation to the attachment points and lengths of the lines suspending it. The attitude of a hoisted load is usually adjusted by moving
