## Seventeen-Year-Old Window Washer Dies After Falling 180 Feet Due to a Rigging Anchor Failure—PA

### Fatality Assessment and Control Evaluation (FACE) Project

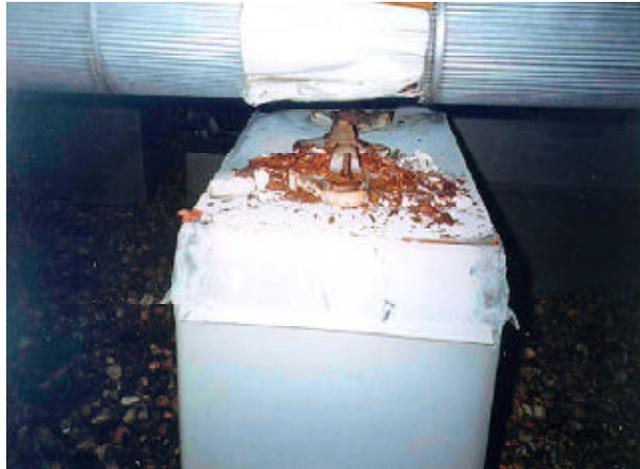
*Bracket used as anchor point for rigging*

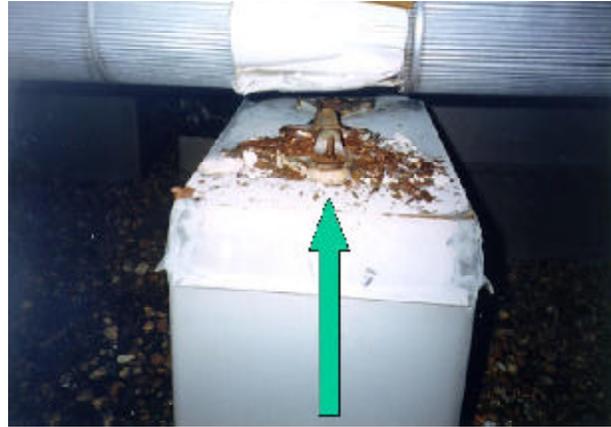
The victim then tied the rope at its midpoint around a bracket supporting one of several 8-inch feed and return steam lines located on the building's roof. The bracket was mounted on a concrete pillar approximately 24 inches above the roof's surface. A roller was located on the interior of the bracket that allowed the steam line to move back and forth on the bracket as it expanded and contracted.

The victim stepped over the parapet wall of the roof, lowered himself to the 20<sup>th</sup>-story windows, and began washing. The victim had washed windows down to the 17<sup>th</sup>-story level when the bracket the rope had been attached to gave way (Photo1) and the vent pipe snapped off, allowing the victim to fall 180 feet to the sidewalk below. The Emergency Medical Service (EMS) was summoned by phone from inside the complex. EMS responded and transported the victim to the hospital where he was pronounced dead on arrival.

When the bracket gave way, pieces were pulled from under the steam line and the steam line's insulation was pulled away. Inspection of the rope revealed the loop in the rope. The only additional anchor that the victim could have used was the vent pipe which was located 5 feet from the steam line bracket. It had been torn from the steam line and was discovered approximately 4 feet from the steam line and 24 inches from the parapet wall of the roof.

*Photo 1 Bracket used as anchor point for rigging*

**Recommendation #2: Employers should ensure that a competent<sup>a</sup> person evaluates and inspects all anchor points and rigging to be used by window washers prior to the start of work.**

Discussion: To ensure that adequate anchor points and required rigging are utilized by workers, employers should ensure that a competent person evaluates and inspects all anchor points and rigging prior to the start of work. The victim had been working on a part-time basis for the company for 1½

**Additionally, building owners who have routine maintenance performed on their buildings should consider the installation of permanent anchor points.**

Discussion: The owner of the condominium complex contracted the employer to wash the windows of the building twice a year. Additionally, routine maintenance and inspection of the steam lines on the roof were conducted periodically. When maintenance will be performed on a building that will require workers to utilize anchor points on the building's roof, building owners should consider the identification or installation of permanent anchor points that would be evaluated by a professional engineer. Any anchor points identified or installed should be able to withstand a minimum load of 5,000 lb, as is considered adequate by the OSHA interpretation of the standard.
