A 33-Year-Old Textile Worker Dies After Being Pinned by a Bobbin Lift/Dump - North Carolina**SUMMARY**

Fatality Assessment and Control Evaluation (FACE) Project

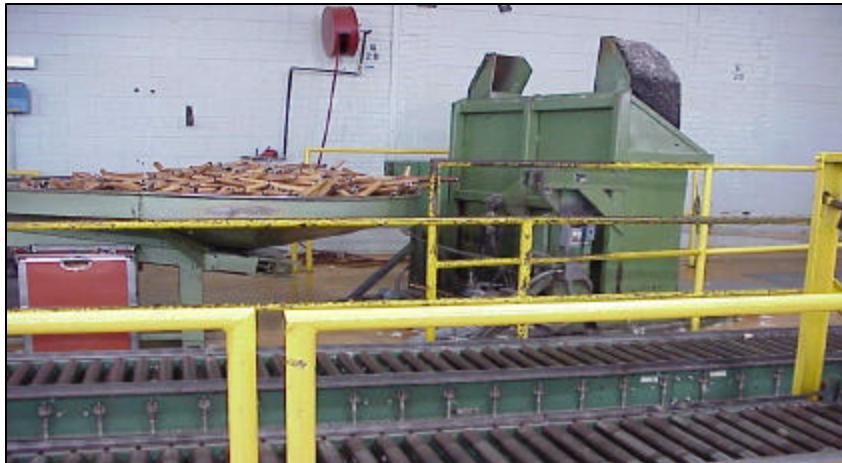
*Bobbin lift/dump*

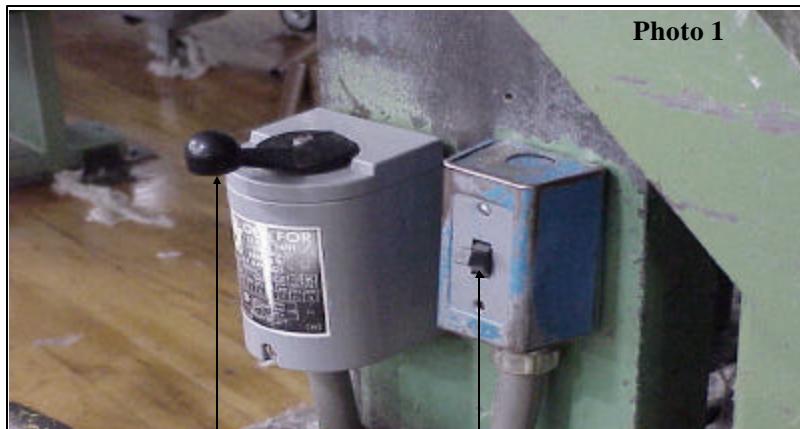
***Photo 1.** Control lever used to operate the machine*

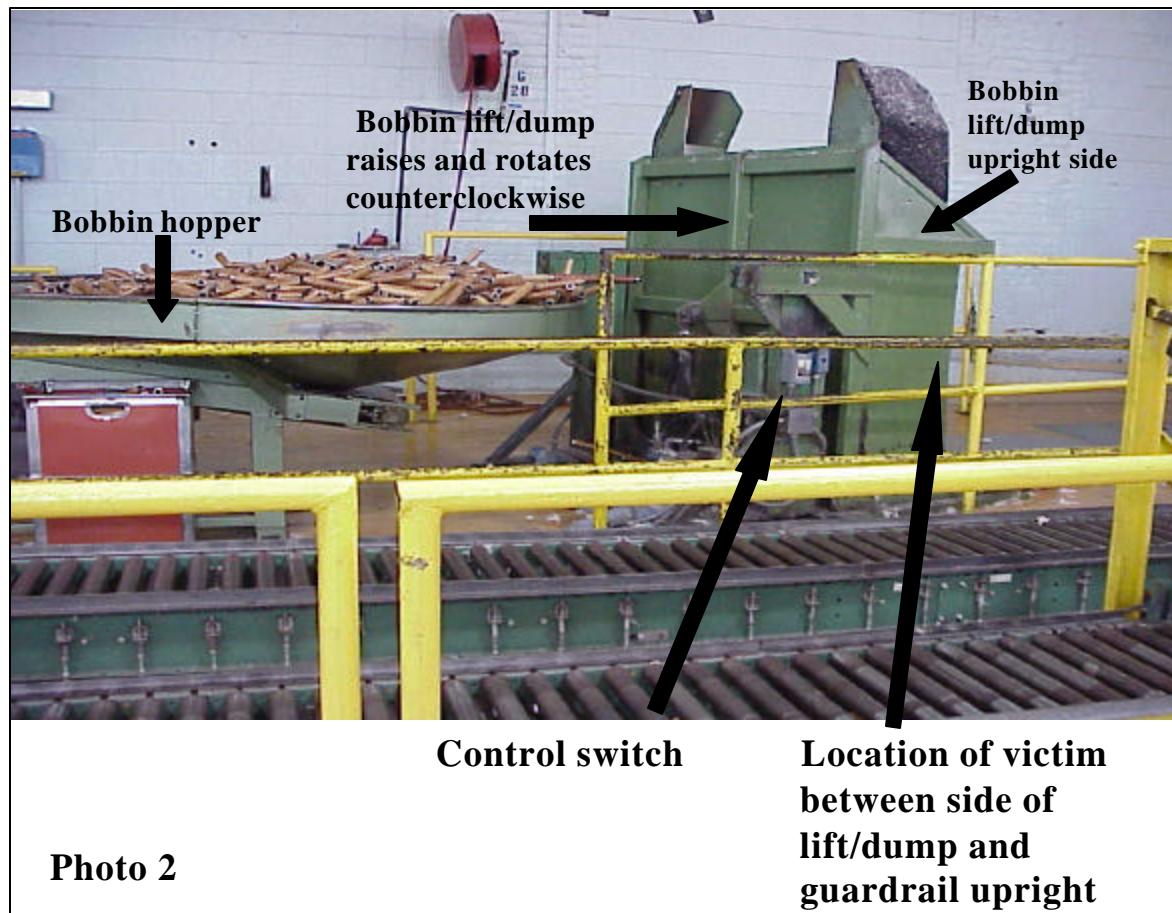
Photo 2. Location of lift/dump and guardrail upright where the victim was pinned

Discussion: The machine involved in this incident was guarded in front to provide a barrier between the moving parts of the machine and the machine operator; however, a potential pinch point existed between the guardrail and the side of the lift/dump. When the victim placed himself between the guardrail and the side of the machine and lowered the dumper, he was pinned between the two surfaces.

Employers should evaluate machine guarding to determine if any potential pinch points are created by the guarding, then modify the guarding to eliminate any pinch points. Machine manufacturers can be contacted to determine if retrofit guarding may have been developed for their products. Since the incident, the employer has made modifications to the machine. A shatterproof plexiglass barrier was mounted directly to the front of the machine. The controls could be accessed by a cutout in the plexiglass. This eliminated any space between the machine and the barrier. The control switch was changed from a one-handed control to a control that required the use of two hands for operation. Additionally, the work station was redesigned to allow the operator more room around the perimeter of the machine.
