Construction Laborer Dies After Being Struck in the Head by Backhoe Bucket- North Carolina

Fatality Assessment and Control Evaluation (FACE) Project

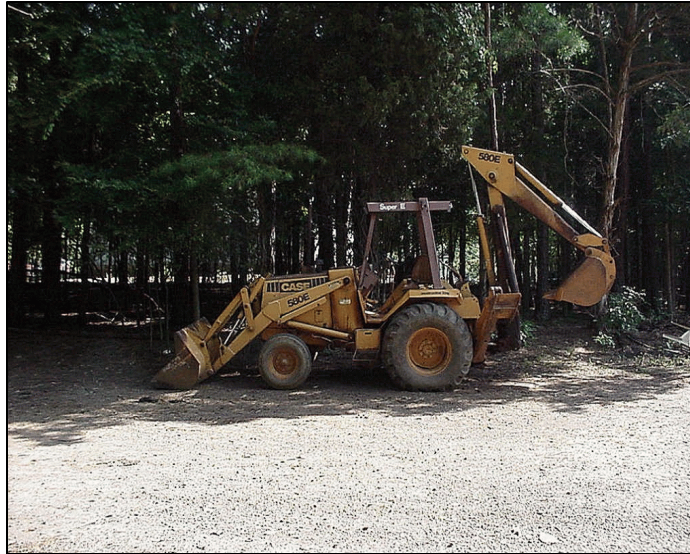
Backhoe used the day of the incident

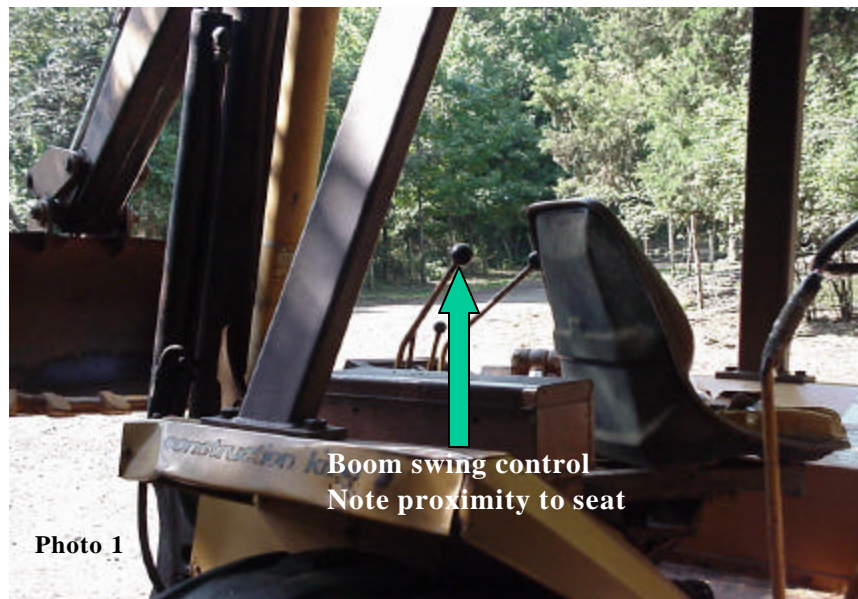
Photo 1

As the operator stepped over the fender and into the cab, he bent over to adjust the seat that had turned to the right as he had exited the cab. As the operator was adjusting the seat, he inadvertently contacted the far left control on the control panel (Photo1), which controlled the swing of the boom. The boom swung toward the house and struck the victim, still standing in the ditch, and pinned him

Photo 1: Boom swing control location on Backhoe

The distance between the left fender and the seat was approximately 10 inches. Anyone entering the cab from the left side would have their path obstructed by the parking brake and the boom swing control on the far left side of the control panel. The distance from the front of the seat to the boom swing control was approximately 11 inches. The seat moved freely right to left to right but had to be lifted to move it front to back. When operated by the owner, it was found that the boom swing control did not actuate the boom until the control had traveled approximately 1½ inches. It is possible that as the operator leaned over to adjust the seat, he leaned against the boom swing control sufficiently to actuate the boom, causing it to swing toward the house, allowing the bucket to strike the victim.

Discussion: The controls for the arm and bucket and swing were unmarked. Although not a factor in this incident, the seatbelt for the machine was also missing. The owner stated that the seatbelt was missing when he purchased the machine 8 years earlier. As stated in the owner's manual, all safety decals on controls should be replaced when missing and the seatbelt should be in operable condition. 29CFR. 1926.602 (a) (1) requires operator seatbelts for this type of machinery.²

Recommendation #3: Employers should ensure that all machine controls are properly identified and that manufacturers' safety features are operable.

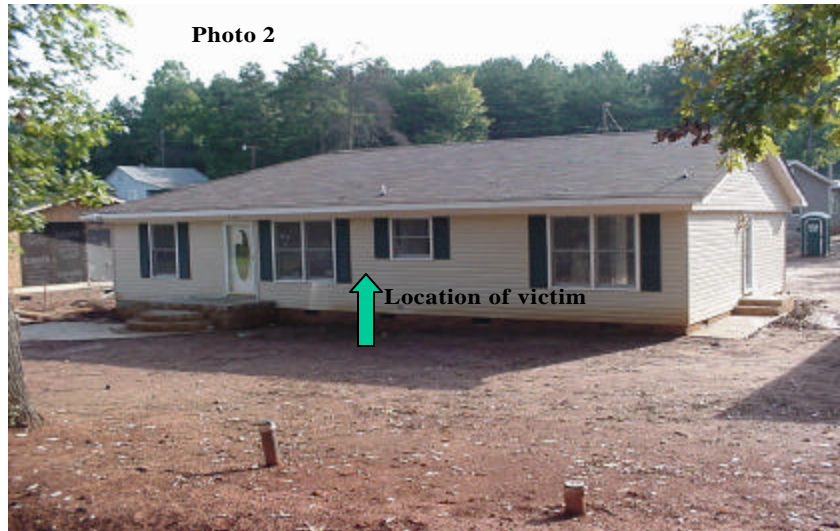
against the front wall of the house (Photo 2). The operator immediately swung the boom away from the victim and ran to his aid while yelling to a resident across the street to call 911. The operator removed the victim from the ditch. He could not detect any vital signs and initiated cardiopulmonary resuscitation (CPR). When the Emergency Medical Service arrived, the operator moved the machine to the other side

Photo 2: Location of the victim
