FACE Report Number: 2001-08

March 14, 2002

36-Year-Old Paper Factory Worker Dies From Crushing Injuries After Being Caught in a Horizontal Baler - Pennsylvania

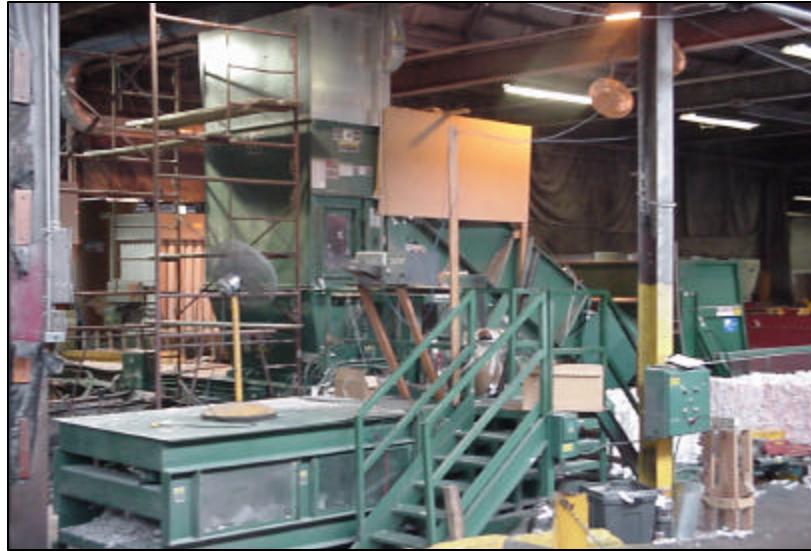
Figure 1. 2-Stage horizontal bailing machine

Subsequent examination by investigators revealed that the baling machine was not shut off and locked out and that the safety interlock on the compression chamber door may have malfunctioned, allowing the machine to operate with the door in the open position.

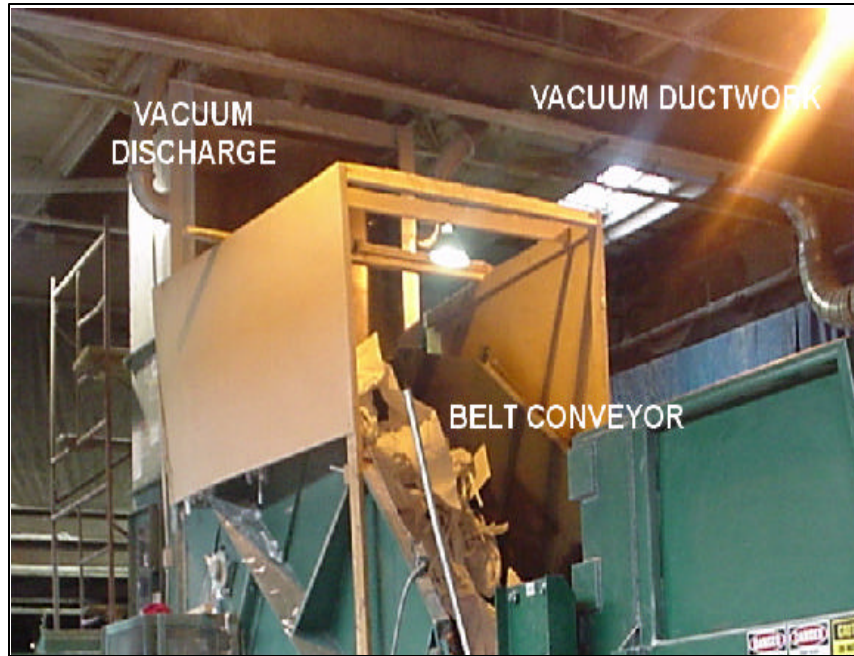
cut and packed in various dimensions. Stock paper from the rolls or sheets is fed through cutting machines that trim and size the paper product according to the customer's specific orders. After cutting, the finished product is boxed and ready for shipment to the customer. Waste paper trimmings are collected at each of the cutters by a vacuum system that conveys the paper through a series of overhead ductwork to a 2-stage horizontal paper baler. The baler is in an isolated location at the rear of the facility away from most of the production areas. The termination point for the vacuum system is an approximately 4-foot by 5-foot rectangular, open-front sheet metal box sitting atop the baler feed chute (Figure 2). Paper falls into a feed hopper then down through a 14-foot chute to the baling chamber.

Figure 2. Baler feed chute

On the day of the incident, scrap paper was being fed into the loading chamber of the baler from the overhead duct work. As reported during the investigation, at some point near the end of the shift, incoming paper to the baler was blocked due to jamming. That jamming condition was signaled back up the line, and waste paper was diverted to the bins. The bins were to be later transported by forklift and dumped into the baler. As reported by workers who responded to the victim's aid, the conveyor was off and the dumper was lowered; however, they were not sure if the baler was off or still in the automatic mode. Access to the loading chamber by climbing up the conveyor belt would have been possible. The victim may have lost his balance and fallen into the baler compression chamber while attempting to free the reported paper jam near the top of the paper discharge chute. The victim was 70 inches tall, and if he had fallen into the baler, he would have been able to reach up to the access door, given that the vertical distance from the bottom of the compression chamber floor to the bottom of the access door is 87 inches. If the victim had reached the bottom of the access door and pushed it open, power to the hydraulic system would have stopped.

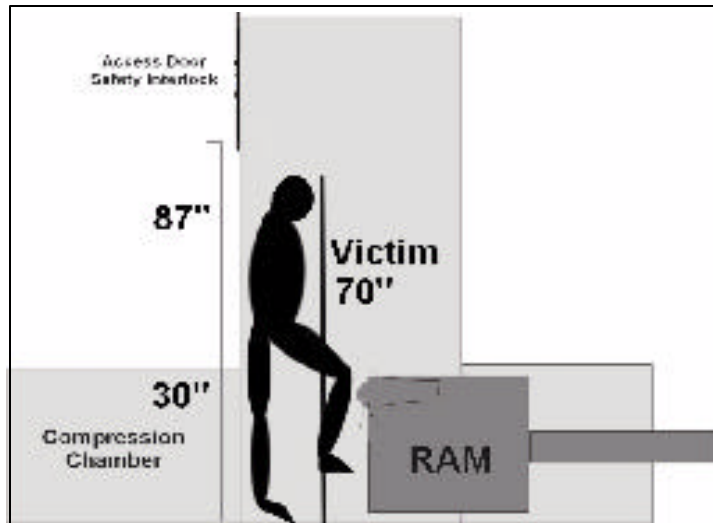
Photographs of the body position inside the compression chamber show that the victim was semi-standing but slumped over against the inside wall of the loading chute. Injuries reported in the autopsy indicate that the victim may have been trying to step up on top of the ram as it started to cycle. Being an experienced baler operator, the victim may have known that the machine was going to cycle and he may have attempted to jump above the ram. The worker who found the victim reported that the access door was open approximately 6 inches. The victim may have reached up in an attempt to open the door knowing that once opened, the safety interlock would stop the ram. He may have succeeded in opening the door enough to activate the safety interlock, causing the ram to stop, but not soon enough to avoid being trapped against the ram and the compression chamber wall. Figure 3 is a graphical representation of the victim's position inside the baler.

Figure 3. Graphical representation of victim inside baler. Autopsy findings suggest that the victim may have been attempting to step up onto the ram as it cycled.

He may have succeeded in opening the door enough to activate the safety interlock, causing the ram to stop, but not soon enough to avoid being trapped against the ram and the compression chamber wall. Figure 3 is a graphical representation of the victim's position inside the baler.

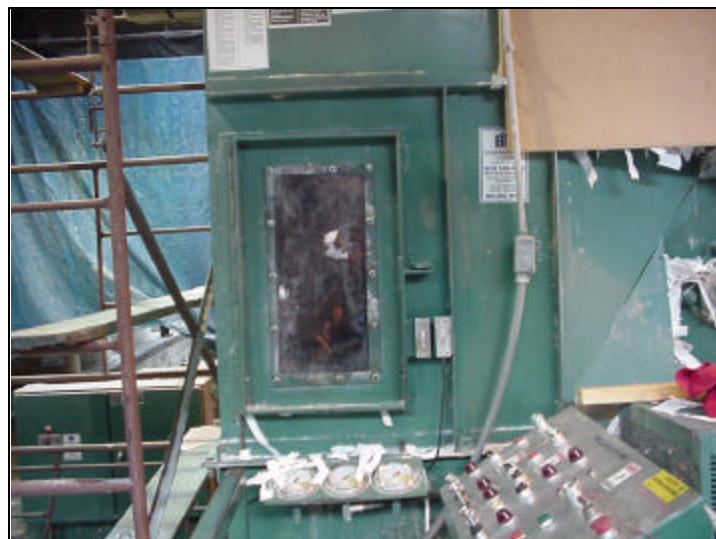
- ▶ *The second scenario has the victim entering the compression chamber access door (Figure 4) to free a jam inside the baling chamber.*

Figure 4. Baler access door

workers and maintenance personnel. Prior to this incident, maintenance moved the contact plates closer together in an attempt to correct the malfunction. It is possible that the victim opened the access door of the baler; and relying on the safety interlock to de-energize the pumps, he entered the chamber to clear a jam. If the safety interlock had failed, power would not have been shut down, and once the victim was inside the chamber, the electric eye would have sensed that the chamber was full and started to cycle.

Workers should be made aware that before attempting to clear a jammed machine, it must be deactivated, locked out and tagged out so that no other person can reactivate it.

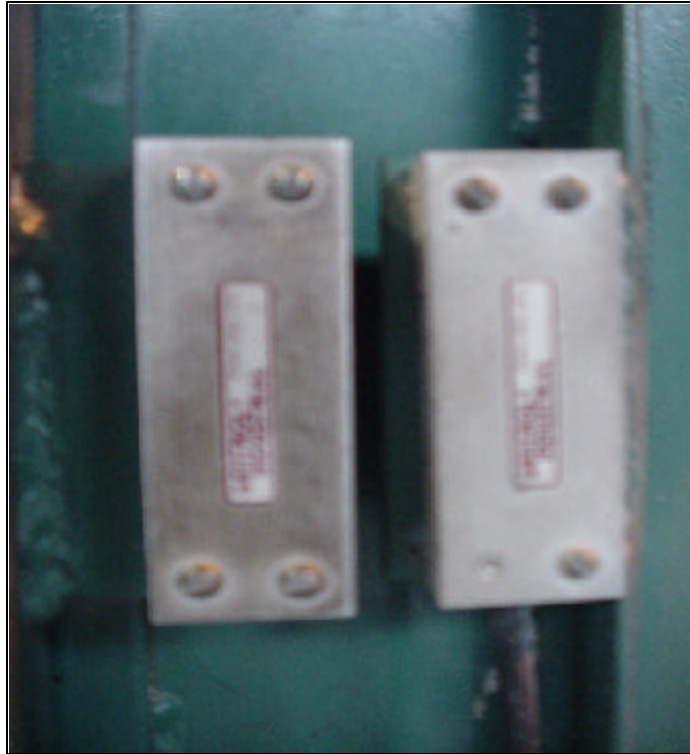
The access door was equipped with a safety interlock that de-energized power to the baler (Figure 5). The interlock is an electro-magnetic switch that activates when the magnetic field between the switch is broken. When the field is broken, power to the hydraulic pumps of the ram are de-energized. It was reported by the maintenance supervisor that the safety interlock intermittently failed, thereby leaving the ram hydraulic pumps energized. This intermittent problem was observed once before the incident, and once after the incident by both

The NIOSH investigators tested the interlocks and could not duplicate the failure. In addition to testing the interlocks, other baler operating features were tested, and the following table outlines the observations noted:

Figure 5. Door safety interlock

When the safety devices are operating correctly, they protect against the inadvertent exposure of persons to the movement of the ram. The safety interlock on the baling machine involved in this incident had been observed failing twice. It is not known if the interlock failure played a role in this fatality. Although the maintenance foreman said there were two occasions when the electrical power to the hydraulic system was on with the interlocked door open, we were unable to produce this condition. The interlock device did not appear to have been tampered with. The interlock maintained the system in an “off” condition when another metal object was placed near the sensing unit.

Any concerns about the integrity of the safety features should be addressed immediately and the machine removed from service until proper repairs can be made by a qualified representative authorized by the manufacturer to make such repairs.
