A Sixteen-Year-Old Male Died After Falling 27 Feet at a Residential Construction Site—Alabama

Fatality Assessment and Control Evaluation (FACE) Project

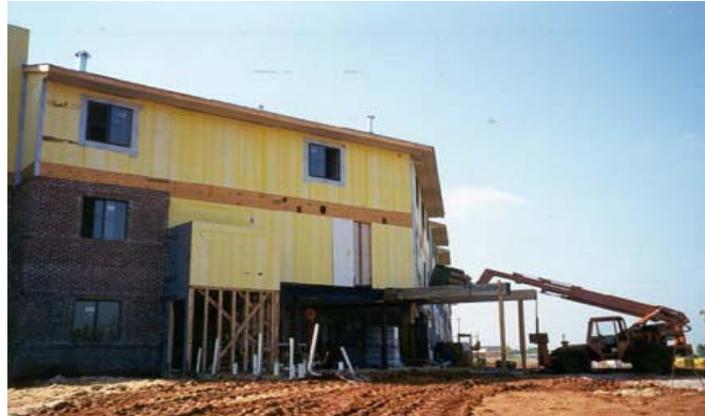
Incident Site

A 16-year-old male framing construction crew member (the victim) died after falling 27 feet from the third story of a residential dormitory construction site. The victim was moving roof trusses that were to be anchored in place using a nail gun. He was supporting himself on an 8-inch wide structural wooden beam. The victim was not wearing or using personal fall protection equipment. When the victim fell to the ground floor inside the building, at least one of the 8-foot by 4-foot trusses fell with him or just behind him, striking

his head when he impacted the ground. Co-workers notified the supervisor who immediately called 911. Co-workers and other witnesses went to the victim to assist him. Emergency responders arrived within a few minutes, and on observing the severity of the head injury, transported the victim to a local city hospital where he was pronounced dead. NIOSH investigators concluded that to help prevent similar occurrences, employers should

- *ensure that all employees are provided fall protection when exposed to fall hazards*
- *develop, implement, and enforce a comprehensive written safety program*
- *provide comprehensive safety training to employees to include, but not be limited to, safe work practices, hazard awareness, identification, and avoidance*

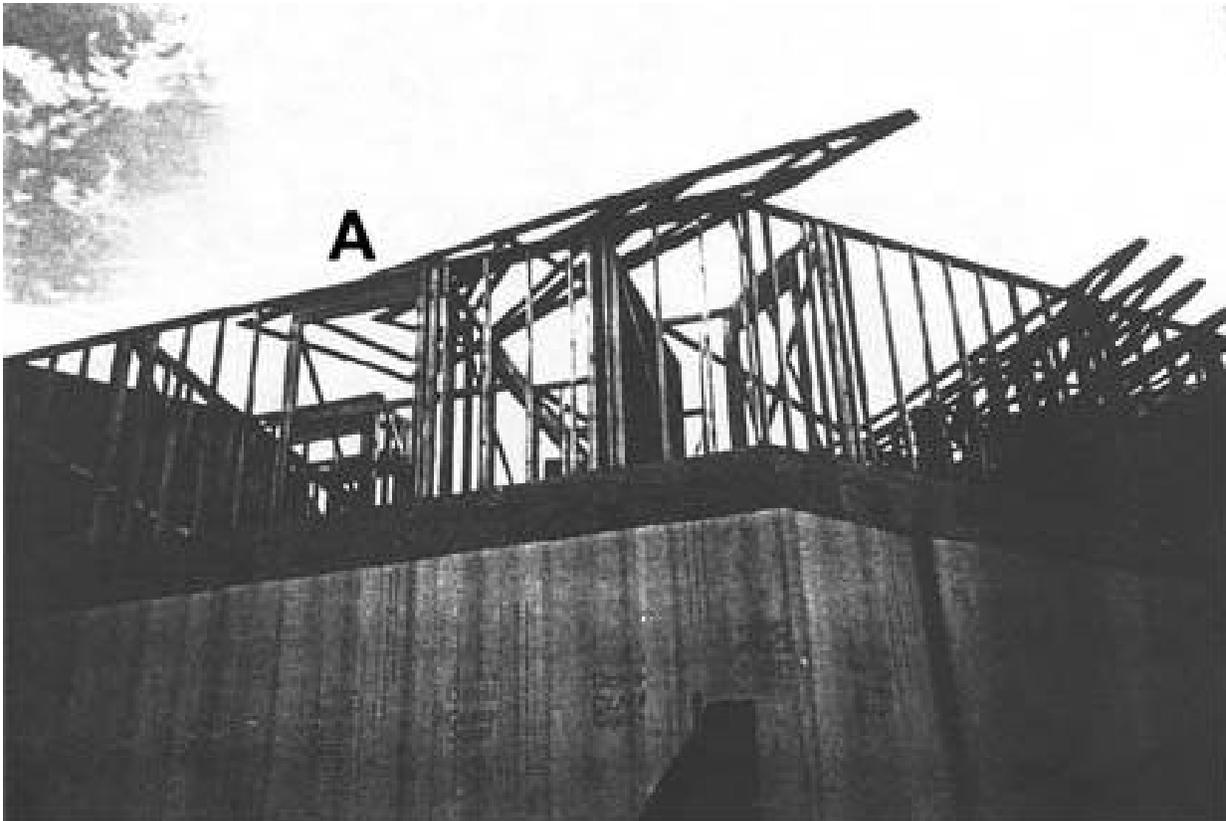
On April 4, 2000, the crew was putting roof trusses in place on top of the third story of the residential dormitory (see Photo 1). The weather was clear and the walkways and work surfaces were dry. A crane had just placed a stack of 4-foot by 8-foot roof trusses at the top edge of the building. The trusses were constructed of reinforced 2-inch by 4-inch lumber. Crew members were in the process of spacing the trusses out along the top of the building frame where they would be later nailed into place using a pneumatic nail gun.

Photo 1. *The three-story residential construction site where the victim fell from Point A to the interior dirt floor, 27 feet below.*

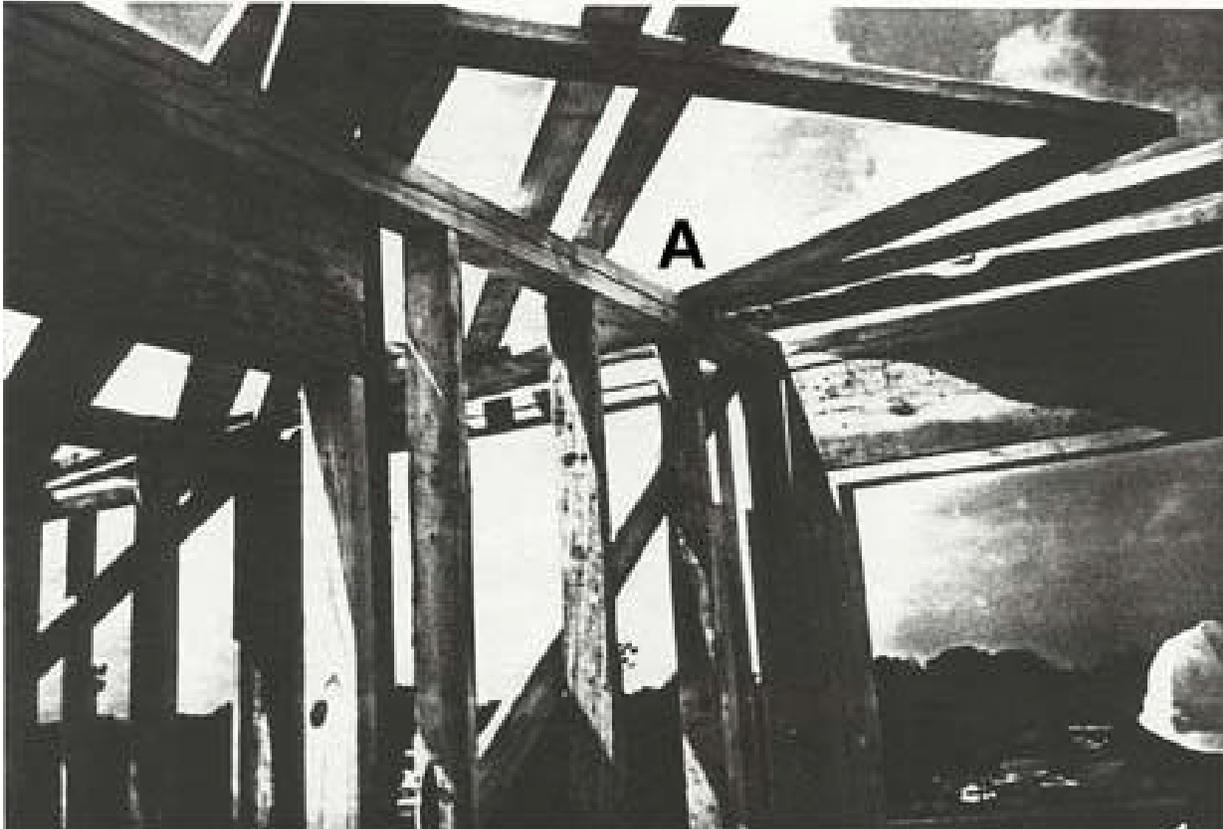
At approximately 9:35 a.m., the victim was observed moving a roof truss into place while supporting himself on an 8-inch-wide wooden structural beam (Photo 2). At some point he fell 27 feet to the interior dirt floor of the building (Photos 3 and 4). The actual fall was not witnessed. The floor area to which he fell was covered with building materials and scrap lumber. One or more of the trusses fell with or just behind the victim, and he was struck on the head by a truss upon impact with the ground.

***Photo 2.** The victim was standing at Point A on a wooden structural beam 8 inches wide. He was attempting to move an 8-foot wooden truss section when he fell.*

Recommendation #1: Employers should ensure that all employees are provided fall protection when exposed to fall hazards.

standard requires that fall protection shall be provided and used. Investigators observed personal fall arrest system equipment available at the work site, but did not see it in use. Had this equipment been used by the victim to tie into a properly rigged life line, the fatal injuries may have been prevented. Requirements for fall protection are found in 29 CFR 1926.501 (b) (1).

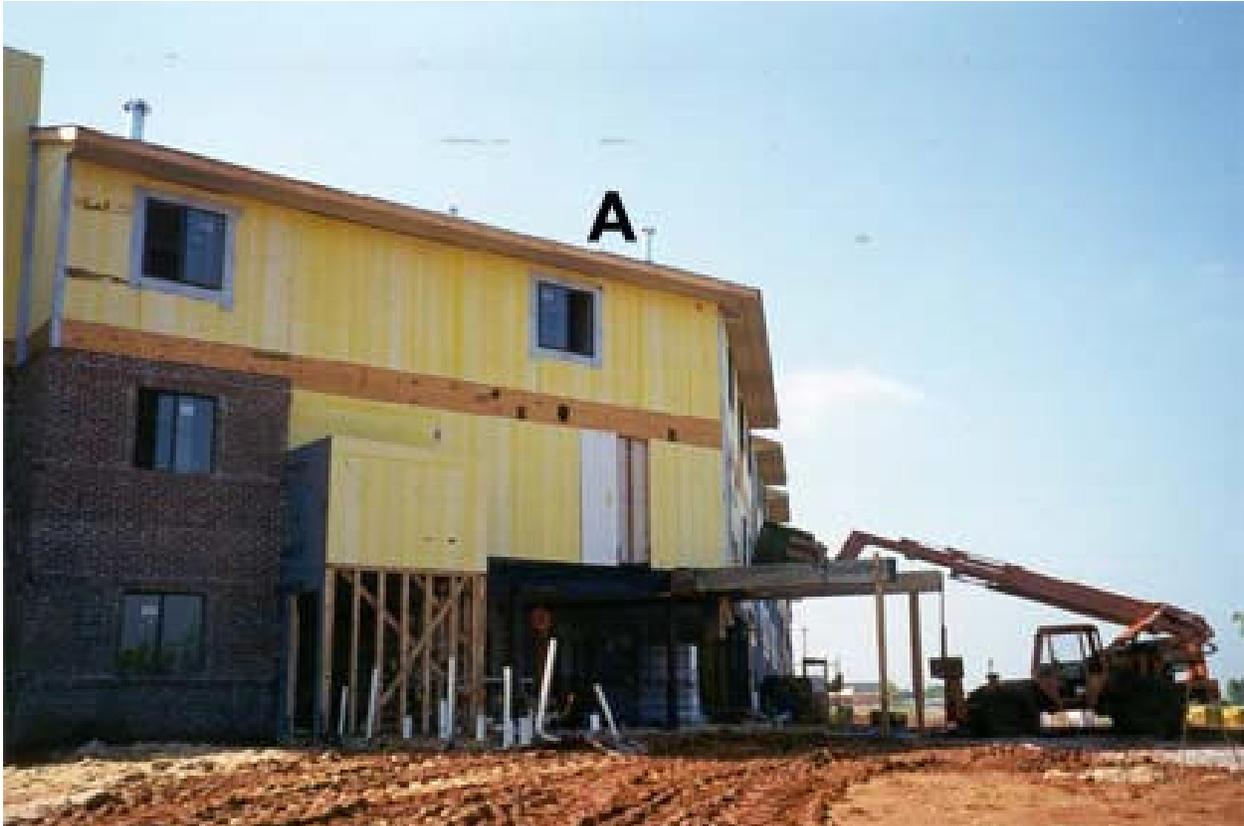
Photo 4. Incident site several weeks after the fatal event. It gives a better depiction of the actual height of the fall from Point A at roof level to Point B on the ground level just inside the interior walls.

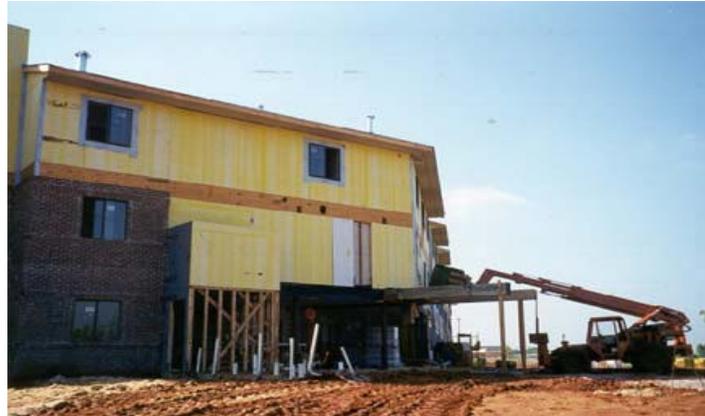
Incident Site

A 16-year-old male framing construction crew member (the victim) died after falling 27 feet from the third story of a residential dormitory construction site. The victim was moving roof trusses that were to be anchored in place using a nail gun. He was supporting himself on an 8-inch wide structural wooden beam. The victim was not wearing or using personal fall protection equipment. When the victim fell to the ground floor inside the building, at least one of the 8-foot by 4-foot trusses fell with him or just behind him, striking

his head when he impacted the ground. Co-workers notified the supervisor who immediately called 911. Co-workers and other witnesses went to the victim to assist him. Emergency responders arrived within a few minutes, and on observing the severity of the head injury, transported the victim to a local city hospital where he was pronounced dead. NIOSH investigators concluded that to help prevent similar occurrences, employers should

- *ensure that all employees are provided fall protection when exposed to fall hazards*
- *develop, implement, and enforce a comprehensive written safety program*
- *provide comprehensive safety training to employees to include, but not be limited to, safe work practices, hazard awareness, identification, and avoidance*

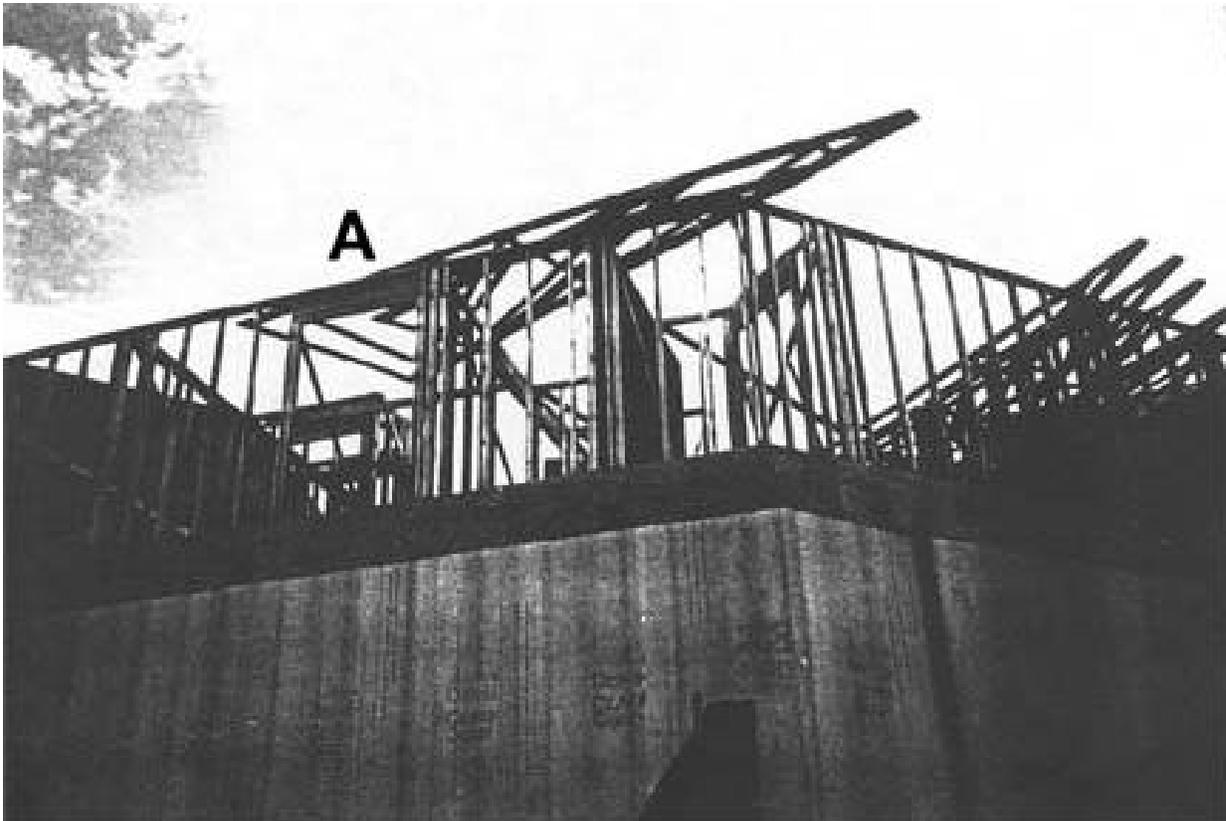
On April 4, 2000, the crew was putting roof trusses in place on top of the third story of the residential dormitory (see Photo 1). The weather was clear and the walkways and work surfaces were dry. A crane had just placed a stack of 4-foot by 8-foot roof trusses at the top edge of the building. The trusses were constructed of reinforced 2-inch by 4-inch lumber. Crew members were in the process of spacing the trusses out along the top of the building frame where they would be later nailed into place using a pneumatic nail gun.

Photo 1. *The three-story residential construction site where the victim fell from Point A to the interior dirt floor, 27 feet below.*

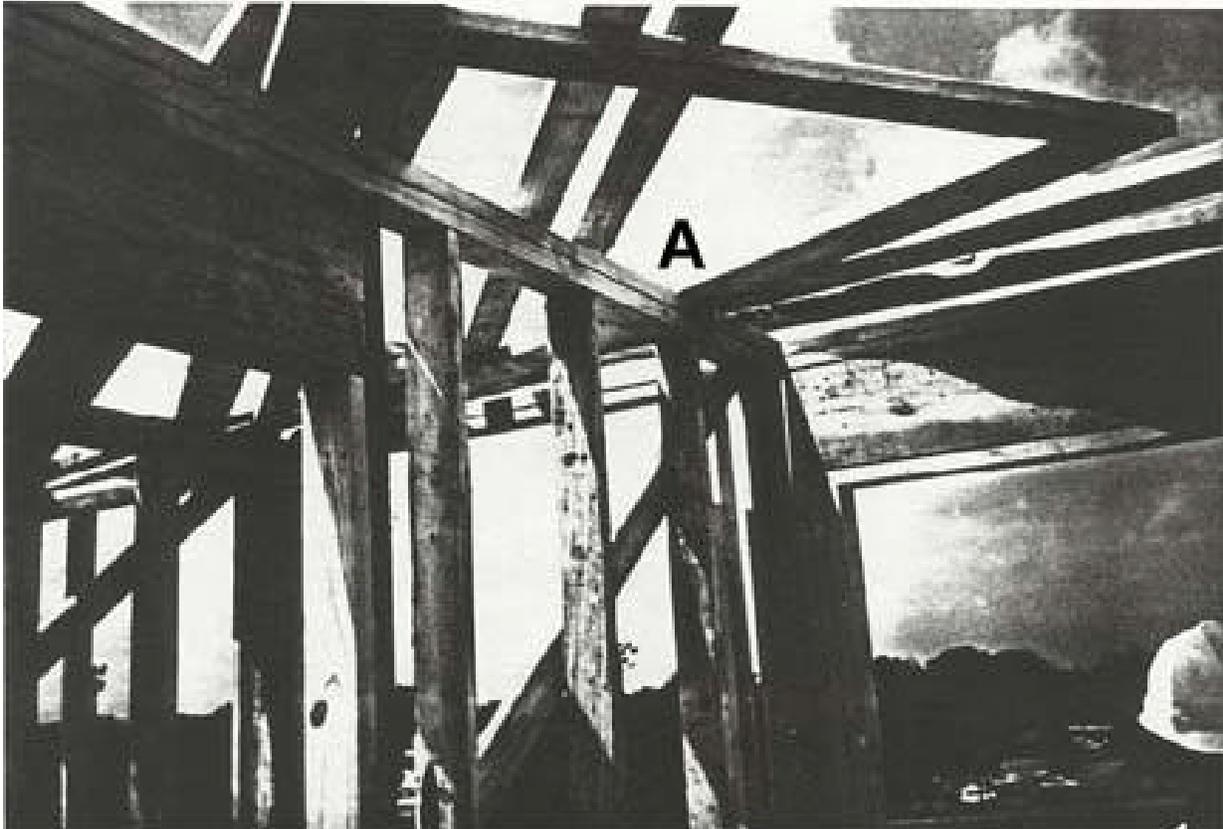
At approximately 9:35 a.m., the victim was observed moving a roof truss into place while supporting himself on an 8-inch-wide wooden structural beam (Photo 2). At some point he fell 27 feet to the interior dirt floor of the building (Photos 3 and 4). The actual fall was not witnessed. The floor area to which he fell was covered with building materials and scrap lumber. One or more of the trusses fell with or just behind the victim, and he was struck on the head by a truss upon impact with the ground.

***Photo 2.** The victim was standing at Point A on a wooden structural beam 8 inches wide. He was attempting to move an 8-foot wooden truss section when he fell.*

Recommendation #1: Employers should ensure that all employees are provided fall protection when exposed to fall hazards.

standard requires that fall protection shall be provided and used. Investigators observed personal fall arrest system equipment available at the work site, but did not see it in use. Had this equipment been used by the victim to tie into a properly rigged life line, the fatal injuries may have been prevented. Requirements for fall protection are found in 29 CFR 1926.501 (b) (1).

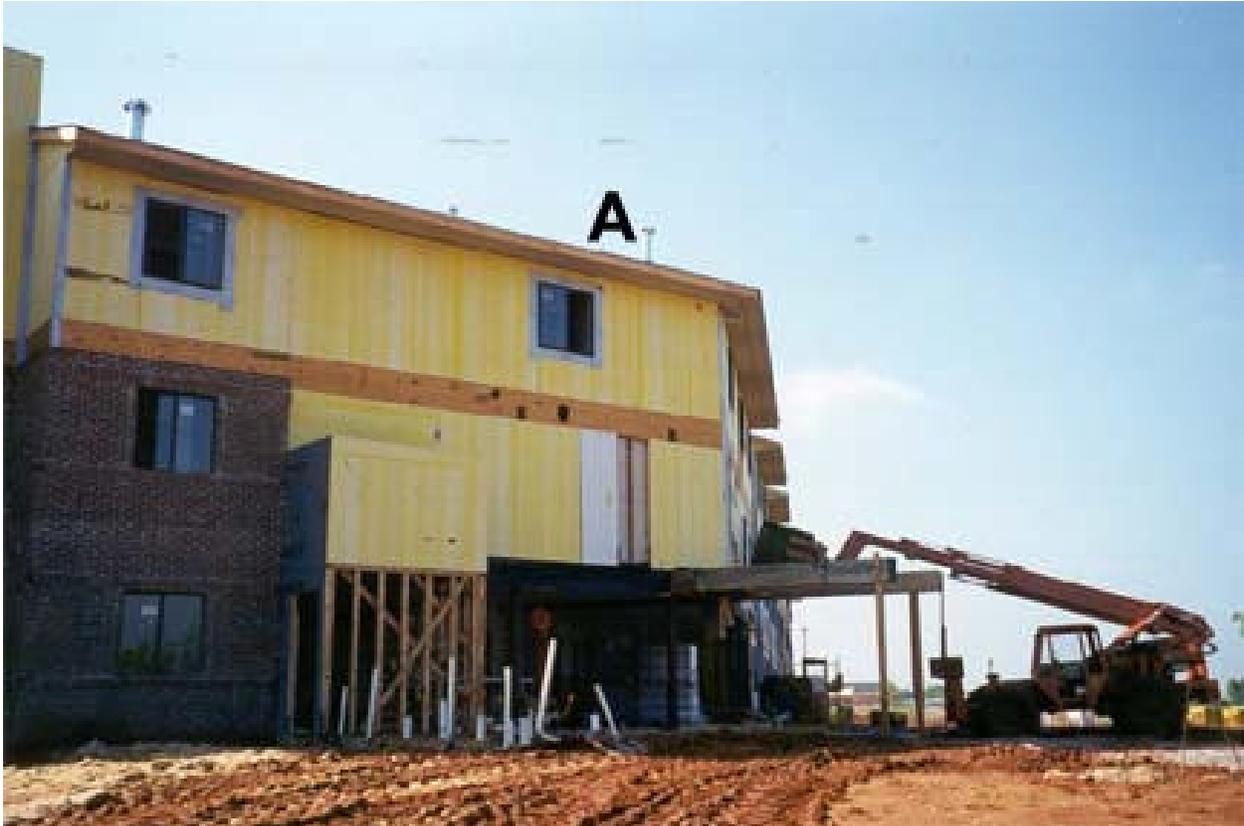
Photo 4. Incident site several weeks after the fatal event. It gives a better depiction of the actual height of the fall from Point A at roof level to Point B on the ground level just inside the interior walls.
