FACE Report Number: 2003-09

November 14, 2003

## *Two Hispanic Guardrail Installers Die After Being Struck by a Guardrail - North Carolina*

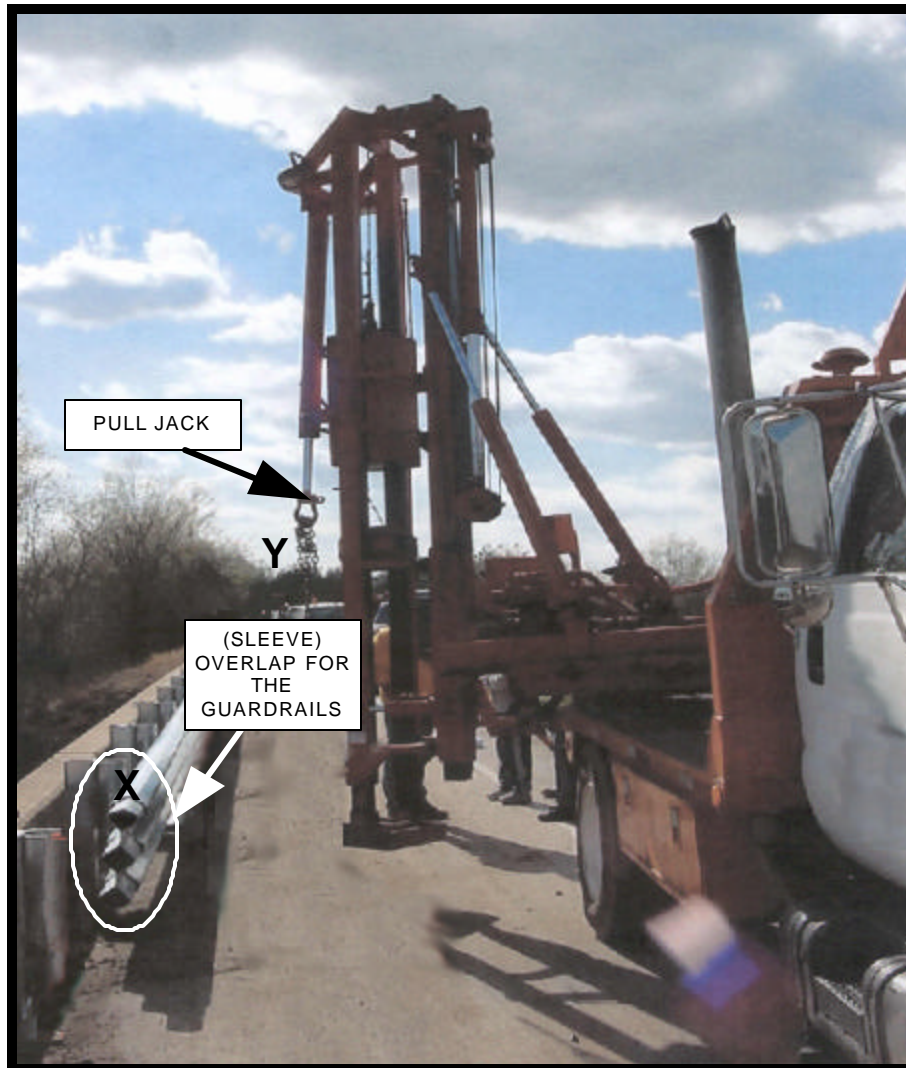
*Photo 1. This photo illustrates the truck-mounted post driver used on the day of the incident. An "X" marks the installed section of guardrail. The section of guardrail being lowered was to be slid onto the existing guardrail, like a sleeve. A "Y" marks the pull jack of the post driver. Photograph courtesy of the County Sheriff's Department.*

On the day of the incident, the crew secured metal posts to the cement railing on the eastbound bridge and installed two 25 foot sections of guardrail without incident. Because the guardrails were too heavy to be placed manually, each guardrail was attached to the pull jack of the truck-mounted post driver by a chain, and then mechanically placed.

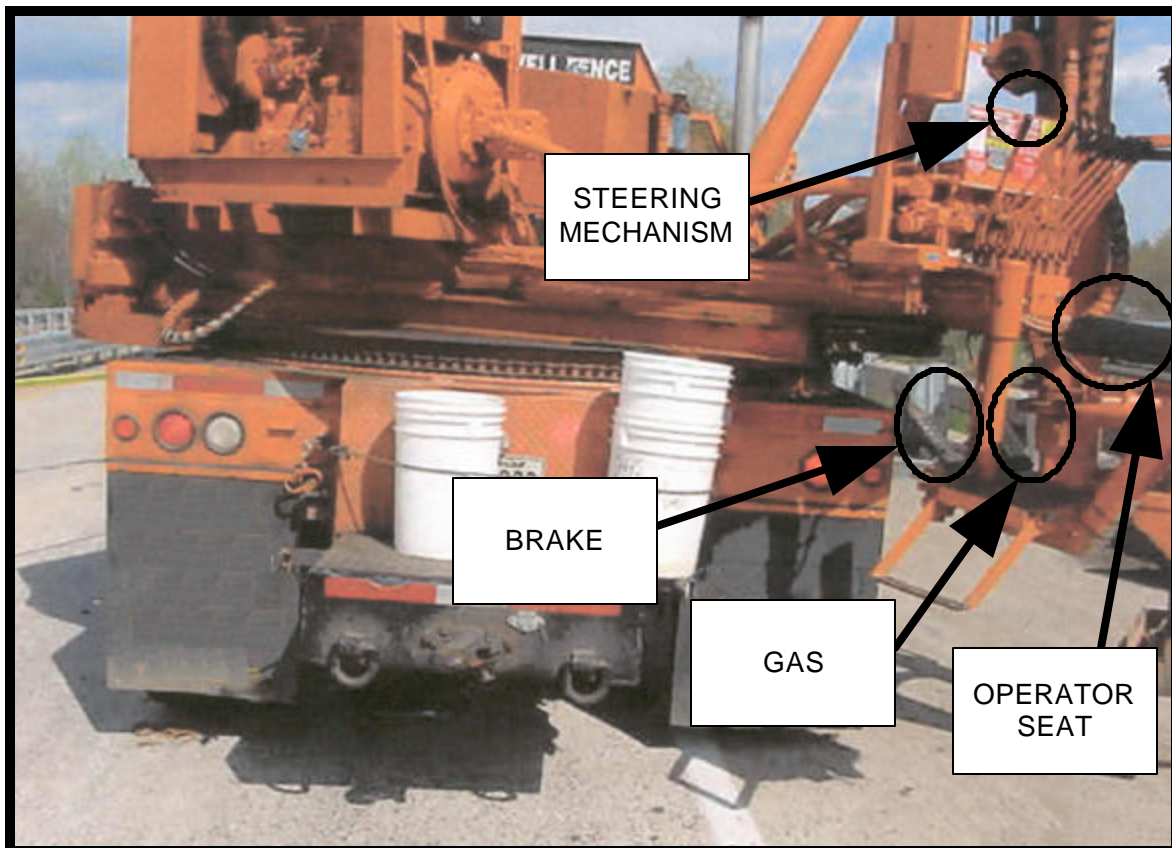
At the time of the incident, the crew foreman was operating the truck-mounted post driver from the rear operator station (Photo 2). The truck has the capability of being re-positioned from either inside the cab or from the rear operator station. The post driver/post-puller equipment is mounted on the truck and is operated from the rear operator station. Two Hispanic coworkers had attached the guardrail to the pull jack with a chain and then moved to a position near the front of the truck. Another Hispanic coworker

*Photo 2. This photo illustrates the rear operator seat and equipment controls. This equipment is operated from a seated position. Photograph courtesy of the NCOSHA.*

***Recommendation #7: Manufacturers should explore the possibility of incorporating emergency stop switches on the rear control panel of the truck-mounted post driver.***

Discussion: The manufacturer of the equipment used in this incident is researching the possibility of incorporating an emergency stop "kill switch" on the rear control panel of the truck-mounted post driver. According to the equipment manufacturer's representative, operators may believe that simply turning the ignition key off from the rear operator station will immediately stop the truck, but this is not how the equipment functions. When the ignition key is turned off, the vehicle will come to a stop when it hits something or rolls to a stop when it loses momentum and reaches level ground.

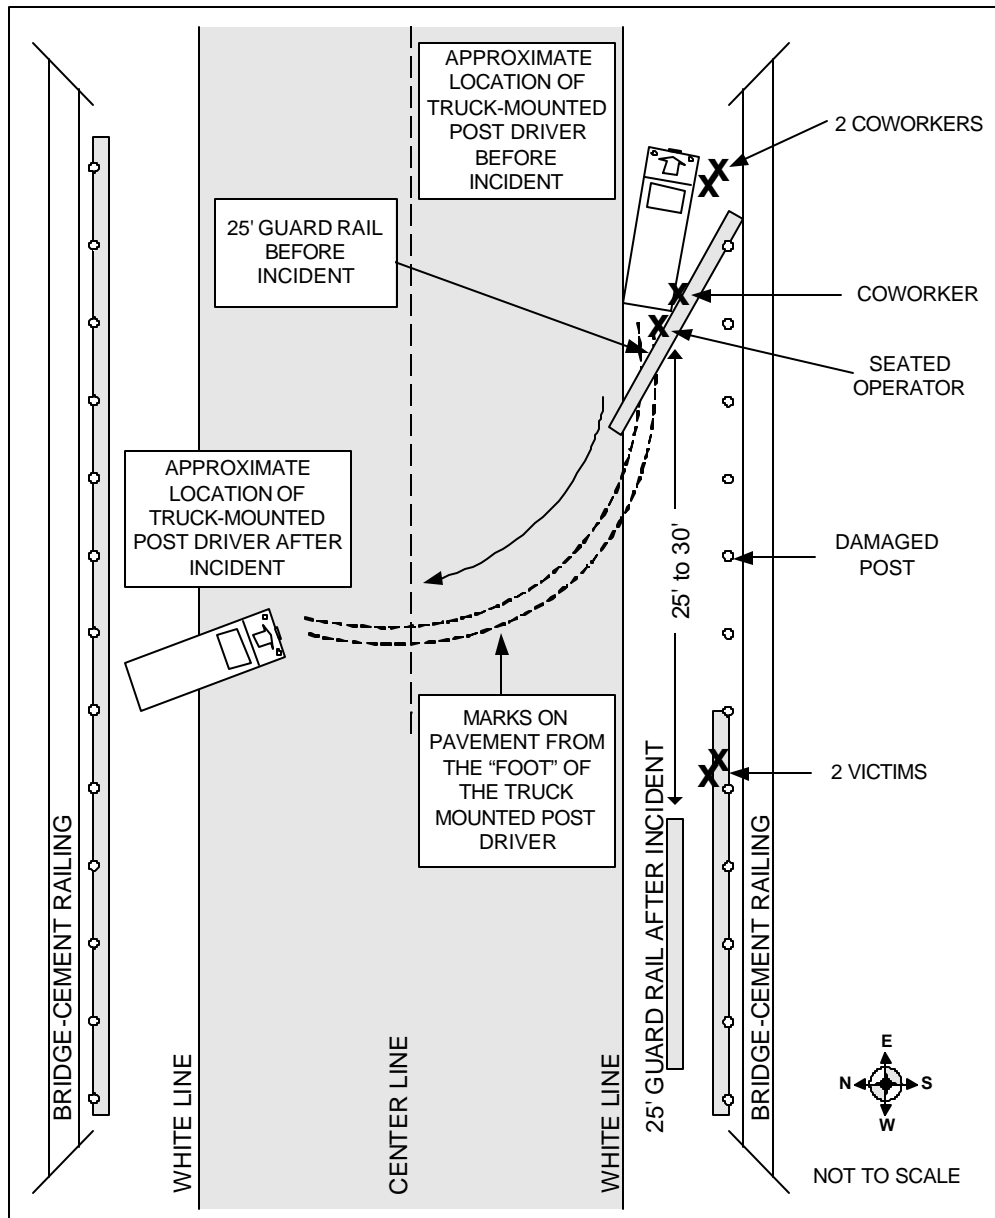
Figure. Adapted from drawing by County Sheriff's Department of incident scene

The truck-mounted post driver was parked facing east on the right shoulder of the eastbound lanes, parallel and approximately 7 feet from previously installed guardrail posts (Figure). The foreman was

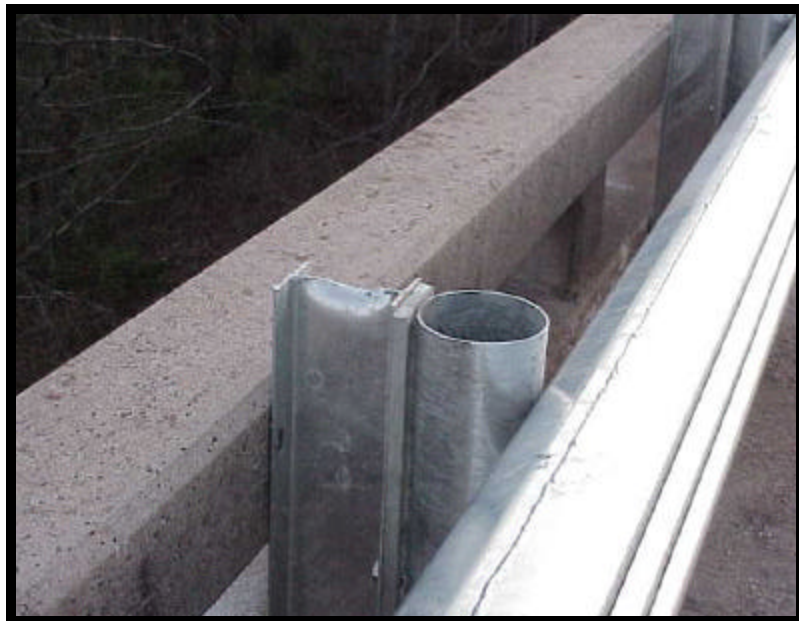
*Photo 3. This photo illustrates the damaged post located 17 feet east of victims.*

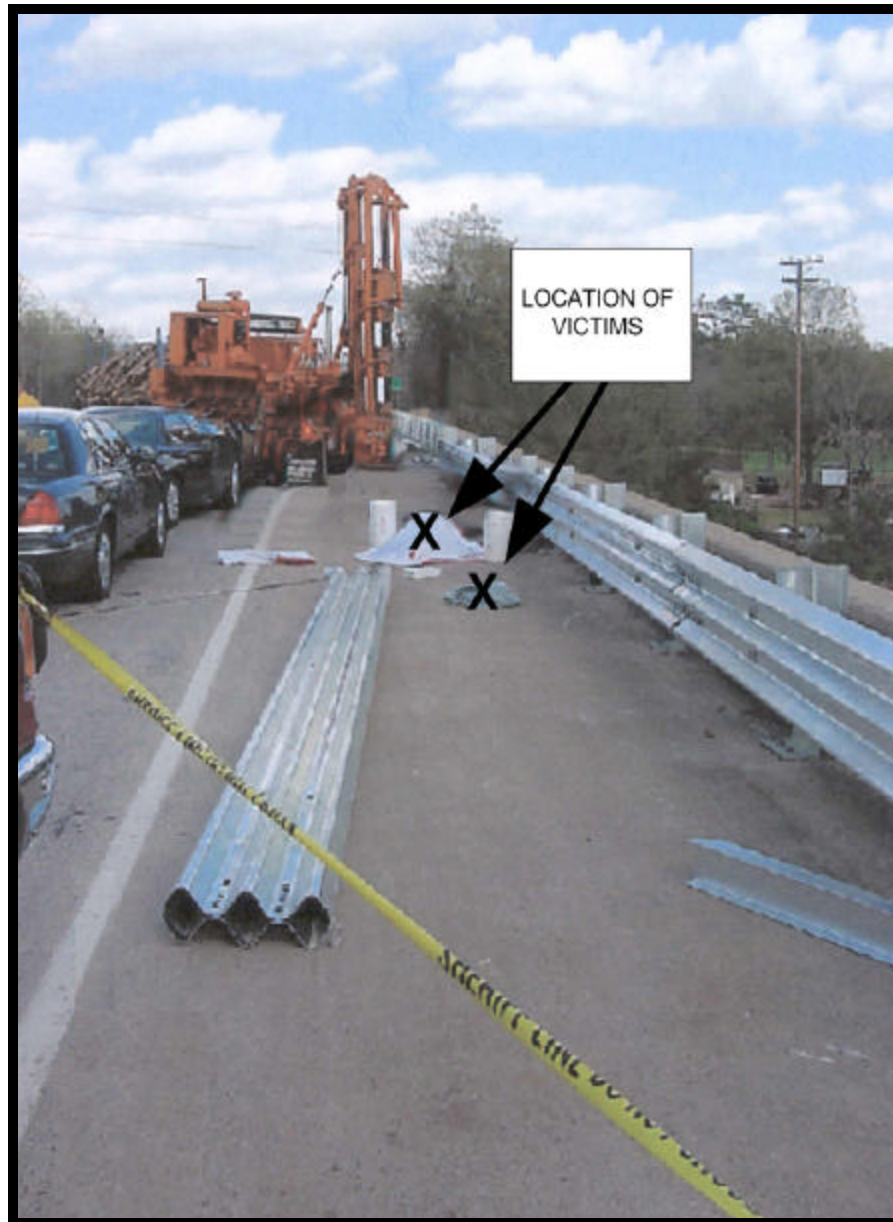
The coworker who had been helping guide the truck operator reported that the truck brushed against him as it moved backwards, but that he was not injured. Both coworkers standing near the front of the truck told sheriff's department investigators that they heard the engine "rev" (speed up) and saw the truck jerk backwards. They saw the guardrail flip up in the air and strike the victims. One of these coworkers told NCOSHA investigators that he saw the guardrail hang up briefly on a post and then swing into the victims. The damaged post was located approximately 17 feet from the location of the victims (Photo 3). The open hook that secured the chain around the guardrail unhooked and the guardrail and unbroken chain came to rest in the closed travel lane just a few feet beyond the location of the victims (Photo 4).

*Photo 4. This photo illustrates the location of the victims and the guardrail following the incident. The truck had been driven back to the right shoulder and parked following the incident. Photograph courtesy of the County Sheriff's Department.*

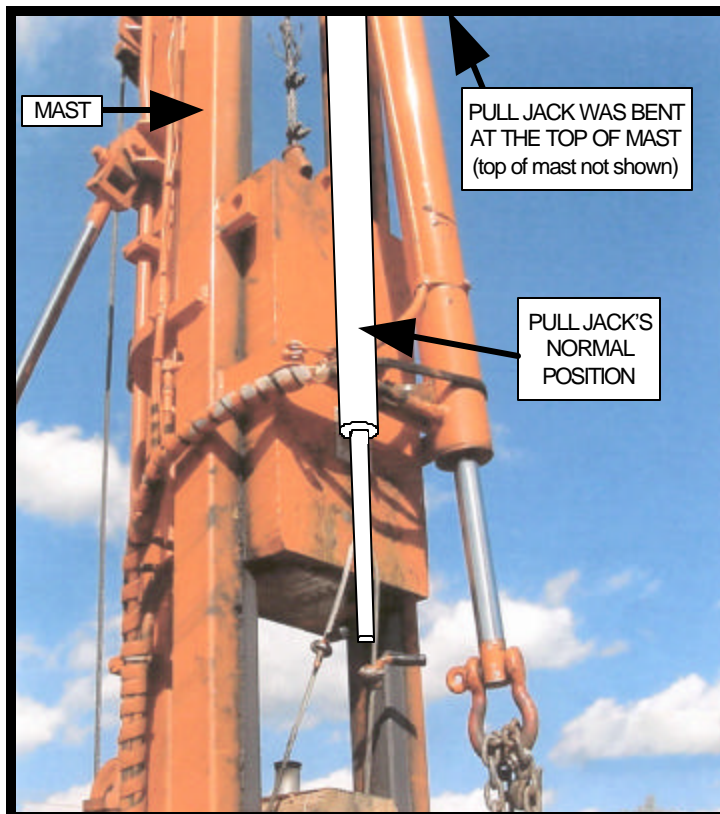
NIOSH investigators and the manufacturer's representative reviewed photographs of the truck-mounted post driver taken by the Sheriff's office after the incident and noted that photographs indicate that the pull jack on the post driver was damaged (Photo 5), corners were sheared off guardrail posts, and the guardrail that was being lowered suffered damage to one end and at the center where the chain had been secured. NIOSH investigators and the manufacturer's representative believe

*Photo 5. This photo illustrates the pull jack on the post driver which was bent during the incident. It also illustrates how the chain was attached. Photograph courtesy of the County Sheriff's Department.*

that evidence and witness statements suggest that the operator pushed the gas pedal instead of the brake by mistake, causing the engine to speed up and the truck to jerk backward. The section of suspended guardrail hung up briefly on a post and then dislodged. The energy released when the guardrail dislodged damaged guardrail posts in its path and caused the suspended guardrail to strike the victims with considerable force.

***Recommendation #6: Manufacturers should clearly identify how equipment is to be used, i.e. the truck-mounted post driver is only to be used for driving and pulling posts and is not intended for other uses, such as hoisting.***

Discussion: Manufacturers should consider writing the operator's manuals to make it clear to the operators what the equipment can and cannot be safely used for. For example, the manufacturer should state that the truck-mounted post driver is not to be used as a hoist. Labeling the machine with information regarding its appropriate uses may also be helpful.
