Construction Laborer Dies After Being Run Over and Crushed by a Grader at a Road Construction Site - North Carolina**SUMMARY**

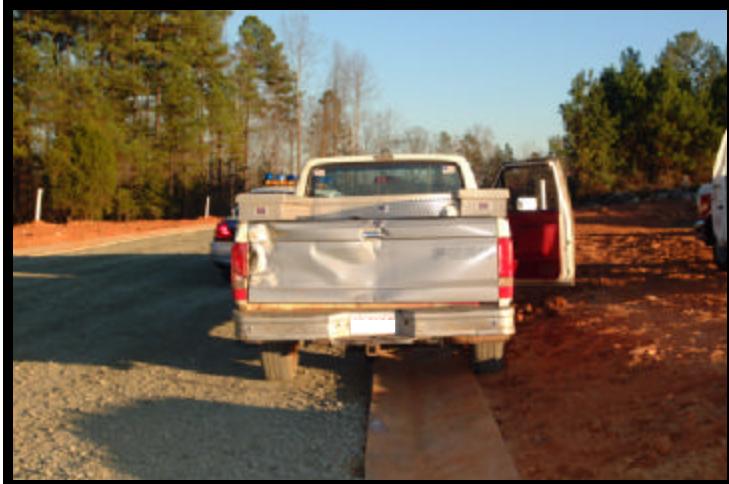
*Vehicle struck by the grader***Fatality Assessment and Control Evaluation (FACE) Program**

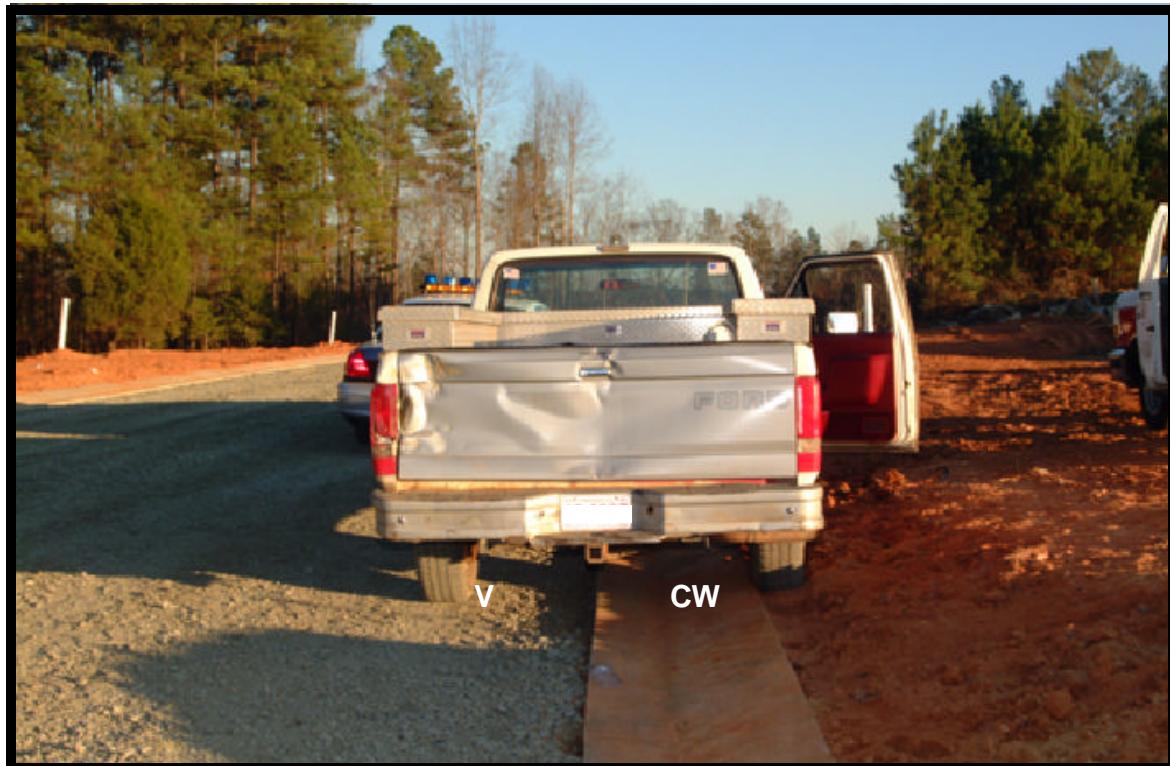
the passenger side of the truck. The coworker was facing toward the entrance and was checking the oil and gas levels in the tamper and was starting to tell the victim to go to the entrance to help other crew members when the incident occurred. Photo 1 illustrates the approximate location of the victim and coworker. The victim was standing at the rear of the truck on the driver's side facing the back of the truck, and the coworker was standing approximately 2 feet from the victim nearer the curb. Neither worker was wearing a high-visibility safety vest. The coworker looked up and saw the grader coming toward them. He yelled for the grader operator to stop. Grader Operator #1 did not hear the warning, and the back tire of the grader struck the victim in the upper back and knocked him to the ground. Grader #1 continued moving in reverse, striking the bumper and tailgate of the pickup truck (Photo 1). The operator stopped after the impact. The left rear tire of the grader had rolled on the victim's upper back and head. The coworker ran to the operator and told him to pull forward to free the victim. The coworker then used his cell phone to call 911. Emergency medical services (EMS) and police personnel received the call at 2:07 p.m. and responded within minutes. The victim had sustained major traumatic injuries to the face and torso. Emergency care was initiated by EMS personnel and the victim was transported to an area hospital where he was pronounced dead at 3:32 p.m.

Photo 1: This photo illustrates the approximate location of the victim (V) and the coworker (CW) at the time of the incident. The tailgate of the truck shows damage that resulted when the grader struck the truck.

Additionally, a prework plan and person-to-person communication may have resulted in the identification of a safer location for parking the pickup truck during the tamper drop-off, a location that was out of the path used by heavy equipment.

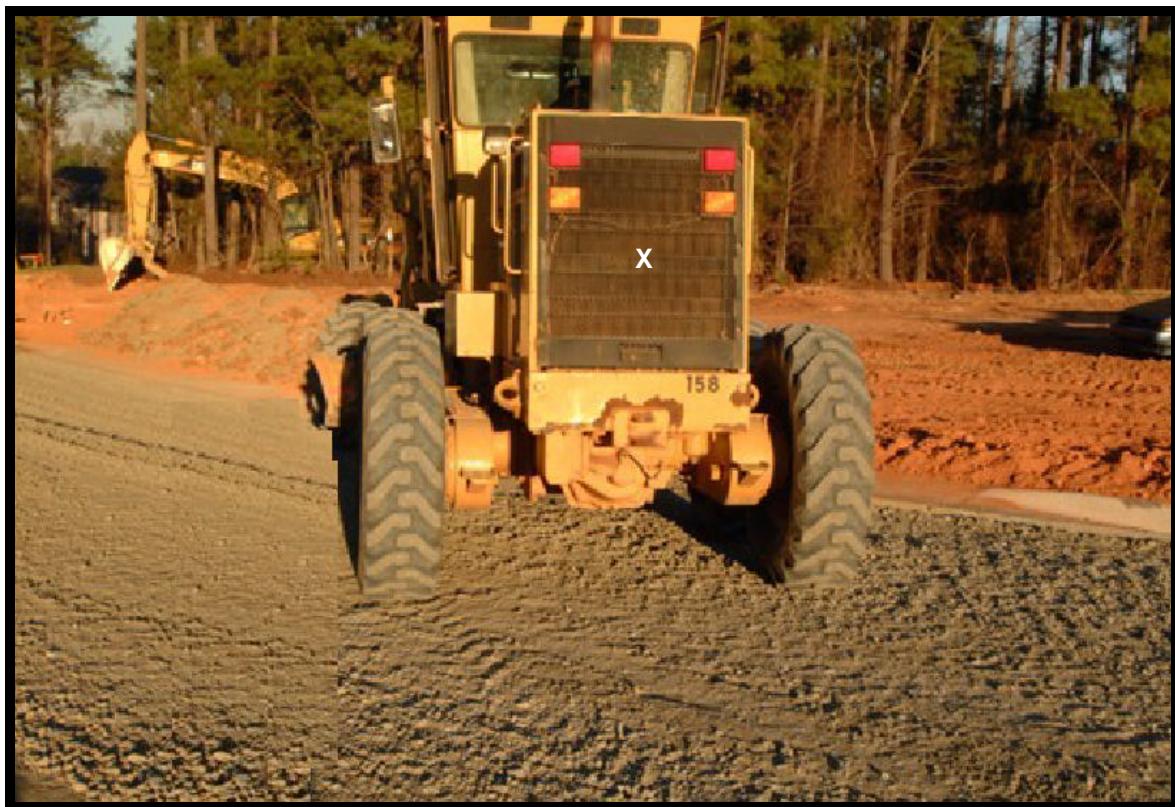
NCOSHA investigators examined road grader #1 (the grader directly involved in the incident). The road grader was manufactured in 1996. According to the construction company owner, he had leased the grader when it was new under a long-term lease from an equipment rental company. He had used the grader for approximately 5 years and had a verbal agreement with the rental company that his company would take responsibility for all minor repairs and servicing which included maintaining or replacing backup alarms. The grader was equipped with a backup alarm (Photo 2). When the backup alarm was tested by NCOSHA and police department investigators on the day of the incident, the alarm emitted no audible signal.

Grader Operator #1 told NCOSHA investigators that he had notified his superiors that the backup alarm was not working properly 2 weeks before the incident, but it had not been replaced. The grader operator told police and NCOSHA investigators that he did not see the workers or their parked pickup truck because the sun was shining in his eyes. Police investigators determined that visibility was nearly impossible when seated in the driver's seat of the grader and looking backward due to the bright setting sun and the dust- and dirt-covered cab windows and mirrors (Photo 3). NCOSHA investigators inspected side mirrors that had been installed on each side of the grader by the equipment lender; they were loose and would not stay in place when adjusted.

Photo 2. This photo illustrates the rear of the grader used at the time of the incident. The backup alarm is positioned behind the grill work and is marked with an X.

Recommendation #3: Employers should ensure that equipment is inspected daily and all defective equipment is removed from service until needed repairs have been made.

Discussion: Employers should designate a supervisor to be responsible for daily preshift equipment checks and for verifying that any problems are corrected. Although equipment may also be inspected by other workers, for example the equipment operator, the supervisor must be responsible for ensuring that inspections are performed daily, that necessary repairs are made, that scheduled maintenance is performed, and that records of all inspections are maintained. Equipment should be removed from service until repairs are made. For example, equipment should be removed from service until a malfunctioning backup alarm is replaced with a functioning audible alarm. According to OSHA standards, earthmoving equipment which has an obstructed view to the rear can be used in reverse gear only when the equipment has in operation a

reverse signal alarm distinguishable from the surrounding noise level or when there is an employee available to signal the equipment operator that it is safe to move in reverse (29 CFR 1926.602 (a)(9)(ii).³

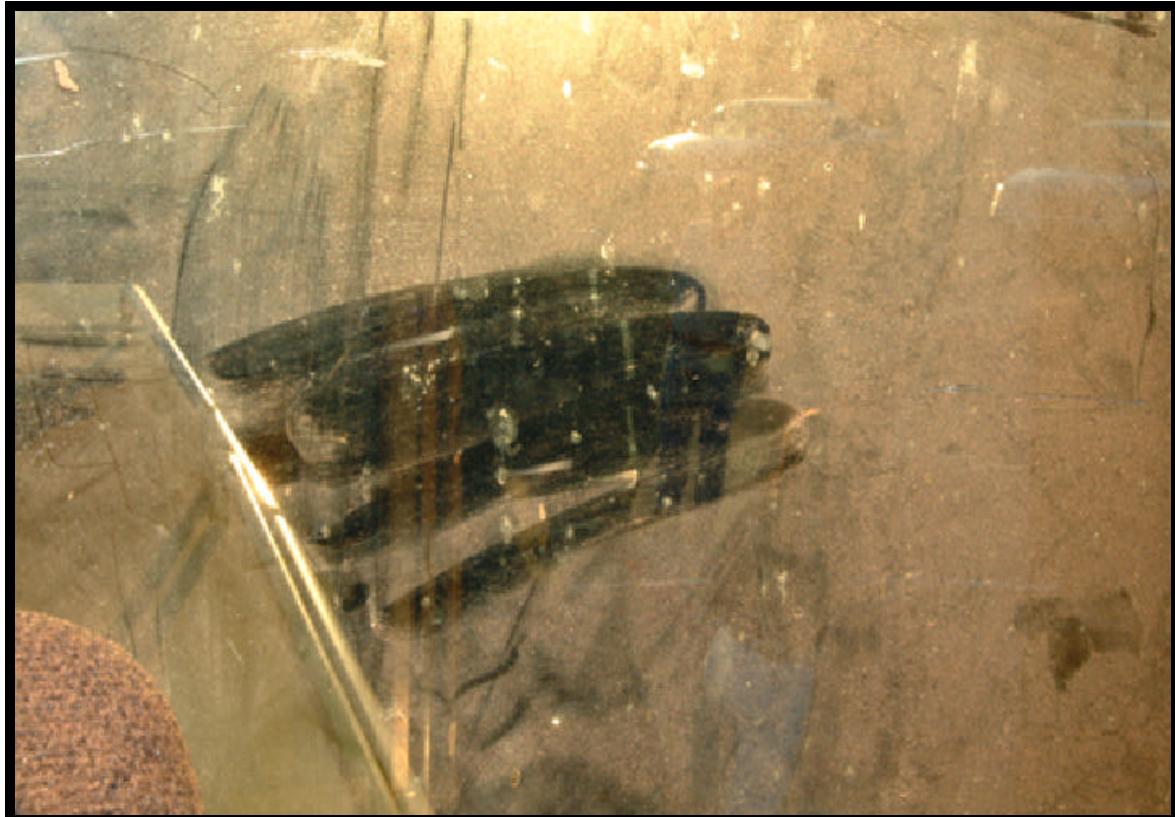
Photo 3: This photo illustrates the view through the back window from the driver's seat of the grader. Some of the dust was rubbed off, and upon careful scrutiny through the haze, one can barely see a person standing several feet behind the grader.

Additionally, all mirrors should be inspected daily to ensure that they are attached and maintained in a manner that allows them to be adjusted by the operator.

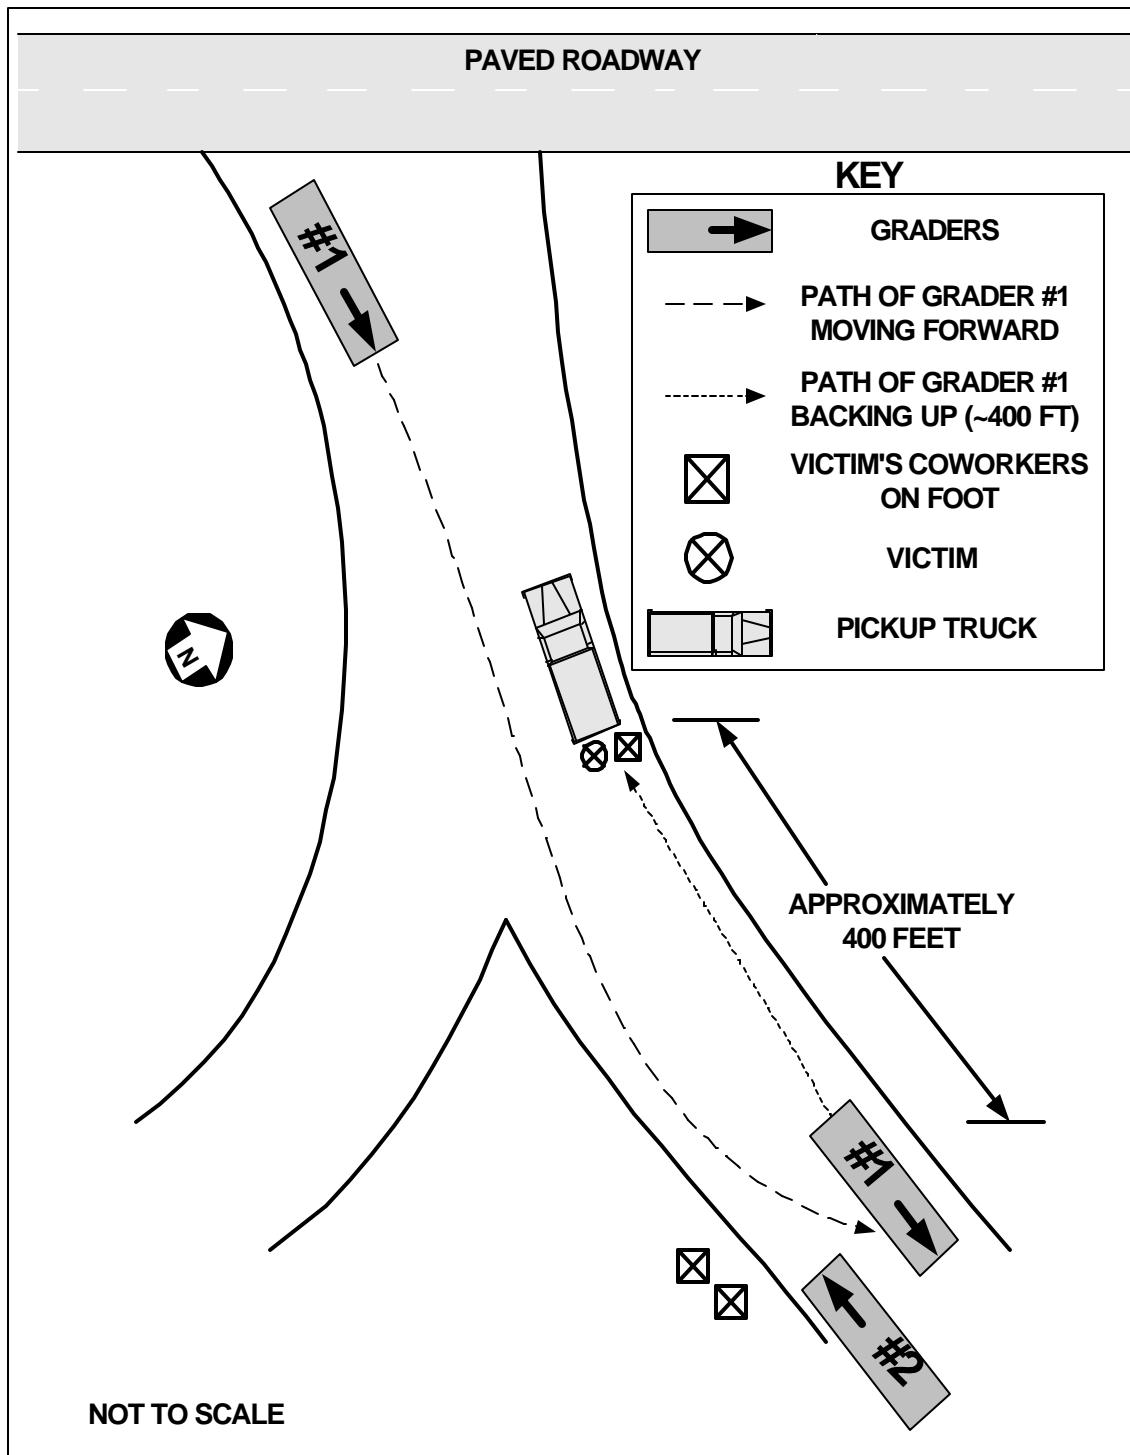
Figure 1: Figure Illustrates Residential Roadway Schematic.

The victim's coworker told NCOSHA investigators that he did not hear any warning sounds coming from the grader. Evidence indicates that several pieces of equipment were running near the location of the incident: the pickup truck, grader #1, and a roller, approximately 400 feet away (see Figure for work-site layout).
