## *Maintenance Mechanic Dies After Being Trapped in the Pneumatic Door of a Vacuum Cooler - South Carolina*

### SUMMARY

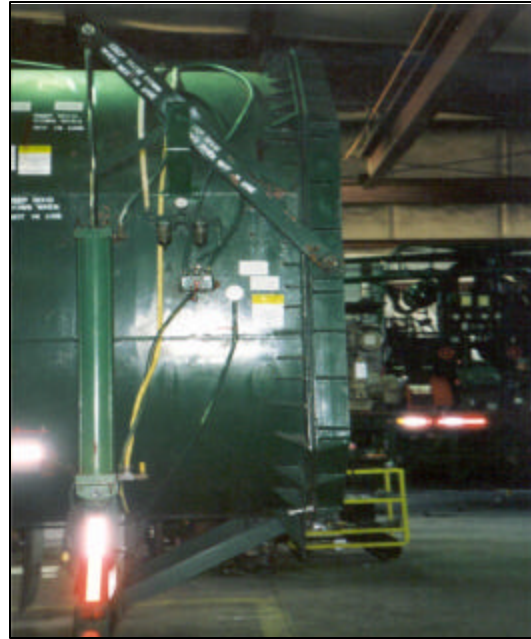
*Incident Scene*

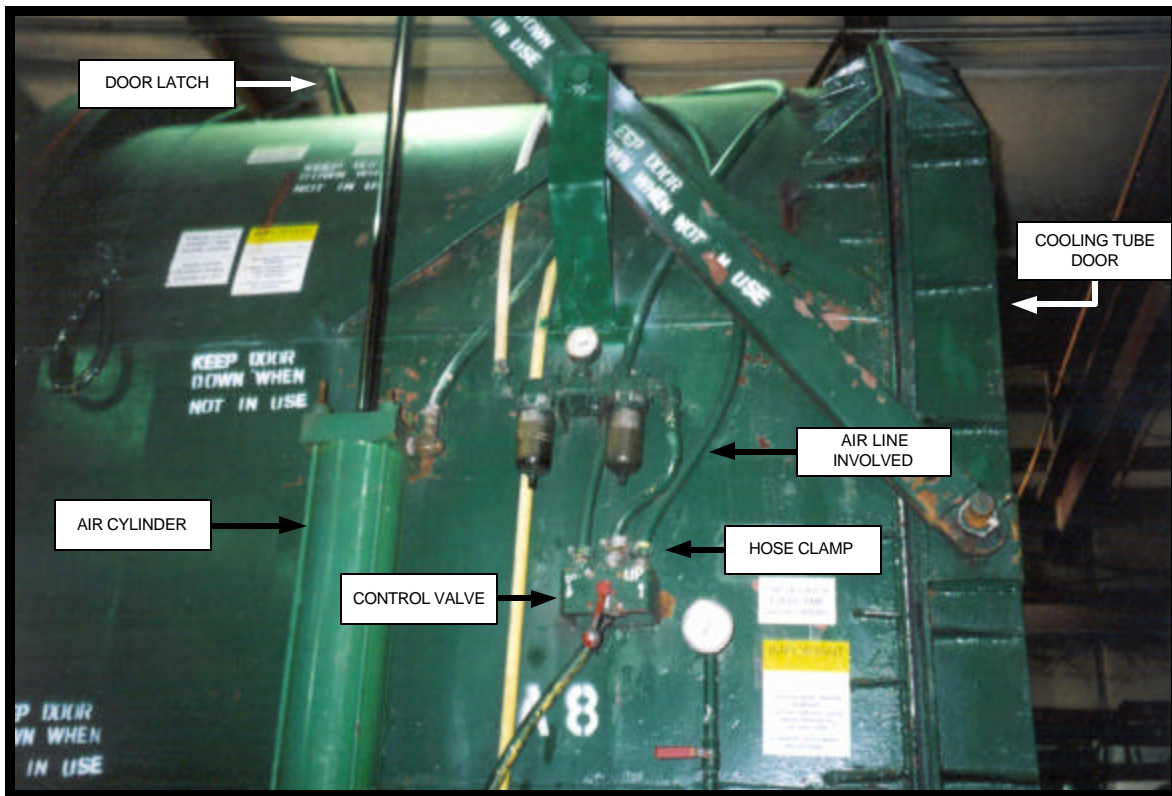
each air cylinder. The control valves were mounted adjacent to each cylinder. Air line connections to the cylinders and valves were secured with worm drive type hose clamps. When a door was raised to its full upright position, it automatically connected to a latch at the top of the tube that held it in place (Photo 1). Standard operating procedure, though unwritten, stated that employees were never to place themselves between the door and the back of the cooling tube or to enter the tube during loading or maintenance activities unless the door was latched to the top of the tube. At the shop, the door could also be suspended by an overhead crane.

*Photo 1. The configuration of the lifting mechanism of the door*

Discussion: Worm drive hose clamps such as those used in this instance can be over tightened to the point that the clamp worm is not fully engaged to the slots in the clamp strap. This reduces the capacity of the clamp. Employers should consider evaluating different types of clamps, such as crimp-type clamps, to determine the most suited for the job.

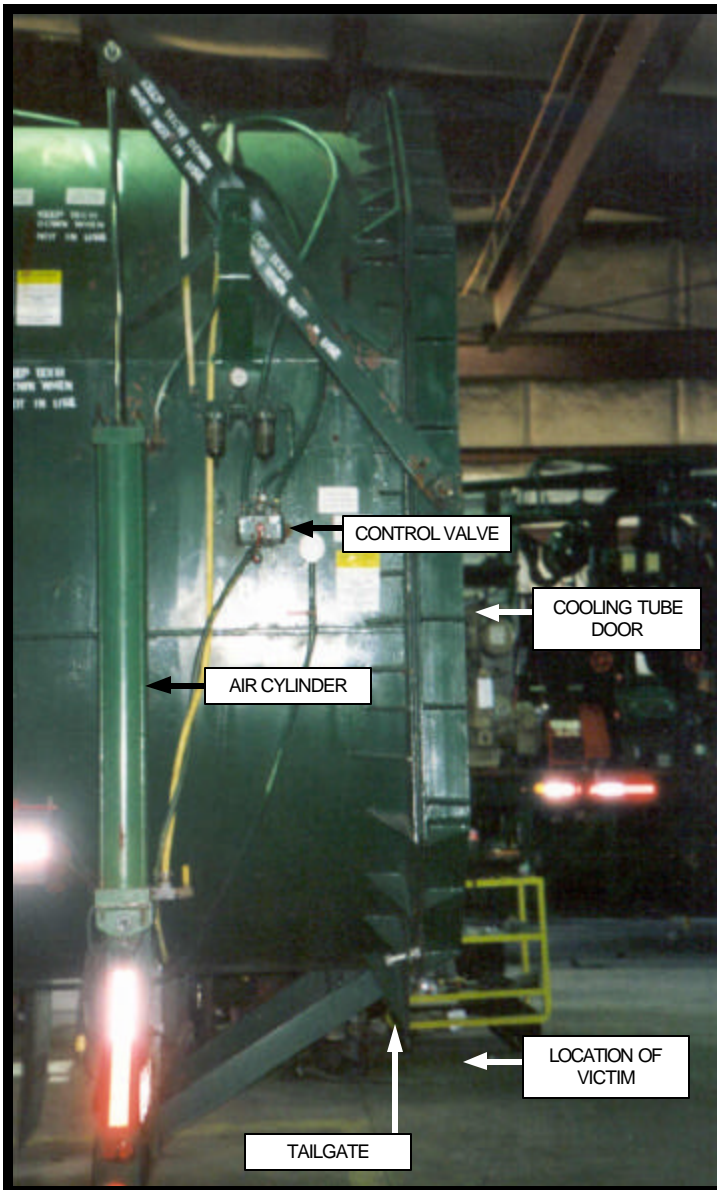
tube to inspect his own work. At approximately 8:30am. the supervisor could hear air rushing from the other side of the cooling tube. As he walked around the tube, he saw the victim caught between the door and the tailgate of the tube. He also noticed that one of the air lines had disconnected from the valve. He connected the air line to the valve and held it on as he worked the valve, raising the door. As the door raised, the victim fell to the shop floor (Photo2). Coworkers immediately initiated cardiopulmonary resuscitation (CPR) while the foreman called 911 from the shop office. The EMS responded and transported the victim to the hospital where he was pronounced dead.

After the incident, the valve, airlines, and clamps were tested after the loose line was reconnected. All functioned properly. Evidence suggests that either the victim did not fully tighten the clamp over the air line on the valve connection, or that he connected it improperly.

A section of a rubber gasket located around the perimeter of the cooling tube was separated from the tube in the tailgate area. A can of adhesive was found open on the floor adjacent to the area where the victim fell to the floor when the door was opened by the supervisor. A putty knife was found on the floor of the cooling tube just inside the tailgate. This evidence would suggest that the victim had noticed the partially hanging seal and after inspecting the air line and valve connections, decided to repair it. He then partially raised the door and stood between the door and the tailgate to make repairs. As he did so, the air line separated from the control valve, allowing the door to lower and pin him against the tailgate. After the airline was reattached to the valve, the door was run through its open and close cycle several times and no malfunction was detected.

*Photo 2. The incident scene and the location of the victim*

Discussion: Although unwritten, standard operating procedures called for the vacuum cooler's door to be supported by an overhead crane or that the door be raised to the top of the cooler tube and locked into position before work was performed near the rear of or inside the tube. This would prevent the door from closing inadvertently due to the loss of air pressure. It would also eliminate an employee's exposure to a potential caught-between hazard. Employers could consider developing safety checklists for employees performing maintenance tasks that would take them step by step through the process in the safest possible manner.
