Hispanic Carpenter Dies After Being Crushed Between the Loader Bucket of a Backhoe/Loader and a Concrete Building - North Carolina**SUMMARY**

Fatality Assessment and Control Evaluation (FACE) Program

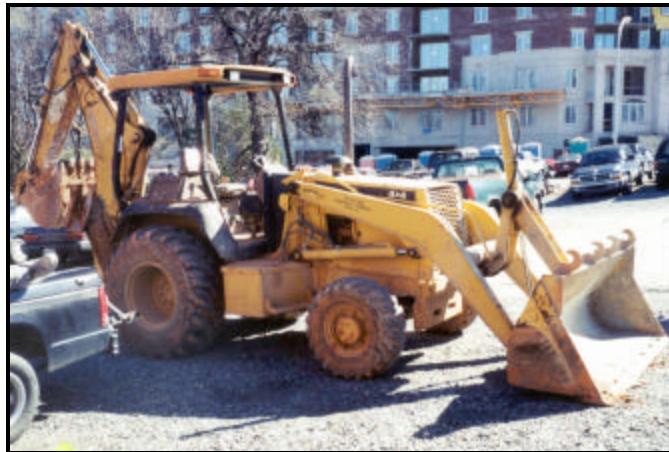
The backhoe/loader involved in the incident

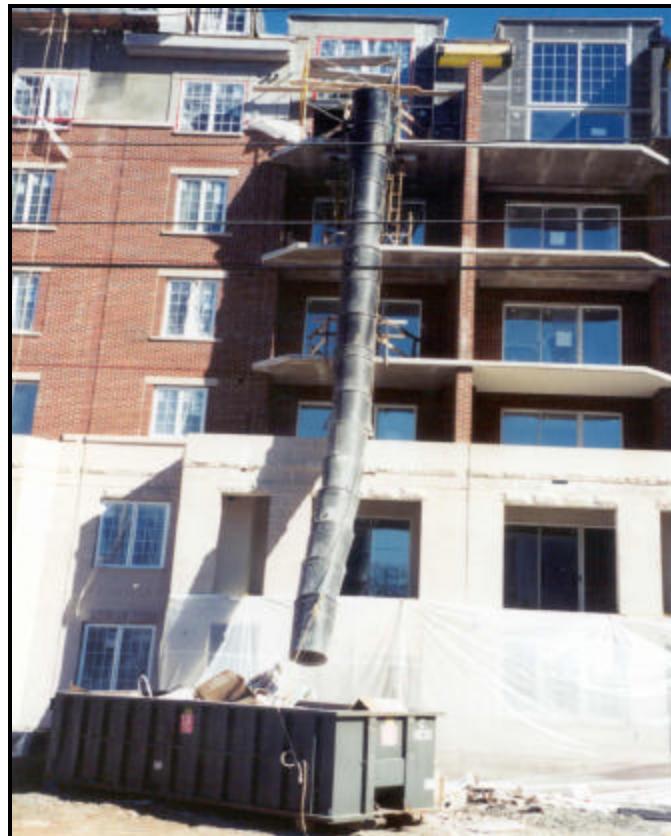
Photo 1. This photo illustrates the debris chute on the building where the incident occurred. The photo was taken 1 month following the incident: an additional structure had been built in front of the window that the victim and coworkers were attempting to cover

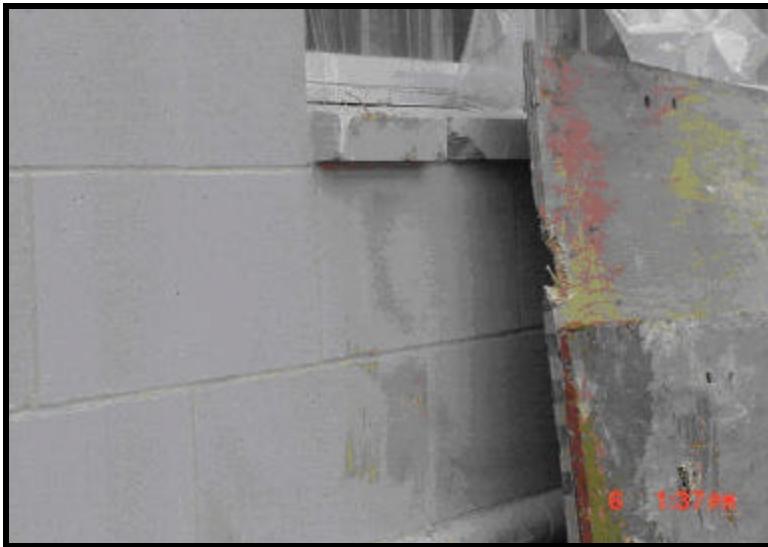
Photo 2. This photograph of the window and the plywood at the incident scene was taken shortly after the incident (photograph courtesy of NCOSHA).

to cover the window (Photo 2) under the chute with plywood to avoid window damage when debris passed through the chute.

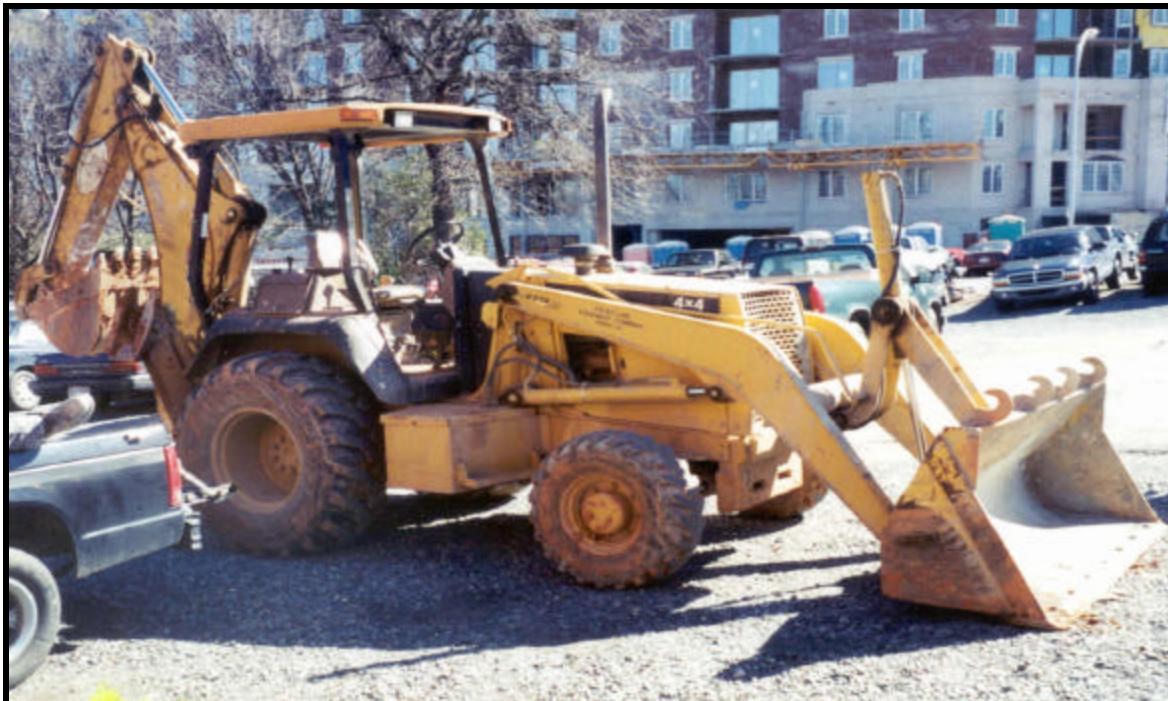
Photo 3. The backhoe/loader involved in the incident

The backhoe/loader used in the incident (Photo 3) was owned by the company. The site superintendent indicated that he had no knowledge that the loader bucket of the backhoe/loader had ever been used to lift or transport people prior to the incident.

When the equipment inspectors from the company and the manufacturer examined the backhoe/loader involved in the incident, they did not find any evidence of malfunction. According to the NCOSHA report, an EMI (Equipment Manufacturers Institute) booklet, written in English and used for training, was found in the backhoe/loader, but the operator's manual from the manufacturer was not.

Recommendation #2: Employers should develop, implement and enforce a written policy that prohibits employees from riding in or working from backhoe/loader buckets.

Discussion: The loader bucket of a backhoe/loader was used as a work surface in this incident. Although no federal standards/regulations are specifically written for backhoes/loaders, the practice of riding on any part of construction or industrial vehicles that are not intended for carrying people is expressly prohibited by OSHA² and is recommended against by the Society of Automotive Engineers (SAE)³ and the manufacturer of the backhoe/loader. The EMI *Backhoe/Loader* booklet recommends against using a bucket for a work platform or personnel carrier.⁴

The bucket of a backhoe/loader was not designed to be used as a work platform. For example, the buckets swing, creating an unstable environment; they are not equipped with fall protection features such as a standard railing; they have a very limited work surface that may not be flat; and the workers do not have access to the operating controls, which is one of the risks that was present in this incident. It is essential that a written policy is implemented and enforced to prohibit workers from riding in or working from backhoe/loader buckets.

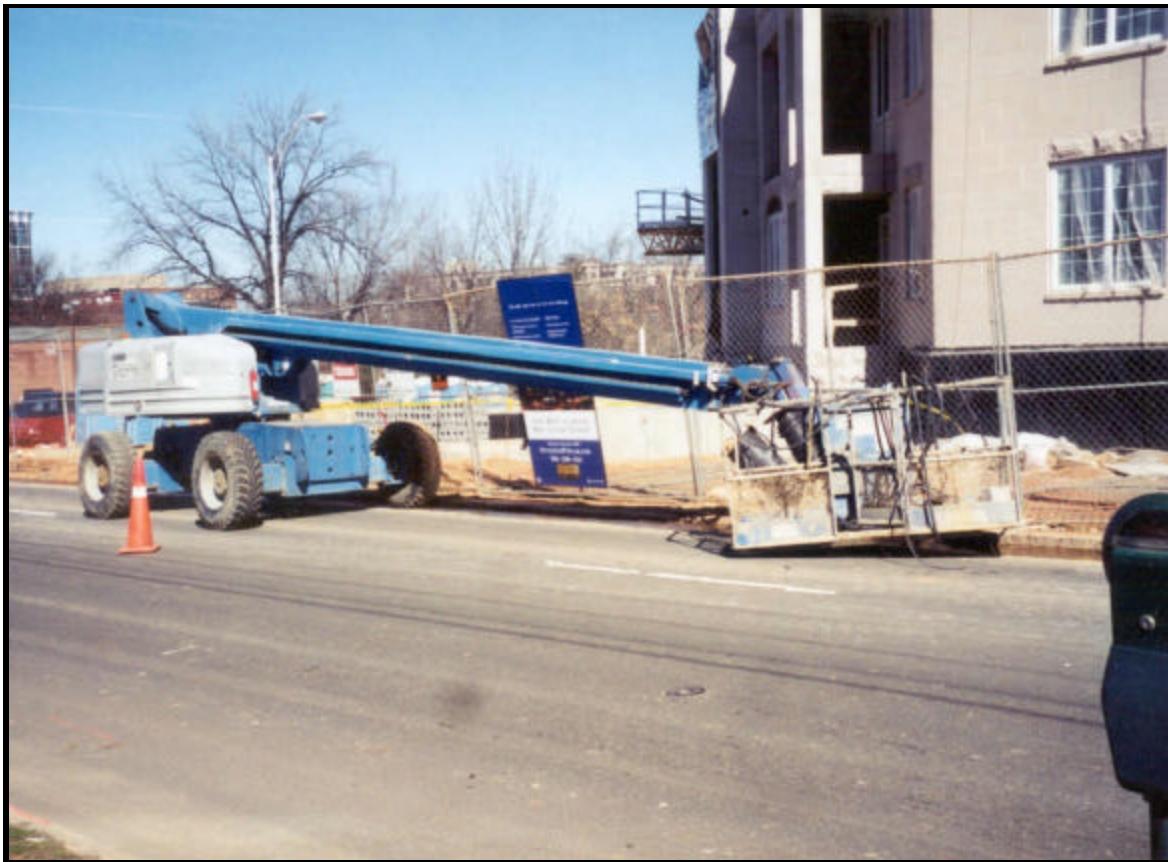
The window to be covered was about 4 to 5 feet above ground level. The victim and his coworkers decided to use the loader bucket (which measured approximately 7 feet wide by 4 feet high by 3 feet deep) of the backhoe/loader to reach the window. Generally, either a ladder or a boom-supported aerial platform (Photo 4) would have been used. According to the workers involved in the incident, a ladder was not used that day because the wet plywood sheets were too heavy to be lifted manually. A boom-supported aerial platform was on site, but it was not used because the equipment would have blocked a traffic lane. According to the statements of the two coworkers during the OSHA interview, the crew was unaware that traffic had been diverted so that equipment could be parked in the traffic lane.

Photo 4. This photograph is of the boom-supported aerial platform which should have been used for the task performed in the incident. This photo illustrates that the traffic lane would have had to be closed when the equipment was in use

Discussion: Because occupational hazards are widely variable by different work tasks or under different work conditions, training/retraining all workers in the recognition and avoidance of unsafe conditions can be a challenge. Recognizing and avoiding unsafe conditions also depends on employees' working experiences. While a company's comprehensive written safety program and its safety training program provide an overall framework for worker safety, a daily prework meeting gives workers instructions regarding the day's scheduled work and an opportunity to discuss potential hazards that may arise and possible solutions. It may also provide effective communication channels for exchange of information related to work assignments, such as the information regarding traffic diversion in this incident. Employers should create a working environment that encourages workers to consult their supervisor whenever an unexpected situation occurs. In this fatal injury case, if the victim and his coworkers had been made aware of the traffic diversion, they might have used appropriate equipment (a long boom-supported aerial platform shown in Photo 4) that was available at the work site, and the fatal incident might have been avoided.

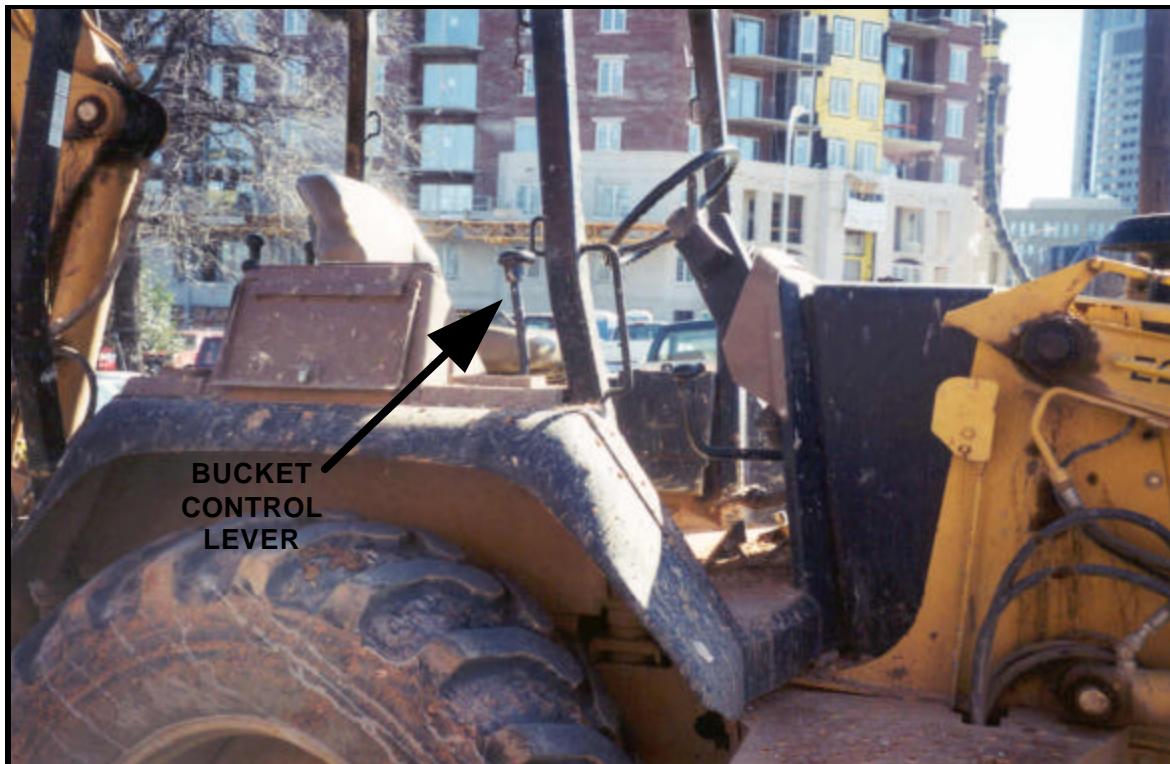
Photo 5. This photograph was taken from the right of the backhoe/loader
