Hispanic Construction Laborer Dies and Two Coworkers Are Injured After Falling 10 Feet From an Unsecured Box on the Forks of a Forklift - North Carolina**SUMMARY**

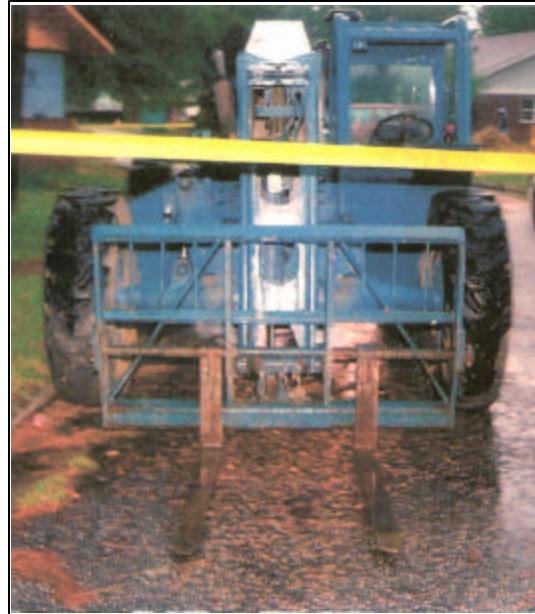
Photo 1. This photo illustrates the forklift used on the day of the incident to lift personnel. Photograph courtesy of the County Sheriff's Office.

The rental company inspected the high-reach telescoping rough terrain forklift that had been used during the incident and determined that it was functioning correctly. The lift capacity of the equipment was 5,000 pounds. According to the rental representative, the rental company does not rent a safety platform/lift carriage for this type of equipment because the equipment is designed for material handling only.

Recommendation 1: Employers should implement a policy which requires the use of a safety platform secured to the lifting carriage and/or forks when lifting personnel with a powered industrial truck (e.g., forklift).

Discussion: In this incident, a wooden job-made trash box used as a work surface was elevated, unsecured, on the forks of a rough terrain forklift. According to OSHA, when using trucks equipped with vertical only, or vertical and horizontal controls elevatable with the lifting carriage or forks for lifting personnel, the use of a safety platform secured to the lifting carriage and /or forks is required for the protection of personnel being lifted.¹

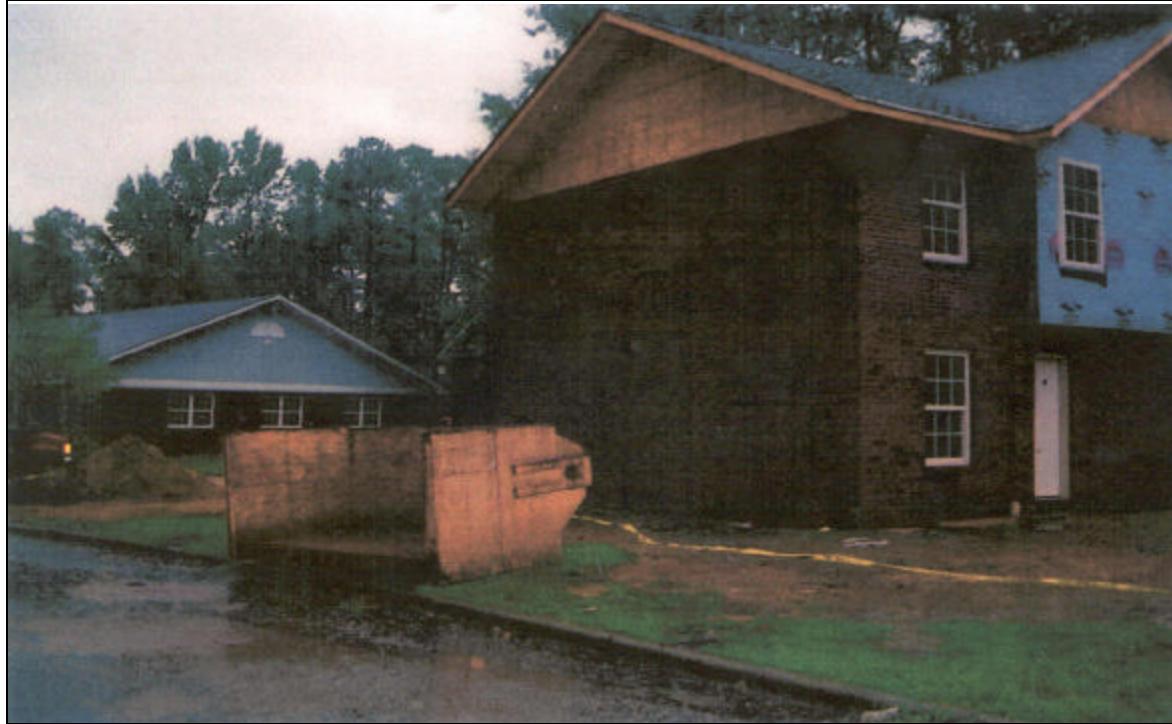
Photo 2. This photo illustrates the wooden box used on the day of the incident to lift personnel. The box was moved before the photograph was taken. Photograph courtesy of the County Sheriff's Office.

The forklift used in the incident had been rented by the general contractor from an equipment rental company and, according to the sheriff's report, the forklift operator had seen the forklift with the wooden box used by other subcontractors to lift personnel and therefore thought it was safe to use. According to the company office manager, the subcontractor owned two forklifts with safety platforms attached, but one of these was in a repair shop and the other was being used at another worksite. According to the NC OSHA report, the wooden box measured 4 feet deep by 4 feet wide by 10 feet long; the forklift was fully functional; and the forks on the forklift were spaced 36 inches apart. The forks on the forklift had the capacity to expand to 66 inches apart. When sheriff's personnel examined the underside of the box, they found no support to prevent the box from tilting on the forks of the forklift. The box had three sides and a floor and had sustained damage on the top left section where it had struck the ground.

A safety platform, which is referred to as a lifting cage, should be equipped with a proper guardrail system and a means for locking the gate. The lift cage must be safely secured to the mast of the lift truck. Forks on the lift truck must be opened as wide as possible. The person operating the lift truck must not leave the lift truck; this ensures that the person in the lift cage can give immediate instructions to the operator. A means should be provided to allow personnel on the platform to shut off power to the forklift.²
