### Fatality Assessment and Control Evaluation Program

FACE Report Number: 2003-03

### *Hispanic Roofer Dies After 15-Foot Fall from a Roof – North Carolina*

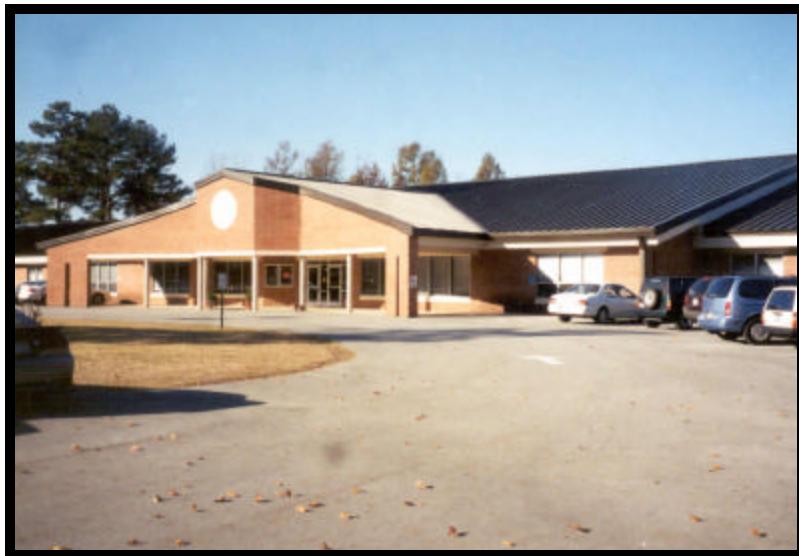
*Elementary School Where the Incident Occurred*

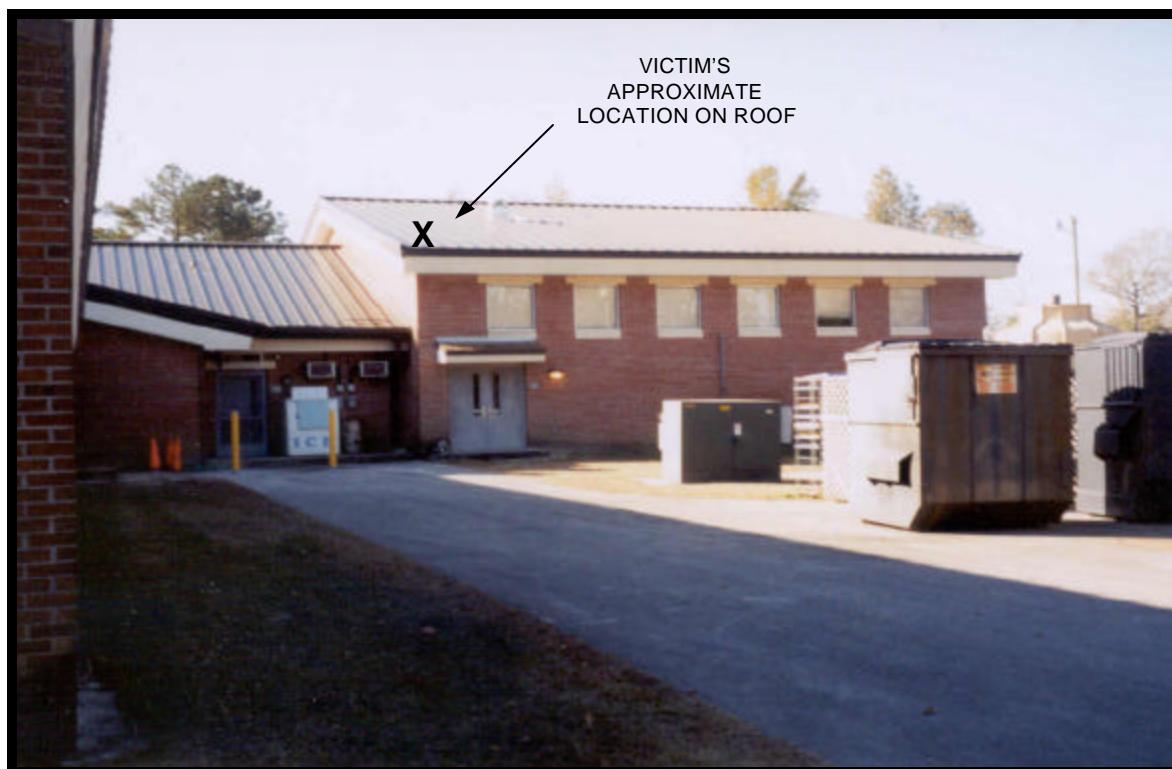
The employer had been contracted to remove shingles from the roof of an elementary school and to install a new metal roof (Photo1). Work had been in progress for over 2 months and the seven-man crew had removed the old shingles and had put down a layer of ice and water shield. Ice and water shield is similar to heavy felt paper with an adhesive backing. It is layered and overlapped on the roof much like asphalt shingles to seal out moisture. The crew had returned to this job on the day of the incident after a lapse of

*Photo 1. This photo illustrates the roof of the elementary school where work was being performed. An X marks the approximate location of the victim on the low-slope roof before his fall.*

**Recommendation #1: Employers should develop, implement, and enforce a fall protection plan that protects workers against potential fall hazards and, at minimum, meets OSHA standards for fall protection.**

**Discussion:** The employer's fall protection plan for the roofing work performed on the low-slope roof on the elementary school gymnasium, a combination of warning line system and safety monitoring system, was not used on the day of the incident—no warning line was installed and no employee was assigned safety monitoring duties. Employees on site were unable to provide OSHA investigators with a reason for the fall protection plan not being used. Employers should require daily inspections before the start of work to ensure that the fall protection system required by the company's fall protection plan has been implemented.

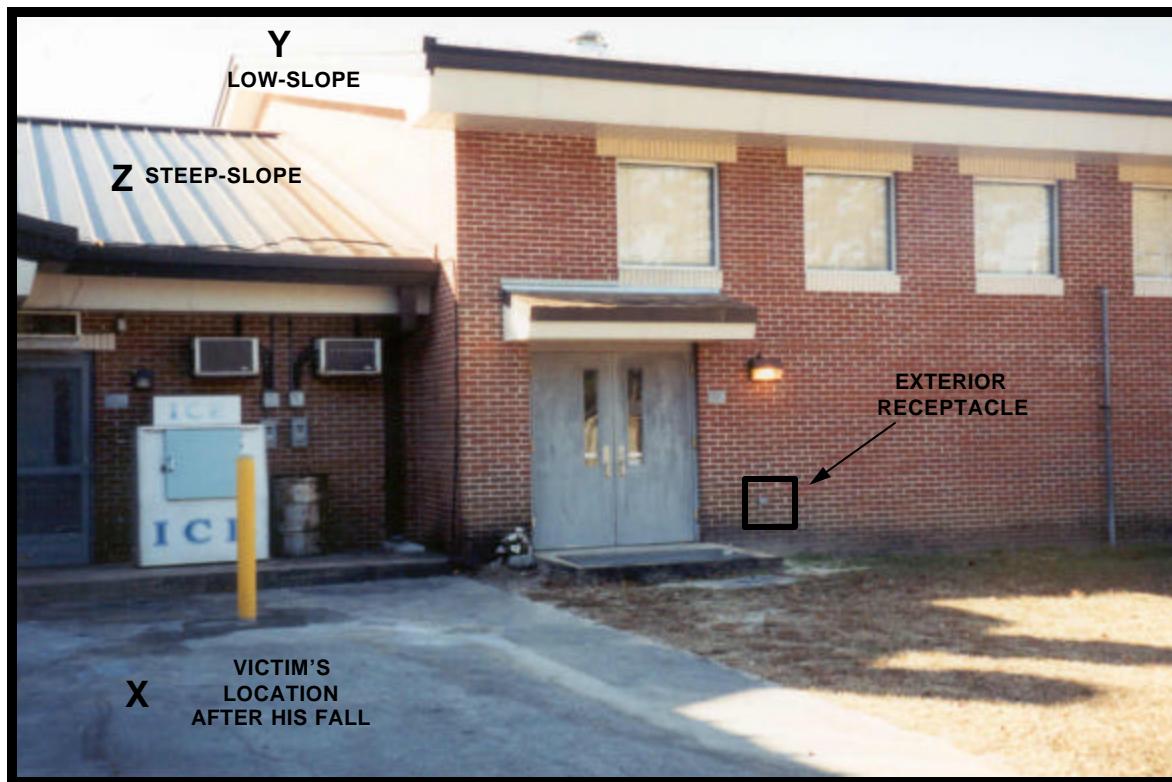
*Photo 2. This photograph illustrates the approximate location of the victim following his fall, marked with an X. The photograph illustrates both a low-slope roof (marked with a Y) and a steep-slope roof (marked with a Z). OSHA regulations define low-slope and steep-slope roofs (29 CFR 1926.500).*

After lunch, the crew returned to the roof while their foreman worked at ground level. The victim was standing near the edge of the roof and began pulling up an additional length of electric power cord for the screw guns. The cord extended down over the edge of the roof and was plugged into an exterior receptacle next to the gymnasium entrance. The cord may have become entangled as the victim pulled it up near the gabled end of the roof. Evidence suggests that when the victim twisted his body to put leverage on the cord to free it, he lost his balance and fell backwards off the roof approximately 15 feet to the asphalt walkway below. A nearby coworker saw the victim fall over the edge of the roof (Photo 2). The foreman

***Recommendation #2: Employers should conduct a site inspection before beginning roofing work to identify all potential hazards and take appropriate steps to ensure that identified hazards are eliminated or controlled before work activities begin.***

An inspection may have identified the placement of the power cord, which extended over the edge of the roof and plugged into an outlet near ground level, as hazardous. Workers were subject to fall hazards as they approached the roof edge to pull up additional lengths of entangled cord and to trip hazards as they walked on the roof using tools connected to the power cord. Had the inspection identified the potential hazard, a decision could have been made to use an alternative method for supplying power to tools, for example battery-operated tools, in this section of roof, thus eliminating the need for the power cord.
