Truck Driver Dies After the Off-Highway Truck He was Operating Rolled Over an Embankment and Came to Rest on Its Top-Pennsylvania**SUMMARY**

*Truck rollover***Fatality Assessment and Control Evaluation (FACE) Program**

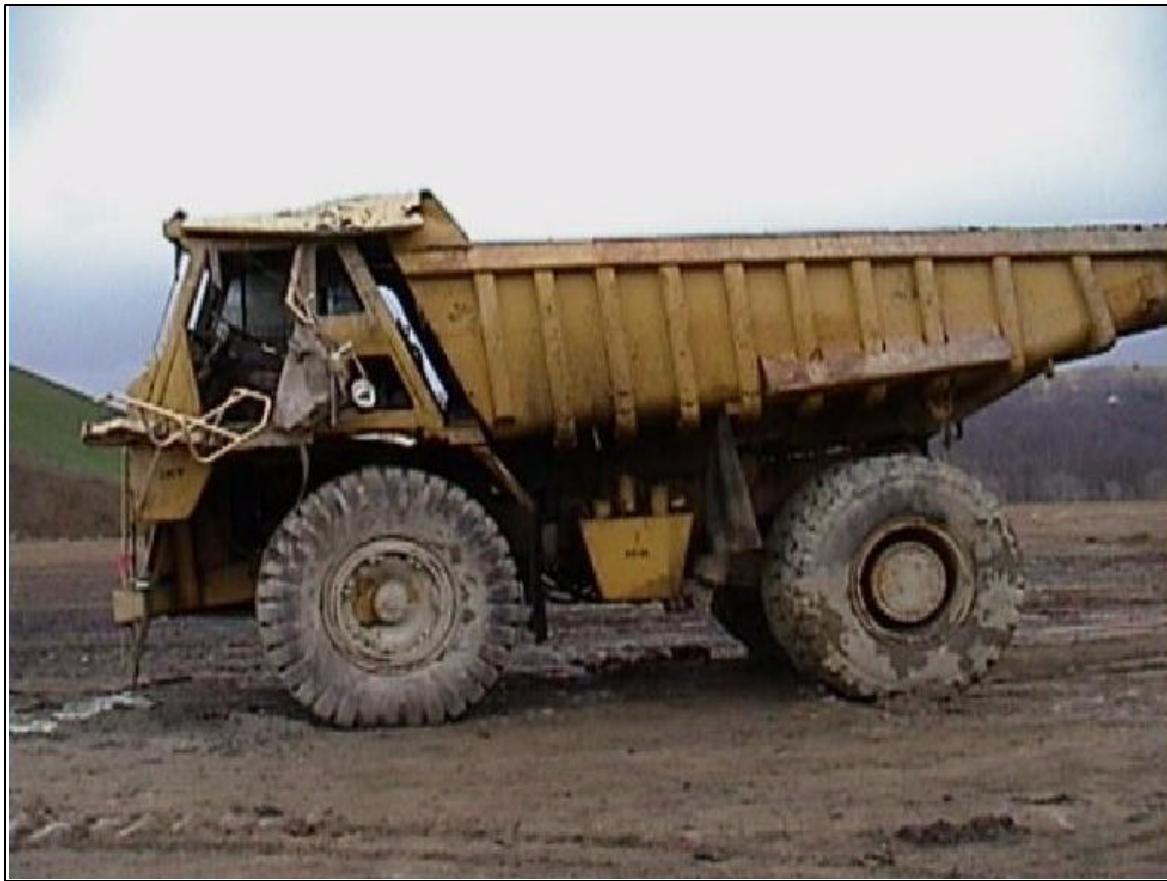
Photo 1. Truck involved in the incident

During the investigation the seatbelt was examined and found to be operational. A NIOSH investigator also sat in the operator's seat and looked through the side mirror on the truck's right side. The investigator could only see about

halfway down the truck's 6-foot-high rear tires. The area around the base of the tires could not be seen. It is likely that the victim could not determine how close he was to the right-side edge of the road.

Recommendation #3: Employers and manufacturers should evaluate the possibility of installing video equipment in the cabs of heavy equipment or installing hood-mounted mirrors that would allow operators to clearly see how close their equipment is to road edges.

Discussion: During the investigation, a NIOSH investigator sat in the operator's seat of the truck and looked through the mirrors mounted on the sides of the truck. The investigator could not see the area around or underneath the 6-foot high rear tires. This suggests that an operator could not accurately determine how close he was to the side or edge of a road. Employers should evaluate the feasibility of installing surround-view camera systems on large heavy equipment. The monitor in the operator's cab would allow equipment operators a clear view of the area surrounding the equipment and allow them to determine if they were approaching a dangerous area. Such surround-view systems are available. Additionally, mirrors could be mounted on a truck's hood in a manner that would assist the operator in determining where a truck's tires were in reference to a road's edge.

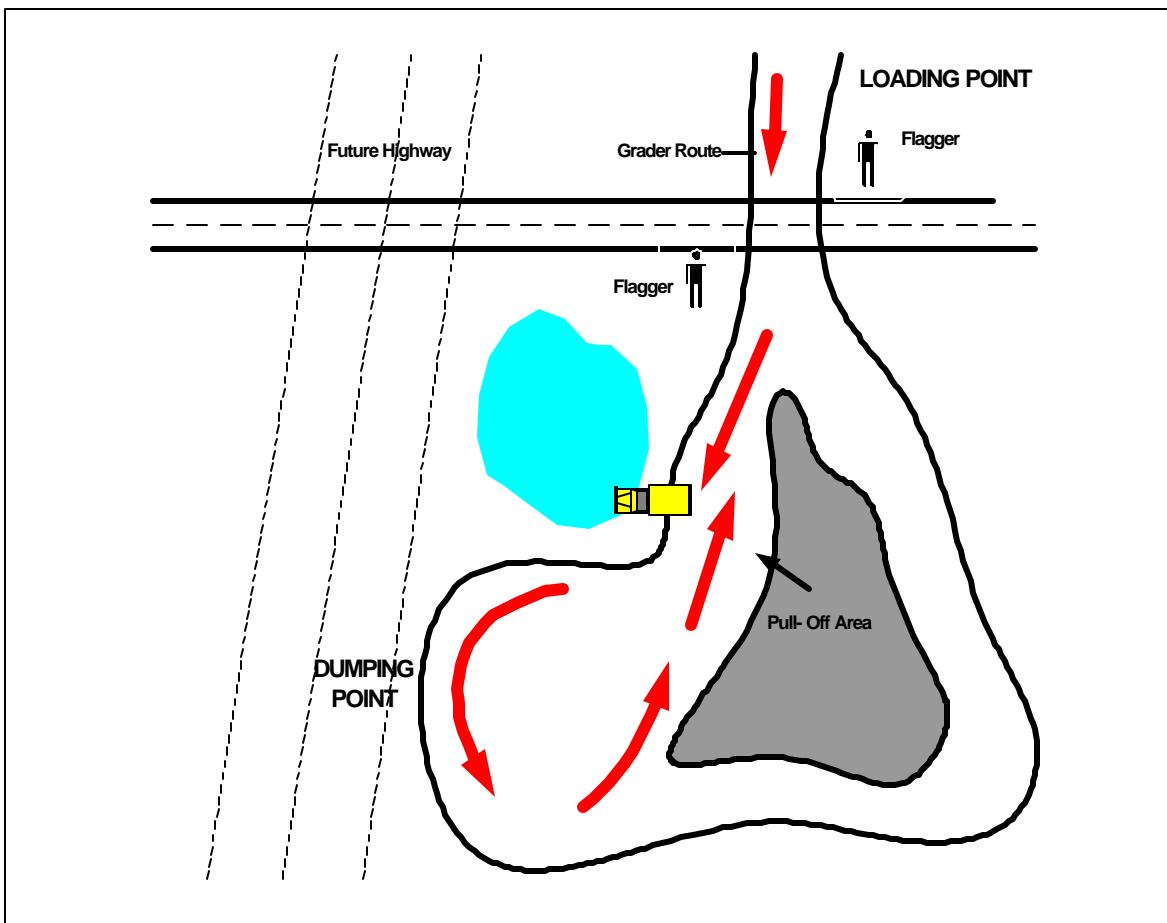
It had snowed the night prior to the incident and there was a light dusting of snow on the already wet ground. The first driver to use the haulage road told the supervisor that the portion of the road from the loading point up the hill to the dumping point was particularly "greasy" and slick and that the entire haulage road needed to be scraped. The supervisor directed the grader operator to scrape the haulage road. The grader operator started at the loading point and began scraping the haulage road up the hill to the dumping point. Standard operating procedures called for one-way traffic on the haulage road; however, when the grader operator reached the dumping point, he turned the grader around and started scraping the remainder of the haulage road coming back down the hill. The victim was hauling his load up the hill as the grader was traveling back down the hill. The two pieces of machinery approached each other approximately halfway up the hill at the turnaround area. The victim steered the off-highway truck toward the right-side embankment to allow the grader to pass. As he did, a portion of the right side of the haulage road gave way, causing the off-highway truck to overturn (Figure 1). The truck rolled over twice, coming to rest on its top in

Figure 1. Haulage road layout

Discussion: Standard operating procedures called for one-way traffic flow on the haulage road. Employers should ensure that one-way traffic flow is maintained on haulage roads, particularly on built-up roads. If for some reason it is necessary for a piece of equipment to travel against the established flow of traffic, all other traffic should be removed from the road until that piece of equipment completes its run.

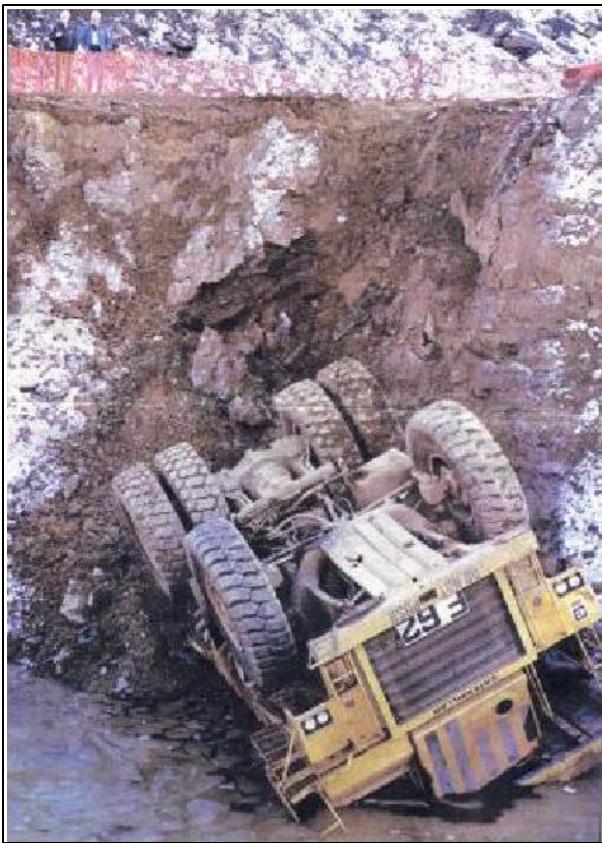
Photo 2. Truck rollover

approximately 4 feet of water that had gathered at the bottom of the embankment (Photo 2).
