Fatality Assessment and Control Evaluation Program

FACE Report Number: 2001-10

Seventeen-Year-Old Part-Time Road Construction Laborer Dies After Being Run Over by a Water Truck--Indiana

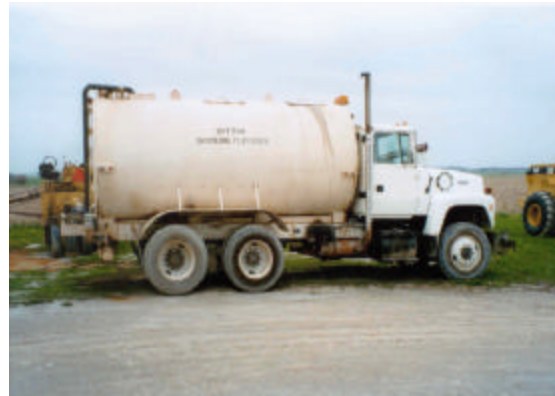
Water Truck Used the Day of Incident

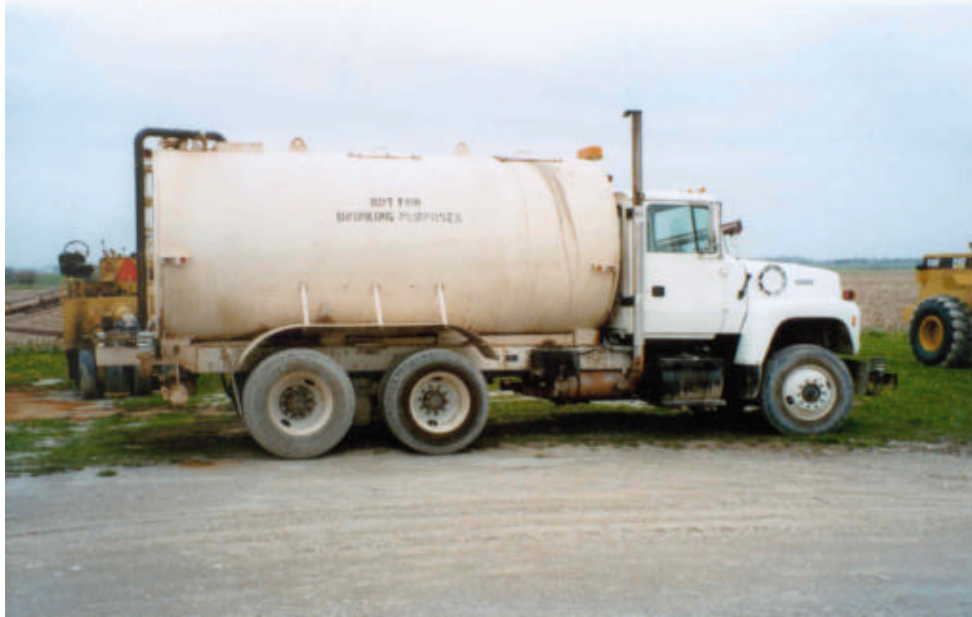
Photograph 1: This photo illustrates the water truck used the day of the incident

The vehicle involved in the incident was a late 1980's, 52,000-pound gross vehicle weight (GVW) truck with a 4,000-gallon water tank installed. Side and rear-view mirrors were present and in good condition. The tank held a patented roadbase stabilizer fluid. There were 600 to 700 gallons of stabilizer in the tank at the time of the incident.

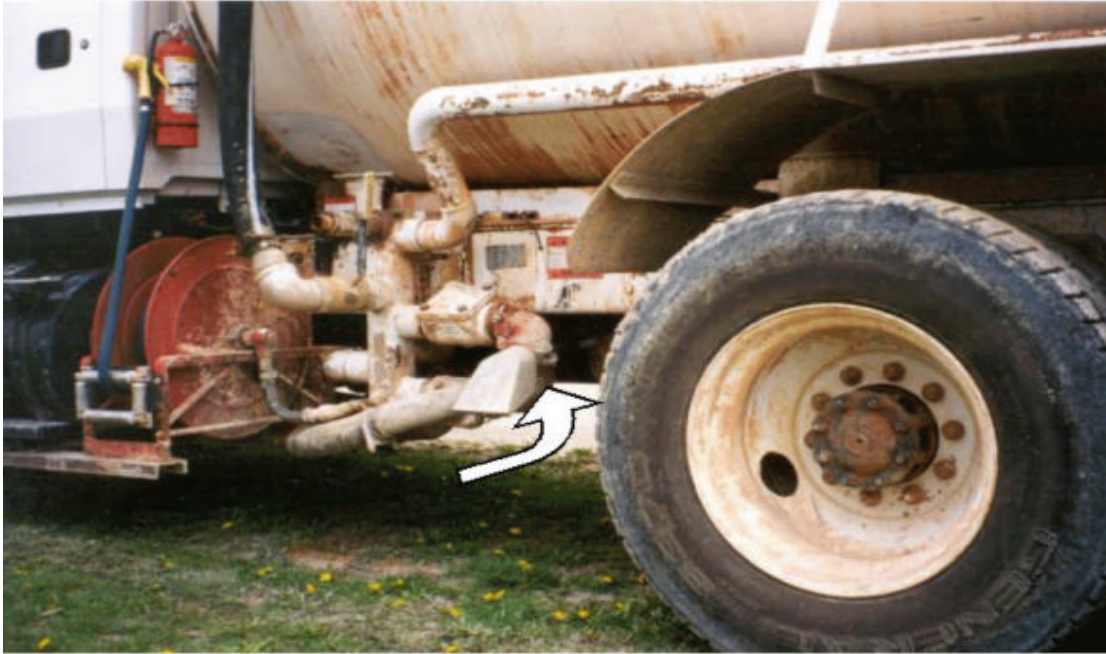
According to the employer, control levers which were mounted inside the cab controlled the delivery of the spray. Because these in-cab controls were not functioning properly, fluid continued to dribble from the tank even after the controls were set in the "closed" position. An external device used to

control the position of the main valve that regulated fluid flow was located under the truck. This device was normally used only to open the main valve at the beginning of the day's work and to close

Photograph 2: This photo illustrates the driver's side of the truck. An arrow is placed in the location where the external control for the main valve was located under the truck.

the main valve at the end of the day's work, but because in-cab controls were malfunctioning, it was being used at other times during the day to completely stop fluid flow. To close the main valve, someone had to crawl under the water truck from a point approximately 27 inches in front of the first set of dual wheels (see photograph 2) toward the center of the truck.

Recommendation #3: Employers should ensure that malfunctioning equipment is removed from service until repairs have been completed.

Recommendation #4: Employers should consider contacting equipment manufacturers to enlist their help in improving equipment safety.

Employers should contact equipment manufacturers to obtain information regarding ways to improve the safety of equipment used on their work sites. In this incident, an older model water truck was used. The external control for the main valve on the water tank was located under the truck and a worker had to crawl under the truck at least twice each day, once to open and once to close the main valve. The external control for the main valve could be relocated from its position under the truck to the side of the truck, thus eliminating the need for workers to routinely crawl under the truck to close the main valve. The location of the fluid gauge for the water tank could also be addressed. An electronic gauge similar to a gasoline gauge could be installed inside the truck's cab. Relocating the gauge inside the cab, thereby removing the need for workers on foot to walk near or climb onto the truck to read the gauge, would reduce worker exposure to hazards. Engineering controls should be used whenever possible to eliminate exposure and should be supplemented with safety SOPs and effective safety training.

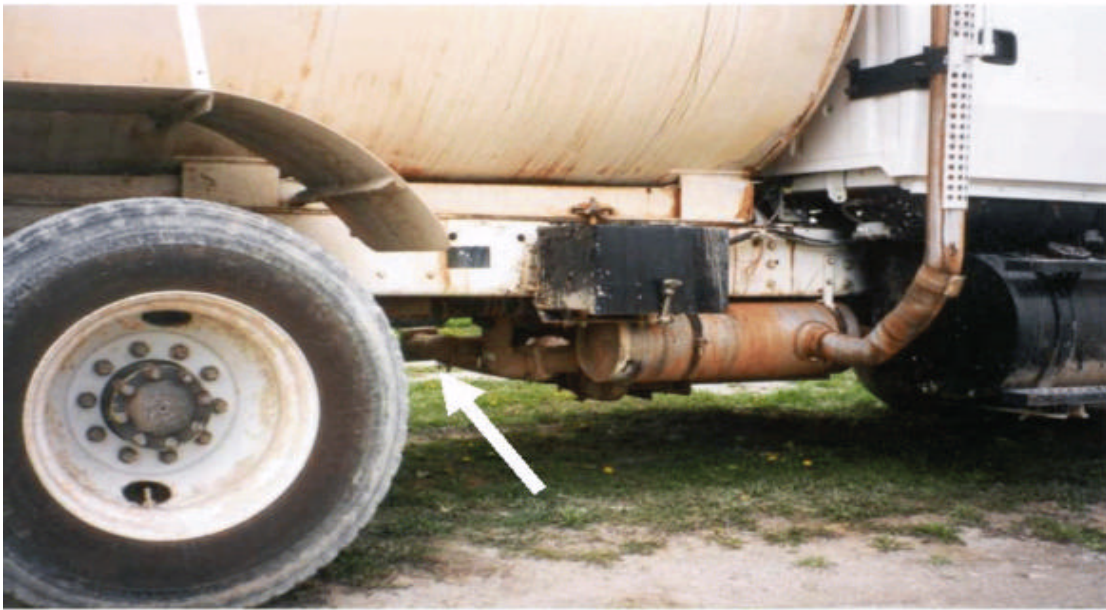
Photograph 3: This photo illustrates (at arrow) the approximate location on the passenger side of the truck where the victim stooped and leaned under the truck just before he disappeared from view.

A coworker, who was located a short distance behind the water truck, operating a tamping roller, saw the victim climb up on a platform and up a ladder attached to the back of the truck where he appeared to be looking at the fluid lines. According to the coworker, the victim stepped down off the platform after reading a gauge while the truck was still moving, and walked to the right (the passenger side) of the water truck, toward the cab. It appeared that he was going to jump on the running board and get back into the cab when he stopped, looked at something under the truck, then stooped and leaned under the moving truck (see photograph 3) and disappeared from view. Within seconds, the coworker saw the victim's legs extending out from the passenger side of the truck. The coworker began yelling and waving to the driver to stop. The employer continued to drive the water truck forward, at what he said was not even walking speed, spraying the stabilizer, until he reached the intersection. When he did not see the victim at the intersection where he expected him to be waiting to crawl under the truck to close the external control for the main valve, he proceeded across the intersection and pulled over on the right shoulder. As he was preparing to get out of the cab to close the external controls himself, he looked back and saw his coworker (tamping roller operator) waving his arms and heard him yelling and saw the victim lying in the road.

Recommendation #1: Employers should develop, implement, and enforce standard operating procedures for work performed in the proximity of vehicles and equipment. These procedures should, at minimum, prohibit workers from climbing onto, leaning under, entering or exiting moving vehicles, and detail safe procedures for working around moving vehicles and under secured vehicles.

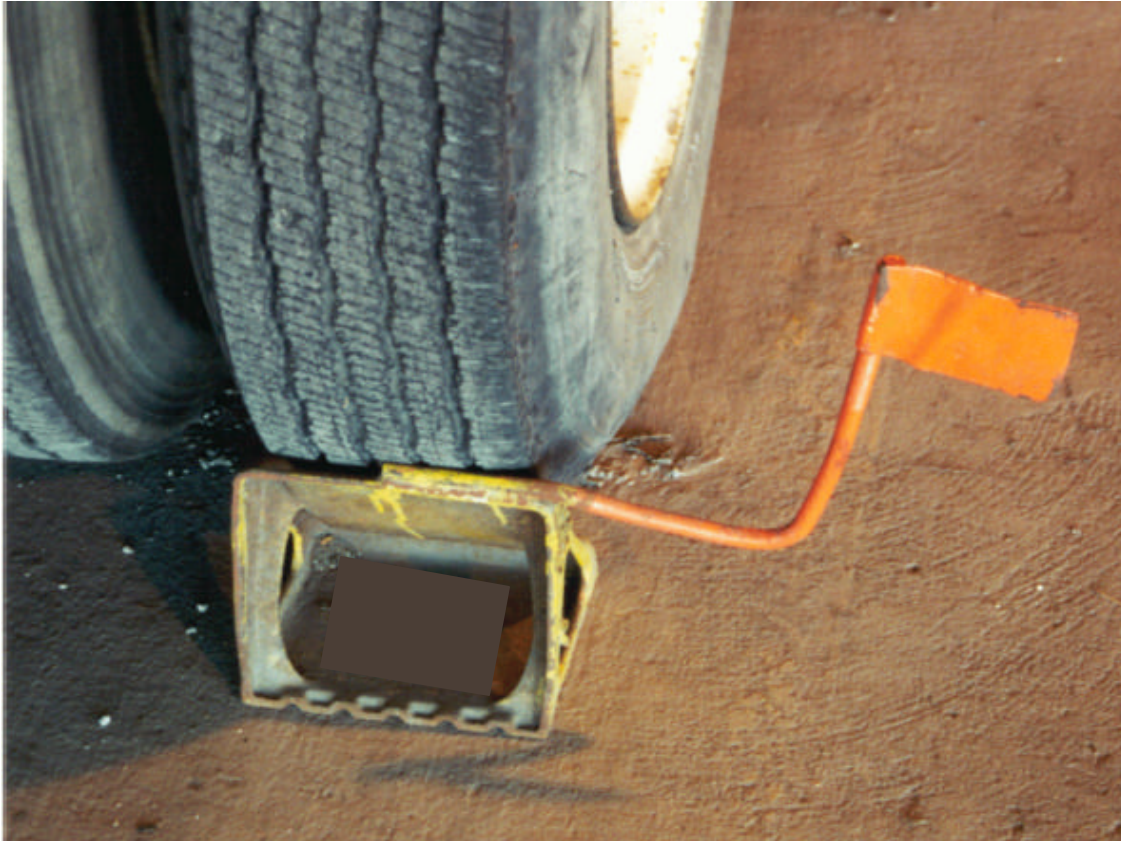
Photograph 5: This photo illustrates a wheel chock with a flag. A metal flag welded onto a metal chock could allow for greater visibility (Photograph courtesy of George Swartz, CSP).

- a system for communicating progress in completing the task;
- instructions on measures that are to be used to prevent unexpected movement of equipment. Steps should, at a minimum, include shutting off the engine; placing the shift lever in park and applying the parking brake, or, if a standard transmission, placing the transmission in the lowest gear and applying the parking brake; placing a warning tag on the vehicle near the controls which indicates that work is being done under the vehicle (or requiring that the driver remains in the truck in control of the keys throughout), and placing chocks (see photograph 5) in front and behind the drive axle tires;

- a system for releasing the vehicle after work is completed, which includes, at a minimum, the driver making visual and verbal contact with the worker on foot. Prior to starting the engine, the worker on foot should remove the chocks while in full view of the driver and well away from the travel path, and the worker on foot should then clear the driver to start and operate the vehicle.
