Seventeen-Year-Old Bagger at Retail Grocery Store Suffers Amputation While Operating a Meat Grinder—Pennsylvania

Fatality Assessment and Control Evaluation Program
Investigative Report #2001-01

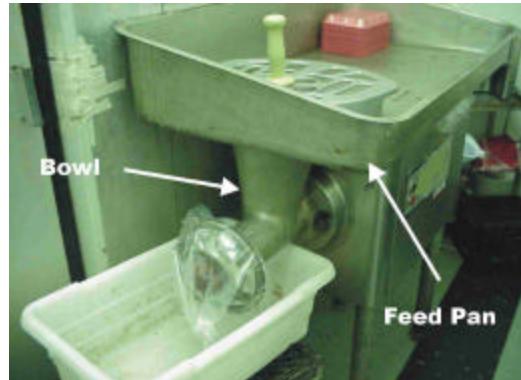
Photo 1. Meat Grinder

On September 12, 2000, a 17-year-old bagger (the victim) at a retail grocery store suffered amputation of the right arm as a result of being caught in a meat grinder while operating the machine (Photo 1). On January 10, 2001, the U.S. Department of Labor, Wage and Hour Division notified NIOSH's Division of Safety Research (DSR) of the occurrence. On March 5, 2001, a DSR safety engineer met with the Wage and Hour investigator, reviewed the case file, and discussed the case. On March 6, 2001, the safety engineer visited the grocery store, examined the meat grinder, and interviewed the meat department manager and the company's bookkeeper. Photographs and measurements of the meat grinder were taken. On March 6, 2001, the safety engineer met with the U.S. Occupational Safety and Health Administration (OSHA) compliance officer assigned to the case and discussed the case.

There were no eyewitnesses to the incident, and when interviewed by the Wage and Hour investigator, the youth could not remember the details of the incident. For this reason, the exact sequence of events is not known. However, during the site visit on March 6, 2001, the meat grinder was examined by the safety engineer, assisted by the meat department manager. Measurements and tests were conducted in an effort to identify a likely sequence of events to explain the manner of energy transfer between the meat grinder and the victim.

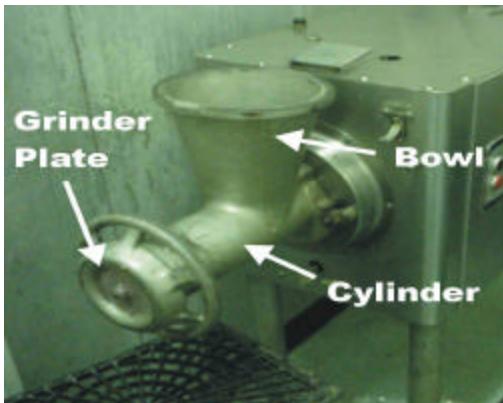
Photo 2a. Grinder Assembly, Guards Removed

mounted under the bowl, rotates inside the grinder cylinder (Photos 2a and 2b). Meat fed manually into the bowl from the feed pan drops onto the rotating worm, which forces it through the cylinder, past a set of four knife blades mounted on the end of the worm, and through the grinder plate at the end of the cylinder. A stuffer is supplied with the machine to assist in feeding the meat down into the bowl.

- The youth may have shut down the machine before raising the feed pan, but did not wait for the worm to come to a complete stop before inserting his hand. The worm coasts to a complete stop 6 to 7 seconds after the machine is shut down and retains enough energy to feed material into the cylinder while coasting to a stop.
- The interlock switch may have shut down the machine as the feed pan was raised but the youth inserted his hand before the worm was completely stopped.
- The youth may not have shut the machine down and the interlock switch may have malfunctioned, allowing the machine to operate as the youth inserted his hand.

When his fingers went below the bottom of the bowl his hand was caught by the worm and fed into the cylinder, amputating his arm below the elbow near his wrist. Coworkers heard his cries for help and called 911. EMS responded within 5 to 10 minutes and the youth was transported to a local trauma center.

Operating characteristics, time-to-stop and stored energy. With the machine running, the motor was shut down by the push button switch and the time for the worm to come to a complete stop was observed at 6 to 7 seconds. After this was observed, it was decided to evaluate the potential for the coasting worm to inflict injury. The feed pan was removed, and with the interlock switch depressed by hand, the machine was started. A piece of beef, 1 x 2 x 10 inches long, was dropped into the bowl immediately after the stop button was pushed. The worm fed the meat completely into the grinder cylinder. The test was repeated, only this time the worm was allowed to coast for several seconds after the stop button was pushed before the meat was dropped into the bowl. Again, the meat was fed completely into the cylinder. The test was repeated for a third time except that the worm was allowed to coast even longer before the meat was dropped into the bowl. The meat was fed completely into the cylinder while the worm was observed to coast to a stop after only three revolutions.

Discussion: The machine in this incident was equipped with several features that protect workers from the uncontrolled release of hazardous energy. The push button start/stop switch mounted on the side of the motor/transmission cabinet was unlikely to be inadvertently activated. The machine was equipped with a safety interlock switch mounted on the top of the motor/transmission cabinet so that the machine could not be started or would not continue to operate if the feed pan was removed. The feed pan was equipped with a permanently mounted bowl guard to prevent workers from reaching into the grinder bowl. However, as noted during the testing and examination of the machine, the grinder worm continued to turn for 6 to 7 seconds after the motor was deenergized and possessed enough energy to feed meat into the grinder cylinder (see Appendix). Redundant protection could be provided by equipping machines of this type with additional or redesigned interlock systems that would prevent removal of the feed pan until the grinder worm had come to a complete stop. This could be accomplished through the use of motion detectors or centrifugal switches.

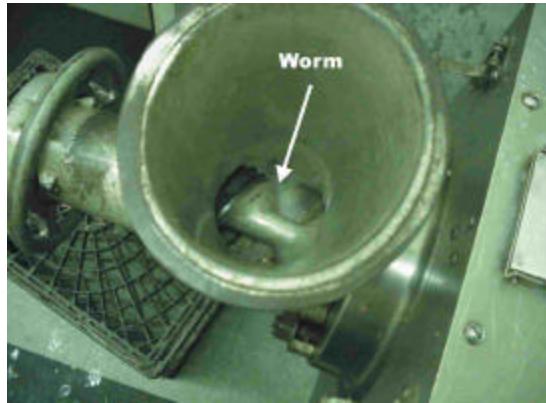
Photo 2b. Bowl Interior, Worm

Machine guarding. The length of the stuffer from its support shoulder to the end was found to be 11 $\frac{3}{4}$ inches. The distance from the stuffer support on the bowl guard to the top of the worm flights was found to be 12 $\frac{1}{2}$ inches. This 1 $\frac{1}{4}$ -inch difference accounts for the tendency of the last piece of meat fed into the bowl to sometimes fail to feed into the worm.

The bowl guard is open on one side only to allow meat to be fed into the bowl. The distance from the open edge of the bowl guard to the bowl opening in the feed pan was about 6 inches. It is very unlikely that a worker could insert a hand and arm through the feed opening for a horizontal distance of 6 inches and then vertically for 12 $\frac{1}{2}$ inches through the bowl to reach the worm flights.

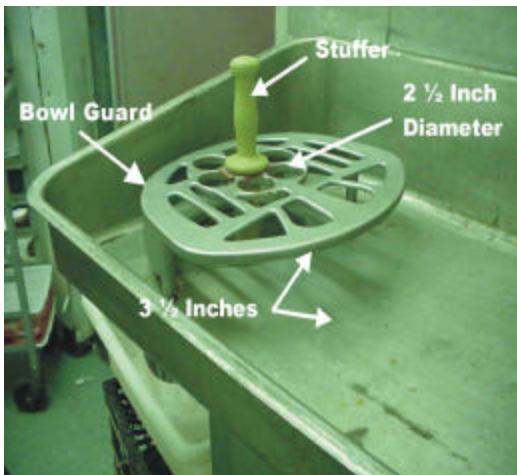
Photo 3. Feed Pan and Bowl Guard

The machine is equipped with several safety features designed to protect an operator from becoming caught by the worm. The feed pan is equipped with a permanently attached aluminum bowl guard covering the feed pan bowl opening (Photo 3). There is a safety interlock switch mounted between the top of the equipment cabinet and the bottom of the feed pan that interrupts power to the motor when the pan is removed (Photo 4). The motor cannot be restarted until the feed pan is replaced and the interlock switch paddle depressed. The feed pan is secured to the top of the equipment cabinet by a hook at the end of the cabinet opposite the grinder assembly and two toggle latches just above

The bowl guard is permanently mounted at a height of 3 $\frac{1}{2}$ inches above the floor of the feed pan. The largest opening in the bowl guard surface was 2 $\frac{1}{2}$ inches in diameter. It is unlikely that a worker's hand and arm could be inserted through these holes.

Safety interlock switch. With the machine running, the feed pan was unlatched and raised up at the feed end. The pan was raised about 6 inches and the interlock failed to shut down the machine. The test was repeated and this time the interlock successfully shut down the machine. The test was performed 4 additional times with the interlock functioning correctly. It was thought that the malfunction of the first test was due to a sticking switch plunger or a sticking switch paddle. The feed pan was completely removed, the interlock switch paddle depressed by hand, and the machine was started. The safety engineer slowly released the switch paddle and the interlock shut down the machine. This test was repeated numerous times, releasing the paddle slowly and quickly. The switch continued to function correctly. In an effort to repeat the malfunction first encountered, hand pressure was exerted on the switch paddle from both sides and front to back while allowing it to raise. No tests were able to repeat the malfunction.

The feed pan was reassembled on the machine but left unlatched. The pan was positioned in several misaligned configurations in an effort to find a position that would provide a large enough opening between the pan and the bowl for access to the interior while still depressing the interlock switch paddle and allowing the machine to operate. No position could be found.

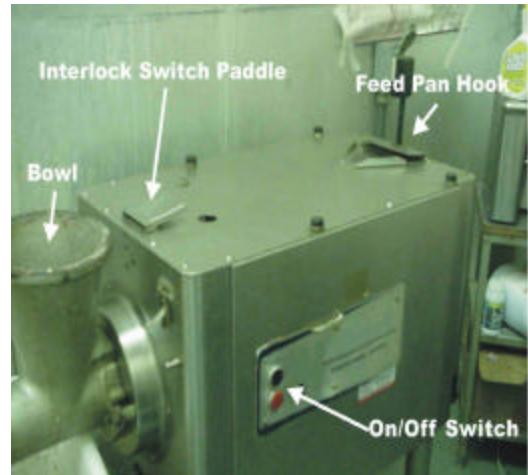
Photo 4. Meat Grinder, Feed Pan Removed

the grinder assembly. A push-button-operated start/stop switch is located on the side of the equipment cabinet. This switch type and its location minimize the likelihood of inadvertent startup by persons leaning or bumping against it.
