## ***Thirty-Eight-Year-Old Stevedore at River Port Materials Handling Facility Struck by Collapsing Crane Boom—Arkansas***

### **Fatality Assessment and Control Evaluation (FACE) Project**

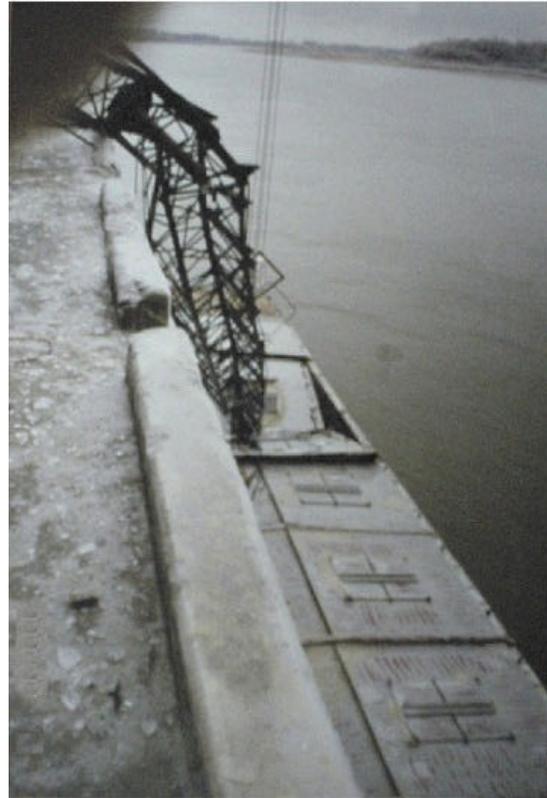
*Photo 1. Collapsed Crane Boom on Barge*

At about 8:30 a.m., the platform was hoisted to the dock and two stevedores boarded the platform, carrying with them a bag of oil dry for use in improving the footing on the icy barge deck. The workers were hoisted, swung out over the barge, and landed on the barge hatch covers. During the landing, the platform was lowered to within a few feet of the hatch cover using the load line hoist. Then, the platform was landed on the hatch cover by lowering the crane's boom, as this method provided a gentler landing than could be accomplished using the load line hoist. The two stevedores dismounted from the platform and gave the signal to hoist the platform back to the dock. At this time, they were standing on either side of the platform. The port manager began to hoist the platform by raising the crane boom. A few seconds later, when the personnel platform was only a few feet above the barge, he heard a noise which he thought was ice breaking off and falling from the crane. He stopped booming up and waited about 10 to 15 seconds. He then engaged the boom hoist and immediately heard a pop. Workers on the dock saw the boom pendants fall slack as the crane boom fell, striking the edge of the dock and breaking over the dock side. When the boom fell, the victim

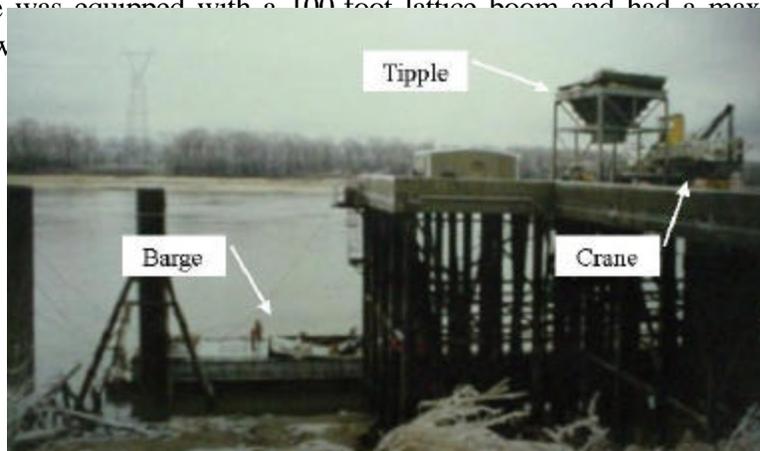
*Photo 2. River port facility showing dock, barge, and crane immediately after incident.*

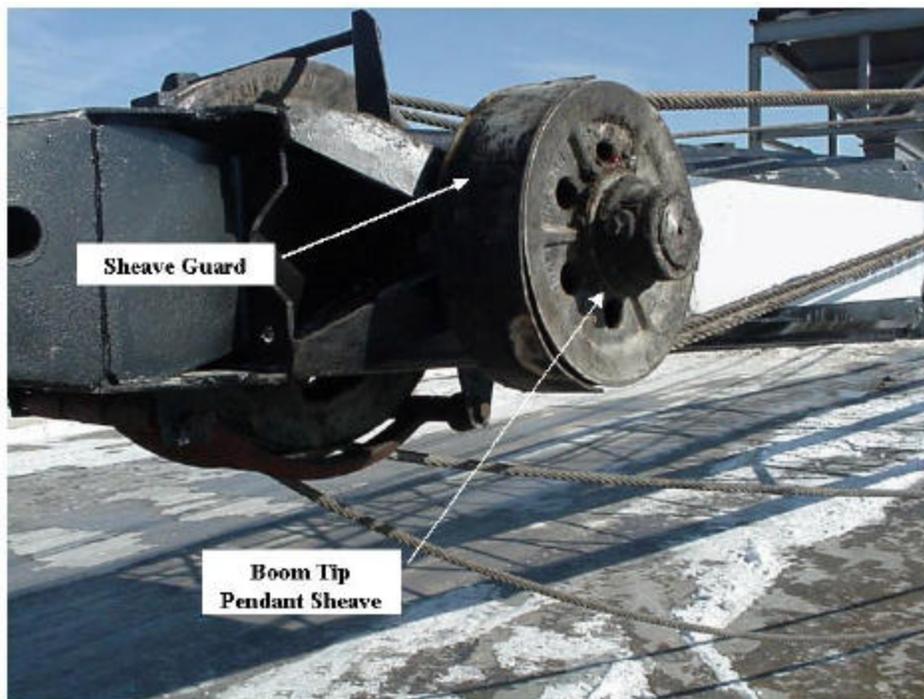
Evidence indicates that as the boom was raised, ice from the top surfaces of the right-side boom pendant collected in the groove of the right-side boom tip pendant sheave. The sheave was equipped with a closely fitted guard to help maintain the rope in the groove (Photo 3). However, there was enough ice buildup to squeeze the rope between the guard and the top of the sheave groove (Photo 4). When this occurred, the entire boom pendant system went slack, allowing the boom to drop (Photo 5). After the incident, the sheave guard was found to have been bent outward from the sheave and the rope had been pinched flat.

*Photo 3. Boomtip pendant rigging, left side shown for clarity. Damage to sheave guard occurred on right side.*

The employer in this facility had implemented a policy of daily examination of the crane for defects that would affect its safe operation. Each morning, before the crane was started and its boom was raised, the crane operator and the maintenance mechanic performed routine servicing and examination. This included lubrication and inspection of the boom tip components. However, on the day of the incident, the boom tip components were not lubricated because on the previous day, shortly after the morning examination and servicing had been completed, work had been suspended. The crane had been parked with the boom angled between 45 and 50 degrees. Since the crane had not been used, workers felt that there was no need for lubrication and the crane was examined with its boom in the raised position. However, as evidenced by the incident, conditions were present at the boom tip pendant sheaves and along the boom pendants that affected safe crane operation.

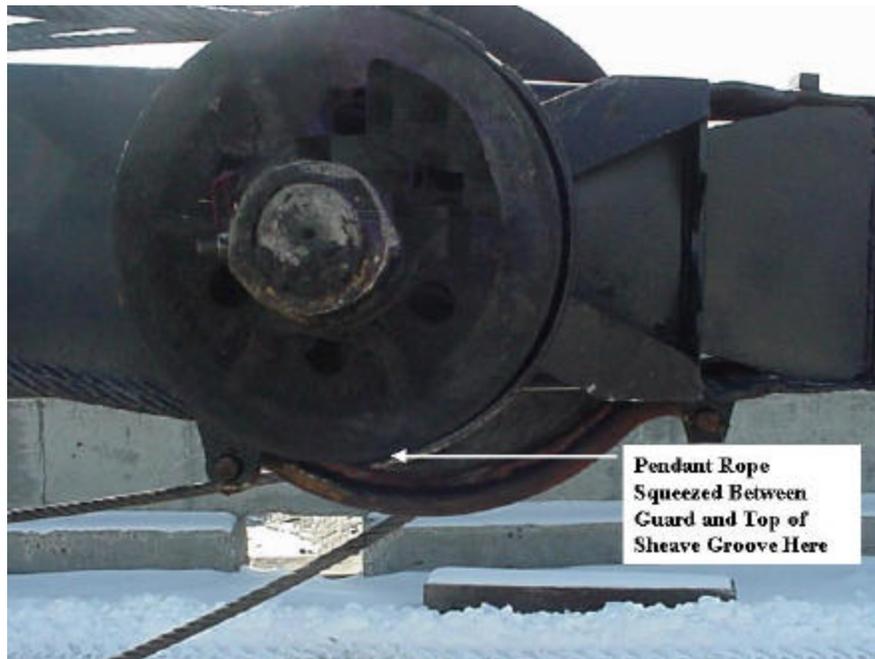
*Photo 4. Right side boom tip pendant sheave, after repair.*

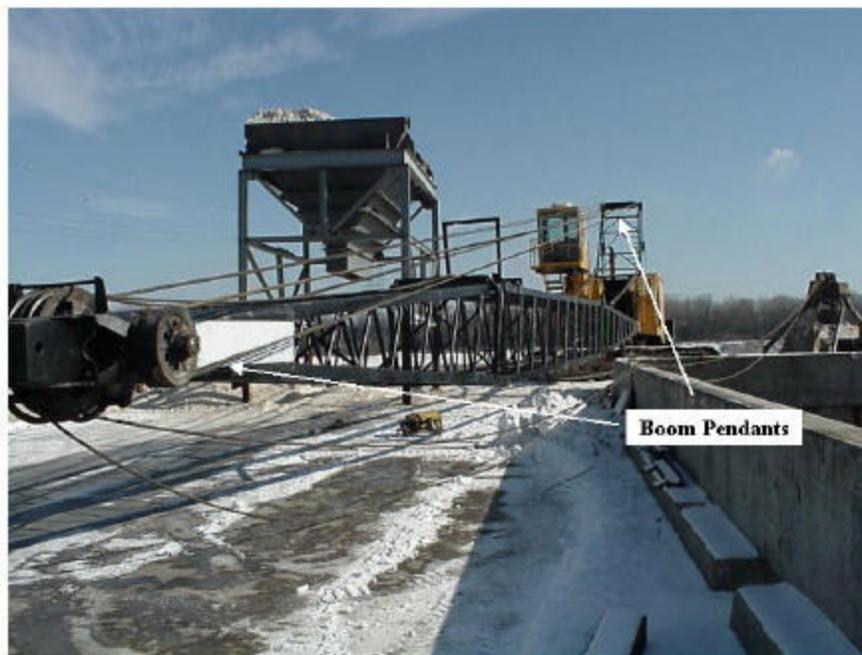
*Photo 5. Crane parked in normal position, after repair.*

Normal procedure was to park the crane at the end of each working day with the boom lowered. However, as previously noted, the crane had been parked with the boom at an angle of 45 to 50 degrees. At this angle, the boom tip sheaves would be about 70 feet away from the eyes of an examiner. Although the exam was conducted, no defects or adverse conditions were noted. Had the boom been lowered to nearly horizontal as normal, the boom tip would have been more easily observed and the severe icing conditions on the tip sheaves and boom pendant ropes may have been noted and corrected.
