Fatality Assessment and Control Evaluation Program

FACE Report Number: 2001-02

State Department of Transportation Highway Maintenance Worker Dies After Being Struck by a Car While Installing Reflectors on a Guardrail

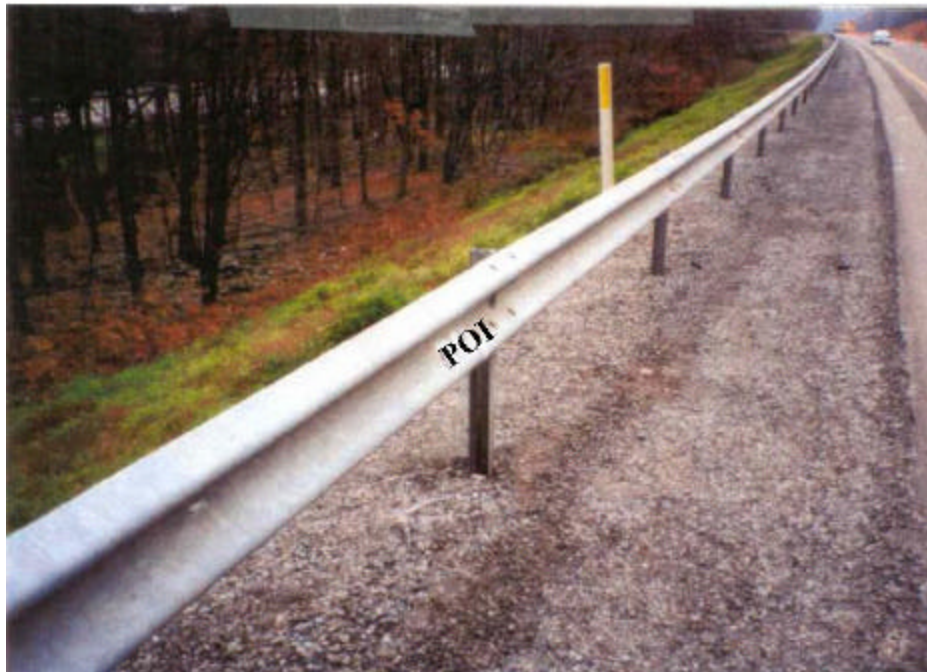
Both workers were standing on the traffic side of the guardrail. They had installed several reflectors, one every 12.5 feet, and had worked about 40 minutes at the site when the incident occurred. They were starting to install a reflector when the victim's coworker, who was standing near the victim, facing and watching traffic, looked up and saw a car approximately 1,000 feet away in the lane nearest them, headed toward them. According to the police report the vehicle speed was estimated at 60 miles per hour. The coworker yelled a warning to the victim, who was standing next to him, but with his back to the traffic installing a reflector on the guardrail. The coworker who gave the warning had just enough time to lift one leg over the guardrail as the car traveled over rumble strips on the shoulder, struck the guardrail, and skidded approximately 35 feet along the guardrail striking the victim (Photo 1). The impact threw the victim over the guardrail and down a slope into the wooded, 200-foot-wide median strip where he came to rest in a ravine approximately 50 feet from the guardrail.

Photo 1. Guardrail on the South Shoulder of the Westbound Lane. Note: The guardrail is marked POI to designate where the apparent point of impact with the victim took place.

Recommendation #1: Employers should adopt policies that require workers to work on the median side of the guardrail whenever it is safe to do so.

The employer's policy should include a method for evaluating the conditions on the median side of the guardrails for safe footing. Wherever the evaluation indicates it is safe to do so, work should be performed from the median side of the guardrail, where the guardrail provides some protection against being struck by oncoming cars.

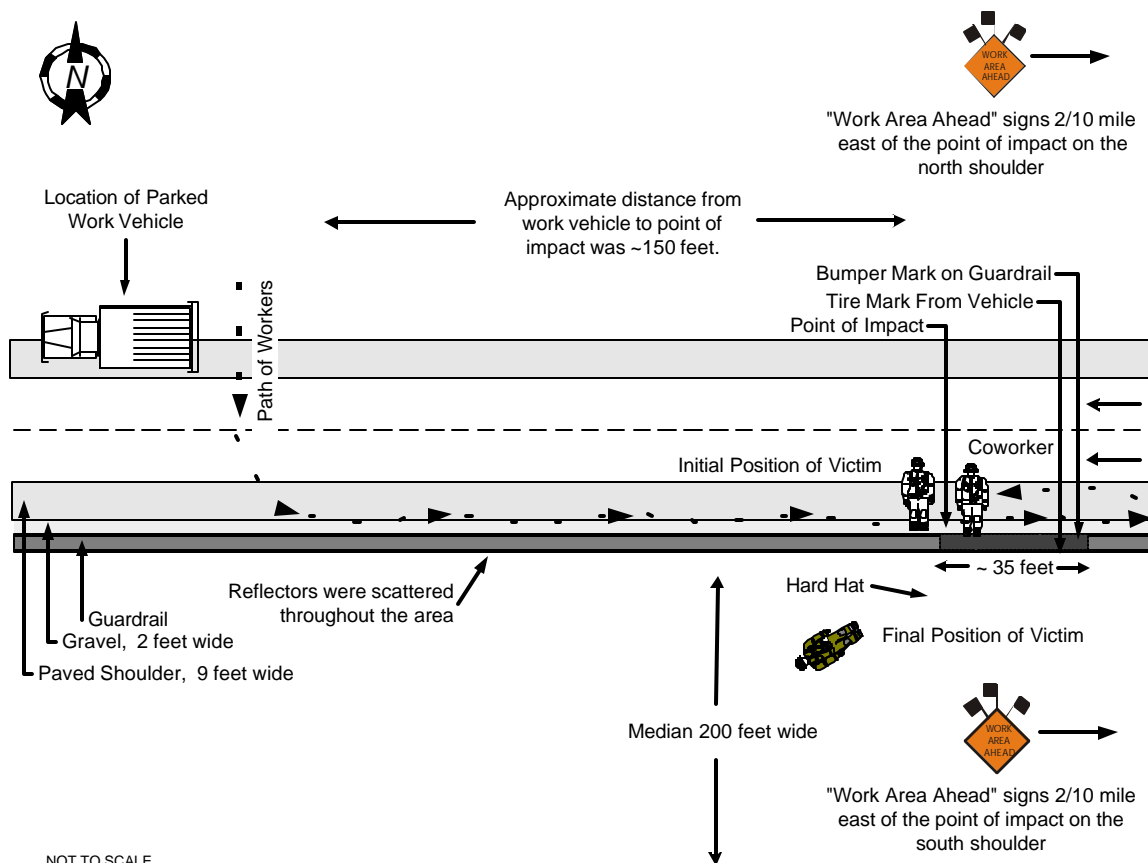
Figure. Aerial View of Incident Site.

The driver of the car drove back onto the highway without stopping and continued traveling west. The figure shows the layout of the incident scene.

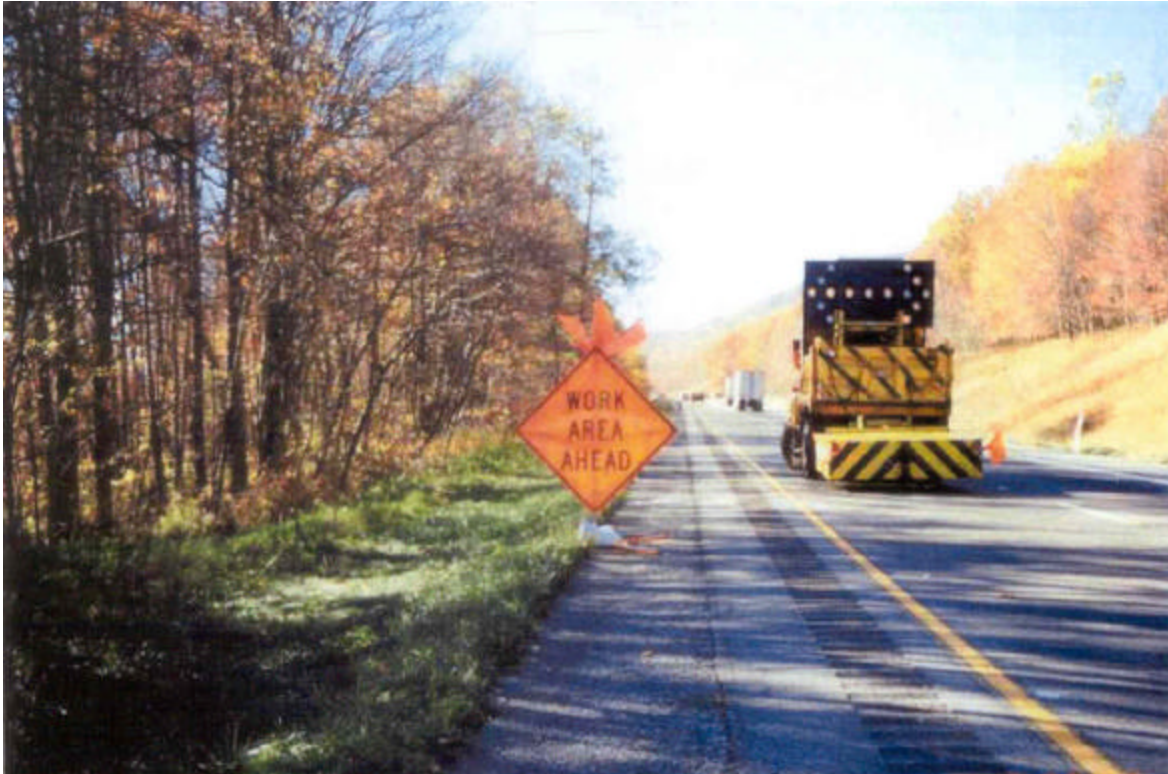
Photo 2. Incident Site. Note: Photograph 2 shows the “Work Area Ahead” sign with 3 orange flags, that the crew had placed along the both the north and south shoulders of the highway. The photograph also shows the rumble strip along the paved shoulder and the yellow line marking the edge of the roadway. These strips are designed to alert motorists who drift off the roadway of the need to correct their travel path. The truck shown in the photograph was not at the site prior to the fatal incident. The truck has a truck-mounted attenuator (TMA) which is designed to attenuate or absorb an impact. It has a lighted arrow directing traffic to the north lane. It was parked in the south lane after the fatal incident and during the investigation when the south lane was closed to traffic. A truck with a TMA, when positioned correctly, increases worker visibility and protection.

Employers should make evaluating the need for supplemental traffic-control devices for specific sites part of their formal scheduling and preparation for highway maintenance work. For example, in areas where the shoulder is too narrow to provide sufficient room for the shadow vehicle to follow workers working along the shoulder, closing the lane adjacent to the shoulder and setting up proper channelizing devices to divert traffic away from the shoulder may be needed. Use of an additional more specific sign may be needed to supplement the “WORK AREA AHEAD” signs, such as a “SHOULDER WORK” sign.

For protecting work operations along the shoulder of interstate highways where high density, fast moving traffic is expected, shadow vehicles should always be used and they should be equipped with a truck-mounted attenuator (TMA). A TMA is a cushion attached to the rear of the protective vehicle and is designed to absorb a rear impact. The MUTCD references the American Association of State Highway Transportation Officials (AASHTO) Roadside Design Guide, Chapter 9,² for guidance on use of impact attenuators. The placement must allow for a buffer distance between the vehicle and the worker. This distance is typically a compromise between anticipated roll-ahead post-collision movement of the protective vehicle and excessive space that would permit traffic to move into the buffer zone. Table 9.3 from the Roadside Design Guide is provided in Appendix 2. Supervisors should consult this table and inform workers of the appropriate buffer distances required for their work situations. Whenever a protective vehicle is occupied by an operator, the vehicle should be equipped with a TMA and the operator should be properly restrained.
