FACE

FACE Report Number: 2001-01

August 21, 2001

State Department of Transportation Worker (Laborer) Dies After Being Struck by Motor Vehicle

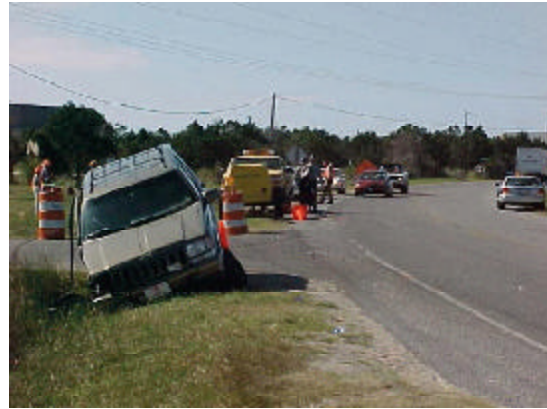
Photo. Incident Scene

On October 25, 2000, a 34-year-old State Department of Transportation worker (the victim) died after he was struck by a motor vehicle while working in a highway construction zone. The victim and coworkers had been preparing the work area, located just beyond a gently curved section of two-lane asphalt-surfaced state highway, for a trench excavation the following day. After installing temporary traffic control signs and marking the pavement for excavation, the crew was preparing to leave the area. The victim was sweeping spillage near the crew's work vehicle, parked on the shoulder near the roadway's northbound lane, when a northbound motorist veered off the roadway and struck the driver's side rear corner of the work vehicle. The motorist continued traveling north, scraping the entire side of the work vehicle and striking the victim, before coming to a stop in a roadside ditch. At the time of the collision, none of the crew members were looking toward the victim, however, they all heard the sound, turned toward the victim, and immediately went to his aid. Emergency personnel were notified via 911 and responded within 5 minutes. However, the victim died within minutes of the collision.

- *consider the use of supplemental traffic control devices in addition to the minimum specified by the Manual of Uniform Traffic Control Devices (MUTCD) during highway construction work*

- *consider installing rumble strips along the roadway pavement edges to warn motorists when their vehicle is approaching the shoulder*

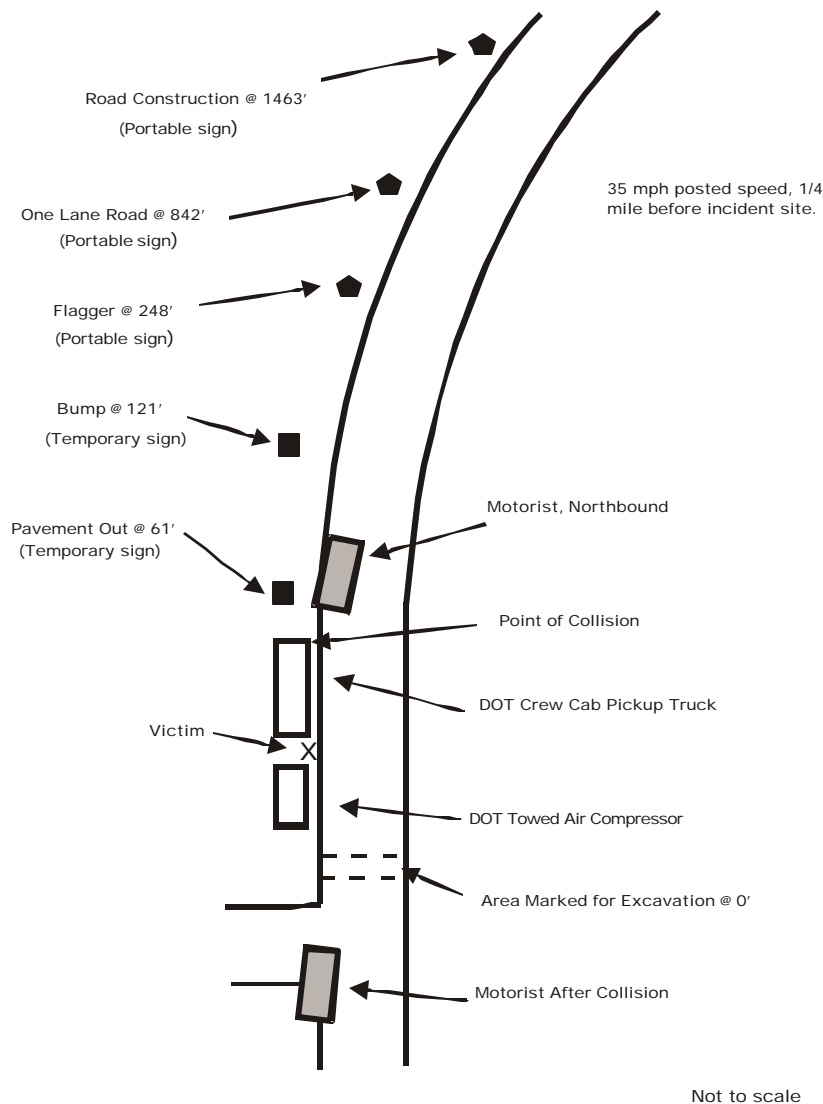
Figure. Layout of Incident Scene

The incident occurred on a two-lane state highway which ran north and south through a small village. The roadway consisted of two travel lanes totaling 24 feet in width with an additional 3- to 4-foot, asphalt-paved bike path on each side. A grassy, sand shoulder, approximately 10 feet wide, was on each side of the pavement. The northbound approach was curved until about 300 feet before the incident site. The pavement edge was level with the shoulder just after the northbound exit from the curve. From there, the height of the pavement edge above the shoulder increased to 3½ inches between 100 and 92 feet before the incident site. The height then decreased to 1¾ inches, 60 feet before the incident site. The roadway, including the curve before the incident site, appeared to be level with little or no crown.

The incident occurred between 10:20 a.m. and 10:25 a.m. as the supervisor and two crew members were located on the side of the southbound lane exploring for utilities and one crew member was located on the access road. Because the crew members and supervisor were not looking directly at the victim his exact location is not known, but when last seen he had been standing in front of the pickup truck, sweeping spillage. A motorist, driving a sport utility vehicle (about 4000 pounds curb weight), was exiting the curve in the northbound lane and drifted toward the outside of the curve. The motorist traversed the bike path and his vehicle's passenger-side wheels dropped off of the pavement and onto the grassy sand shoulder. The motorist continued traveling with his wheels off the pavement and sideswiped the rear corner of the DOT pickup truck, shoving it approximately 20 feet north. The motorist vehicle then struck the victim and continued north with its right side airborne for about 50 feet. It traveled an additional 65 feet with ground contact before coming to rest in the northbound roadside ditch. The victim was thrown north approximately 20 feet after the collision. All the crew members heard the sounds of the collision and turned toward the victim. The supervisor and two crew members went to the victim and one crew member went to the motorist's vehicle. A crew member notified 911 at 10:31 a.m. and emergency personnel were on the scene by 10:35 a.m. The victim was transported to a local clinic where he was pronounced dead, having expired within minutes of the collision.

Recommendation #1: Departments of transportation should consider the use of supplemental traffic control devices in addition to the minimum specified by the Manual of Uniform Traffic Control Devices (MUTCD) during highway construction work

Recommendation #2: Departments of transportation should consider installing rumble strips along the roadway pavement edges to warn motorists when their vehicle is approaching the shoulder.
