Sixteen-Year-Old Produce-Market Worker Dies From Crushing Injuries After Being Caught in a Vertical Downstroke Baler—New York**SUMMARY**

Fatality Assessment and Control Evaluation Program
Investigative Report #2000-19

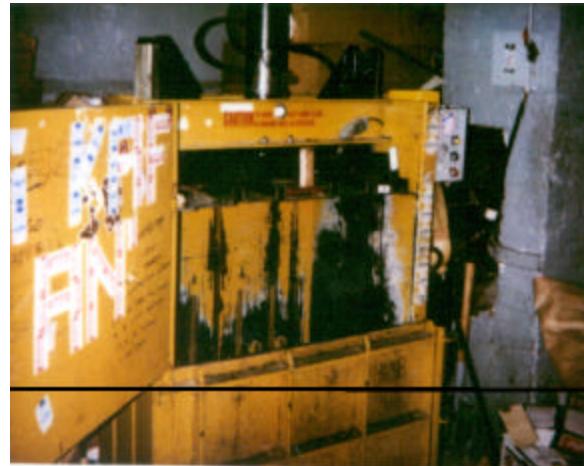
A 16-year-old male produce-market worker (the victim) died from crushing injuries after being caught in the vertical downstroke baling machine that he was operating (Figure 1). The victim, working alone in the basement of a small produce market, was crushing cardboard boxes when at some point in the compacting process he was caught by the machine's hydraulic ram. The victim was discovered by an exterminator spraying the basement, who notified the store manager to call police and emergency medical services (EMS).

***Figure 1. Vertical Downstroke Baler***

Subsequent examination by investigators revealed that the safety interlock had been bypassed, allowing the machine to operate with the loading door in the open position. The victim may have reached into the baling chamber during a compression cycle to adjust a tie wire or a liner box and was caught by the ram platen.

In an effort to speed up the process of compressing boxes at this market, workers had defeated the safety interlock on the upper door. A wad of paper had been jammed into the hole that the door pin passed through, to simulate the door being closed. By defeating the interlock, the baler could be

operated with the upper loading door open. When the victim was found, it appeared that he had been just starting a new bale. The wire had been threaded through the baling chamber and secured to the outside of the baler and a flattened box was in place in the base of the compaction chamber. He may have leaned over into the compression chamber trying to quickly adjust a tie wire or the base box when he was caught in the ram as it moved downwards.

Recommendation #1: Employers should ensure that all safety devices on baling machines are functioning correctly and enforce proper operation.

Discussion: The baling machine involved in the incident was equipped with safety devices in compliance with ANSI Z245.5-1997 standards for Baling Equipment—Safety Requirements. Specifically, the machine was equipped with a loading chamber closure consisting of a door that had a plunger pin welded at the bottom. When the door is closed, the pin passes through a small hole in the frame of the baler and engages a power interlock switch, allowing operating power to the motor and hydraulic pump. When the door is opened, the interlock switch is disengaged, cutting power to the motor and hydraulic pump. In this incident, the interlock power switch was bypassed with a wad of paper jammed into the pin hole to simulate the door pin. By doing so, the baler was allowed to operate with the load chamber door open. If the interlock had been operable, this incident may not have occurred.

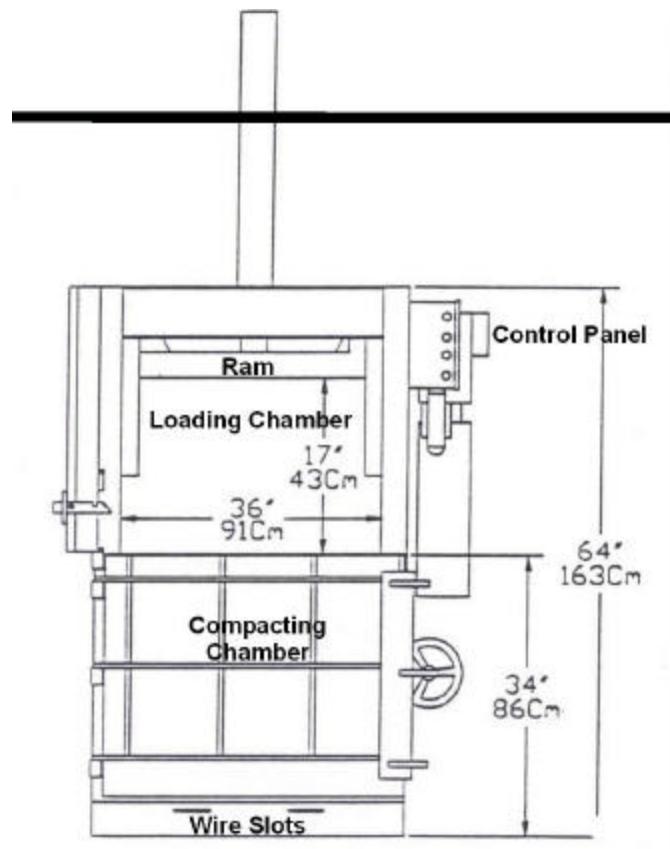
Figure 2. Vertical Downstroke Baler Specifications

The dimensions of the baler are shown in Figure 2. The baler stands 96 inches high by 32 inches wide and utilizes hydraulic pressure to compress materials. A maximum ram pressure of 41,350 pounds can be generated from the 1½ horsepower electric motor and two stage hydraulic pump. An electrical control panel is mounted on the front, upper right side of the baler. The control panel is equipped with three buttons marked UP, DOWN, and EMERGENCY STOP (Figure 3).
