FACE Report Number: 2000-15

August 22, 2000

A Plant Production Supervisor Dies After Being Crushed Between the Boom Arm and Front Chassis of a Skid-Steer Loader - North Carolina

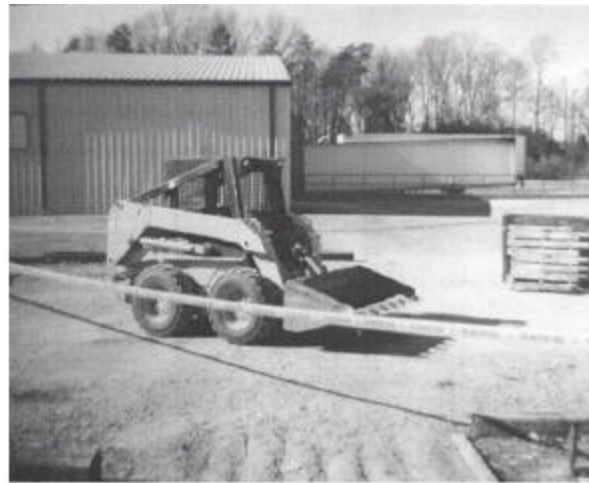
Photo 1. Skid-Steer Loader

A 41-year-old male plant production supervisor (the victim) died after being crushed between the left boom lift arm and the front chassis of a skid-steer loader (Photo 1). The skid-steer loader had been dropped off that morning by a rental agency representative who gave basic operating instructions to the victim and the plant maintenance supervisor. Later in the day the victim, who had been in the plant, was exiting the rear of the plant when he observed the maintenance supervisor having some difficulty operating the loader. The victim approached the loader to assist. The maintenance supervisor had no prior skid-steer loader experience and had been running the loader for approximately 10 to 15 minutes. He told the victim that he thought there was something wrong with the hydraulic system. Both men attempted to troubleshoot or identify the problem. The victim, who had some skid-steer loader experience and had been operating the loader earlier that morning, told the maintenance supervisor to raise the boom. While talking to the maintenance supervisor about a control handle on the right side of the operator's seat, the victim moved under the boom's lift arm to show him the control. Reaching across the front of the loader cab from left to right, the victim moved his arm to the right side of the maintenance supervisor, reaching for the auxiliary boom-control lever. From this point the exact sequence of events is not clear, however, for some reason the boom and bucket assembly came down rapidly on top of the victim, who was between the left boom lift arm and the front chassis of the loader. During the incident a hydraulic line ruptured at the elbow fitting on the left boom lift arm, spraying the maintenance supervisor and cab with hydraulic fluid.

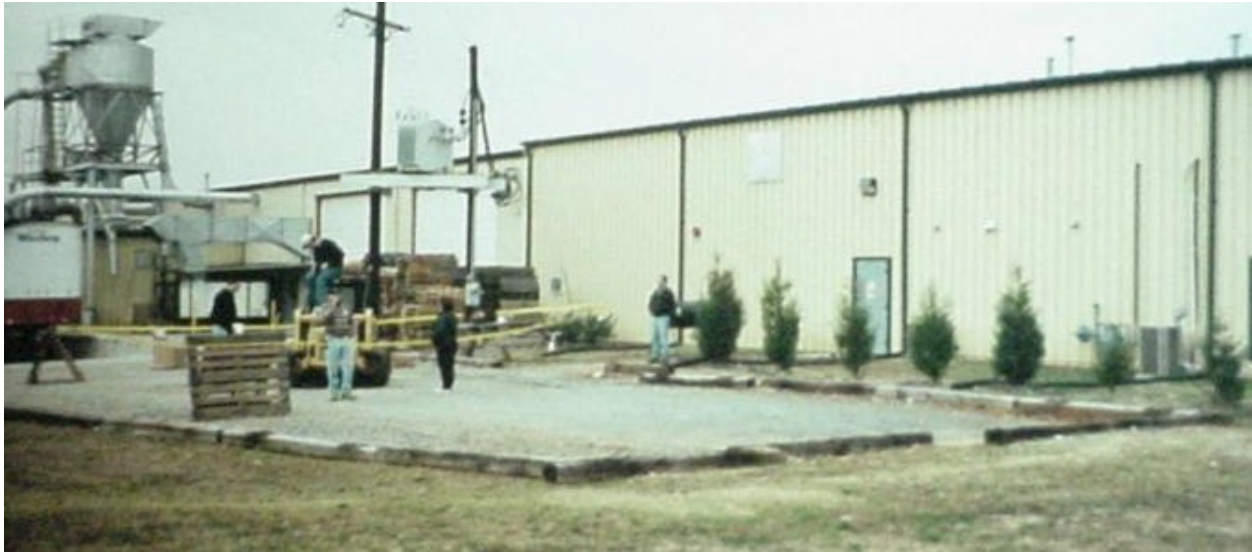
Photo 2. Gravel Lot

At approximately 11:45 a.m., the maintenance supervisor began to operate the loader on a gravel-covered lot in the rear of the plant (Photo 2), to familiarize himself with the machine's operation. The terrain was level and the weather was clear and dry. The maintenance supervisor had been operating the loader for about 10 minutes and thought that the machine was not performing properly. At this time, the victim was exiting the rear of the plant and observed the maintenance supervisor

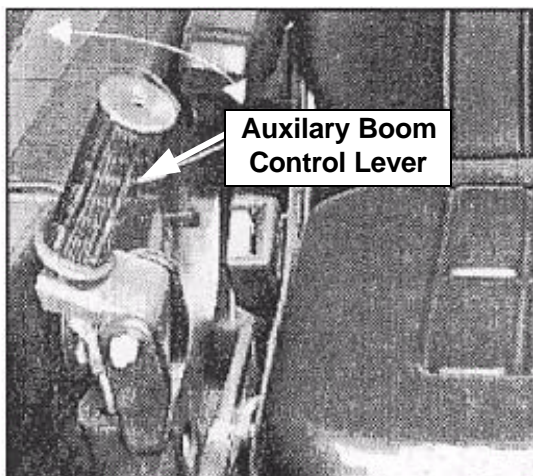
Photo 3. Auxiliary Boom Control Lever Controls Left and Right Hydraulic Couplers

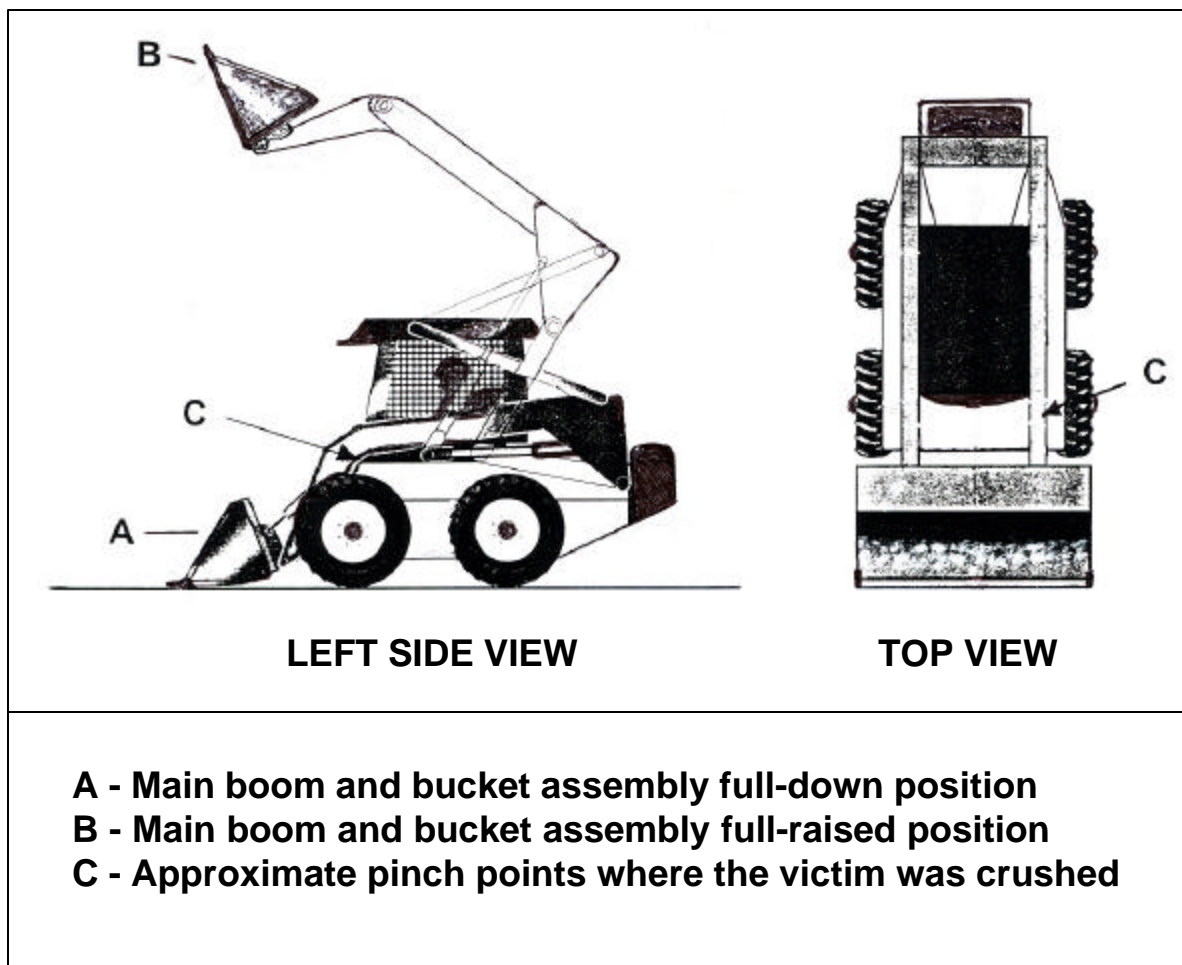
Figure. Skid-Steer Loader

left lift arm and the front chassis of the loader (Figure). Hydraulic fluid from a broken elbow fitting on the left lift arm started spraying all over the cab. Two contractors who witnessed the incident came over to help. The maintenance supervisor then raised the main boom and the victim fell to the ground. The operator backed the loader away from the victim and shut down the machine. Some employees came out of the plant to help. The victim was not moving and cardiopulmonary resuscitation (CPR) was attempted. Emergency responders had been called. The maintenance supervisor had been soaked with hydraulic fluid and was assisted back into the plant. Emergency responders arrived within minutes and continued CPR. Medical treatment was continued at the incident site, however, the victim sustained massive crushing injuries to the head and chest and was pronounced dead at the scene.

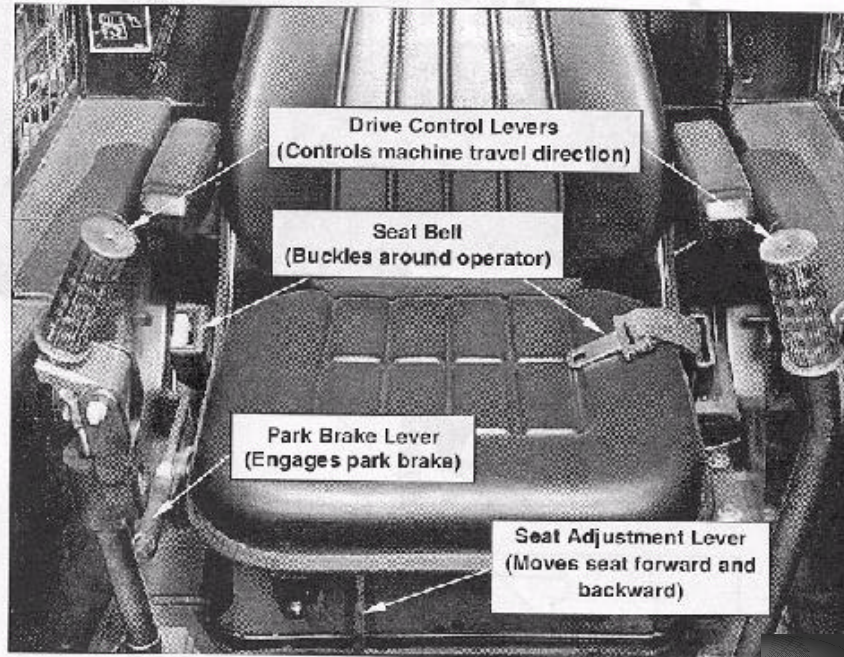
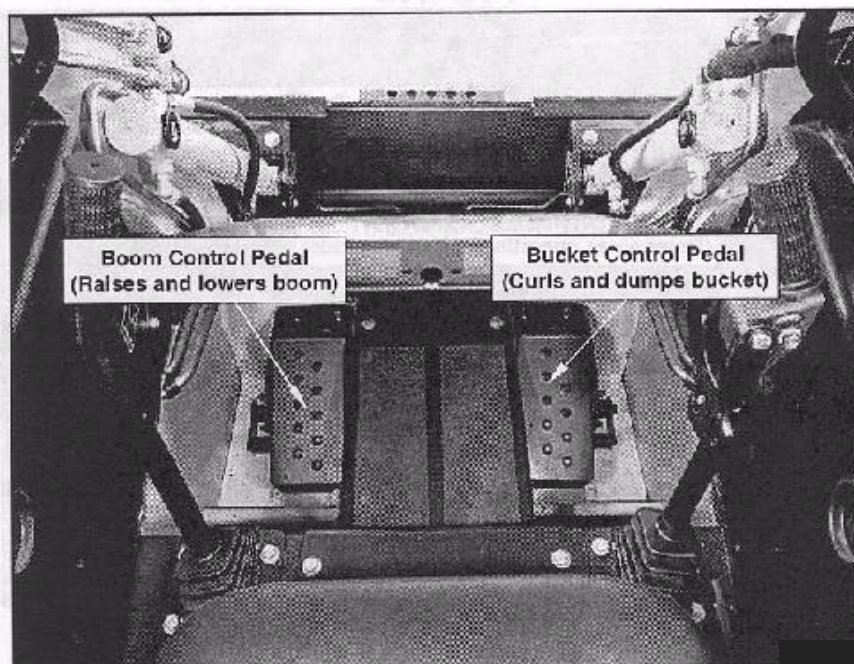
Photo 4. Controls

The investigators visited a local tractor sales company, and through the courtesy of the general manager, observed the operation of a loader similar to the one used in the incident. The operation and function of all foot and hand controls were demonstrated to the investigators while the loader was running (Photo 4). The left foot peddle operates the up-and-down movement of the boom lift arms. The right foot peddle operates the bucket assembly from the full-scoop-up position to the full-down or dump position. There are right and left control levers that resemble joy sticks. They control forward, reverse and the turning movements of the skid-steer vehicle. A two-position hand grip on the top of the right control lever operates the left and right hydraulic couplers and allows the operator to use auxiliary boom equipment such as a post hole digger, if attached. If placed in the full-down position toward the operators seat it provides hydraulic oil to operate the auxiliary equipment. In the full-up position it will reverse the flow of hydraulic oil away from the auxiliary coupler. The control handle should be locked in the center-neutral position when not in use to prevent overheating of hydraulic oil. The throttle is to be fully open when operating the machine. It was noted in the operator's manual that if the throttle is not in the full open position the loader will operate more slowly. This may explain the perceived slow operation by the maintenance supervisor. There is a parking brake lever to the right of the operator's seat. The operator's manual states "Before you work on the loader or any attached equipment: lower attachments to the ground, or rest the lift arms on the lift-arm stops." There is a lift-arm stop control lever that can be activated from the operator's seat to deploy the lift-arm stops. Once deployed the boom can be lowered to rest the lift arms on the stops. These stops prevent the boom from inadvertently being lowered and allow for maintenance access to the underside of the boom.
