FACE Report Number: 2000-14

October 20, 2000

Sixteen-Year-Old Mechanic's Assistant Died After Being Run Over By the Rear Wheels of a Tub Grinder - Connecticut**SUMMARY**

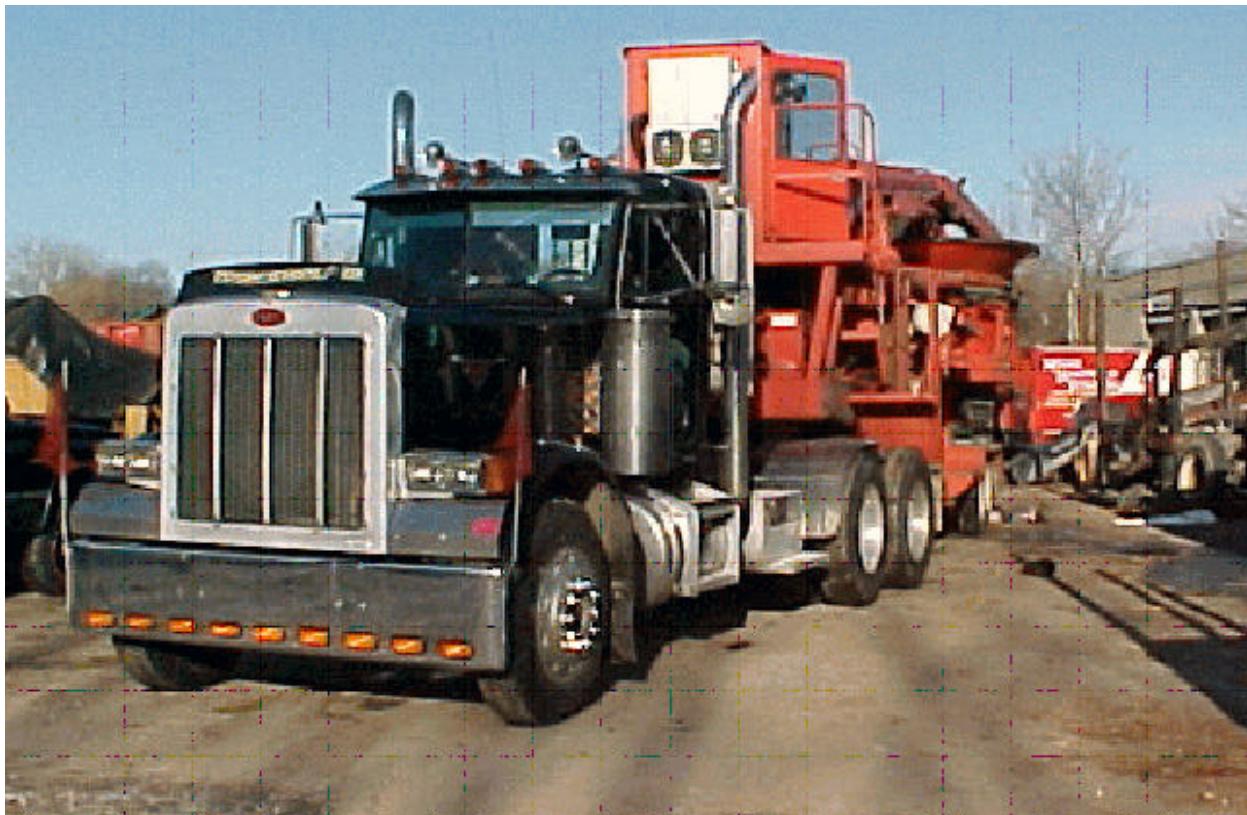
Photo 1. Preparations were being made to pull the trailer-mounted tub grinder to an off site location.

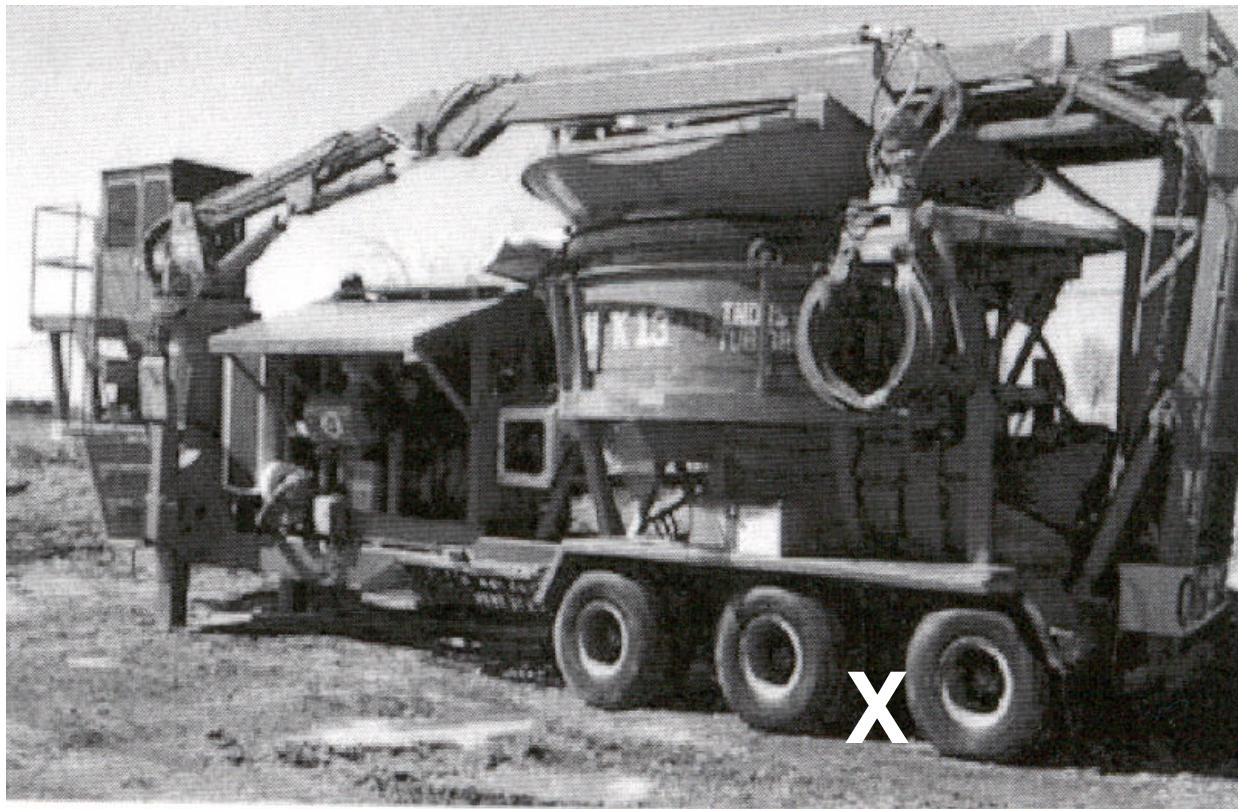
Photo 2. The Tub grinder shown is the same make and model as the trailer-mounted tub grinder used in this incident. The X indicates the approximate location of the victim's body following the incident.

over and then dragged between the second axle wheels and the third axle wheels of the tub grinder before the truck could be stopped. A crane was used to lift the 74,000 pound tub grinder off the victim's chest. The victim was pronounced dead at the site at 8:30 a.m.

Recommendation #1: Employers should develop, implement, and enforce standard operating procedures for repair work performed under vehicles.

Standard operating procedures should be developed, implemented, and enforced, which include safety procedures that should be followed when equipment maintenance or repair requires workers to be located under or near parked vehicles. The procedures should include, at minimum, the type of system employees are to use to identify equipment under repair, the measures they are to utilize to prevent unexpected movement of equipment under repair, and the method employees are to use to communicate among themselves regarding the planned maintenance and repair work and their specific tasks and responsibilities. A pre-maintenance, pre-work meeting should be held with all involved workers to outline/review the procedures to be used during maintenance activities and to outline/review each worker's specific responsibilities and tasks. At a minimum, prior to beginning repairs under parked vehicles, the mechanic and truck driver should go over the steps required in the repair process and develop a system for ongoing verbal and visual communication throughout the repair process. Steps may include the following: shutting off the engine; placing the shift lever in park if there is a park position or, if there is no park position, placing the shift lever in the lowest possible gear; applying the parking brake; placing a warning tag on the vehicle near the controls which indicates that it is under repair; and placing chocks, one in front and one behind, the drive axle tires. Following repairs, the mechanic, driver, and supervisor should conduct a walk-around inspection to make certain that the area under and around the vehicle is clear of people and property. Only after the inspection should the chocks and the warning tag be removed, and the driver given clearance to move the vehicle. An employee should be assigned the duties of spotter and, in full view of the driver and well away from the travel path of the vehicle, should direct the driver from the area where maintenance and repair work was completed.

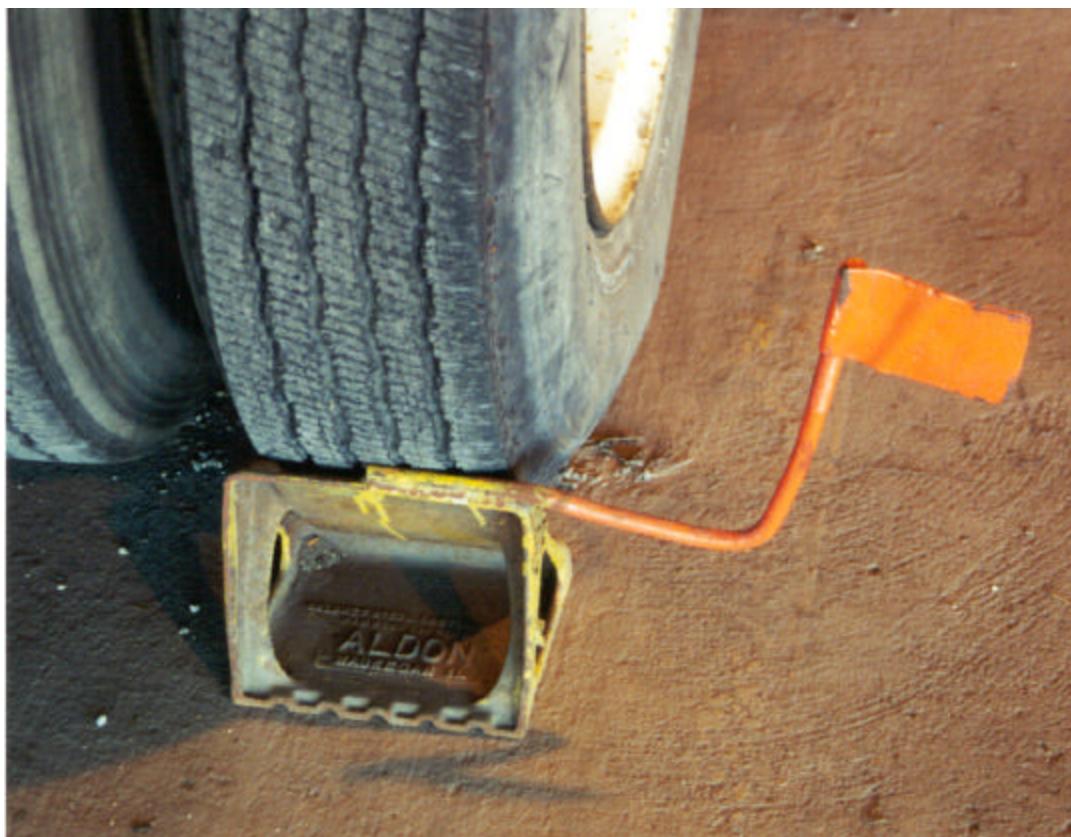
Photo 3. Wheel Chocks With a Flag. A metal flag welded onto a metal chock allows for greater visibility. (Photograph courtesy of George Swartz, CSP)

As an additional precaution, employers may choose to purchase steel wheel chocks that have had a flag welded to them by the manufacturer (see Photo 3). The flag, when painted a bright fluorescent color such as red, orange, or yellow, makes the chock more visible to workers in the area and alerts them that maintenance is being performed. Note: The flag on the chocks would not replace the warning tag system placed near the vehicle's controls mentioned earlier, but could provide a redundant measure to alert workers that repairs are in process.
