FACE Report Number: 2000-13

15-Year-Old Part-Time Worker at Retail Grocery Store Suffers Amputation While Assembling Meat Grinder - Utah**SUMMARY**

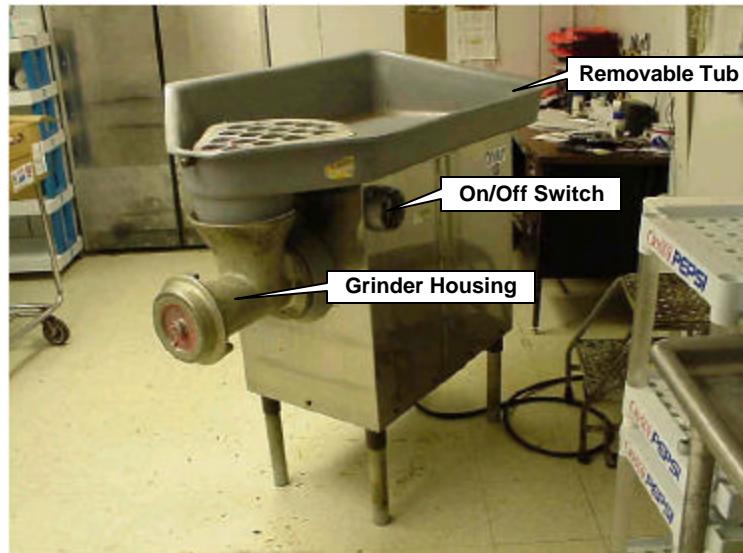
Photo 1. Meat Grinder, Front and Left Side

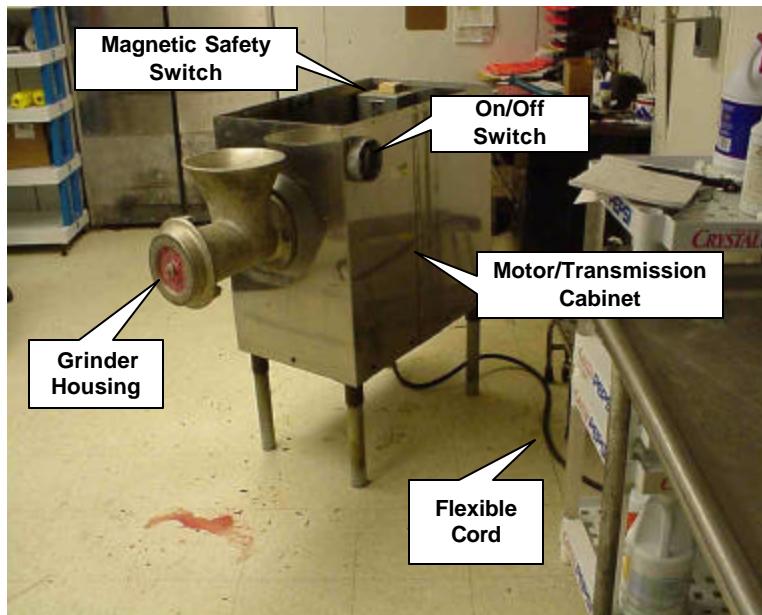
The machine involved in this incident was a meat grinder powered by a 5-horsepower electric motor. Electric power was supplied by a flexible cord and plug connected to a wall receptacle. The receptacle, located behind a desk in the meat department, was inaccessible for routine disconnection and the flexible cord remained connected at all times. The machine was equipped with a chain-

driven auger that rotated inside a barrel-shaped housing. Meat was fed into the grinder through a hopper-shaped feed-throat and extruded through grinder plates by the auger (Photo 2). The grinder was controlled by an on/off switch operated by a lever mounted on the left side of the motor/transmission cabinet. Prior to the incident, this switch had been unprotected from inadvertent operation. The motor/transmission cabinet was covered with a removable plastic tub which held the

Photo 2. Meat Grinder, Tub Removed, Front and Left Side

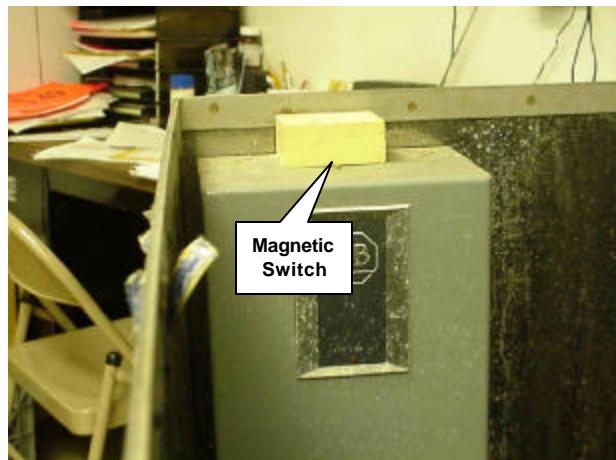
material being fed into the grinder throat. The machine was equipped with a magnetic safety switch mounted on top of the motor starter such that a magnet mounted underneath the plastic tub would activate it, allowing the motor to operate (Photo 3). When the tub was removed from the grinder, the switch would interrupt electric power to the motor, preventing operation. This switch, however, had not been functional since before the store was purchased 16 years earlier. Store employees were not aware of the presence of this switch until after the incident.

Photo 3. Magnetic Safety Switch, Plastic Tub Removed

learned that the grinder had been equipped with a magnetic safety switch that would interrupt the power when the plastic tub was removed. At the time the employer had purchased the store and grinder, the switch was not functioning, and the employer and meat department staff had been unaware that the machine had ever been equipped with such a device. The switch was mounted on top of the motor starter enclosure (Photo 3). It was designed to be pulled closed by a magnet mounted underneath the plastic grinder tub, located directly over the switch when the tub was in place. Apparently the magnet had loosened and fallen from the tub, and the switch had been bypassed electrically by a previous store owner. Had this switch been operable, the machine would not have started when the on/off switch was inadvertently activated with the tub removed. To ensure that all safety devices are operable, employers should contact manufacturers or equipment distributors to examine equipment when purchased, especially if previously owned, and restore it to safe condition. Additionally, the equipment should be examined regularly by employees who have been trained to recognize the hazards of operating the machine and in the correct operation of safety devices. All defects identified should be corrected before returning the equipment to service.

Recommendation #2: Employers should ensure that all equipment, including manufacturer-provided safety devices, is maintained in safe operating condition.

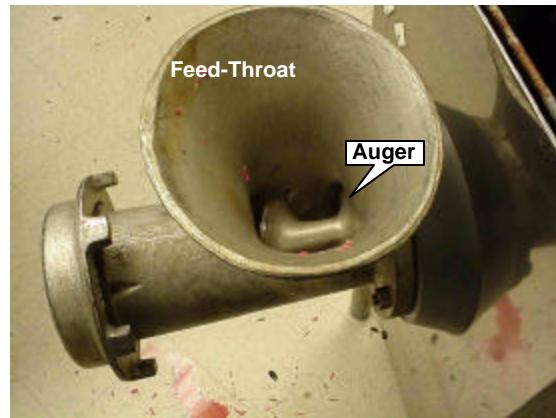
the meat grinder. He attached the barrel-shaped grinder housing, finger-tightening the four bolts that secured it to the transmission case. He then inserted the grinder's auger through the front of the housing. He reached through the feed hopper and into the housing with his right hand to guide the auger into engagement with the drive mechanism (Photo 4). Evidence suggests that as he did so, he inadvertently leaned against the on/off switch lever and moved it to the on position. The grinder started and the auger began to feed his hand and arm through the grinder housing. He shut down the machine and withdrew his arm. He then left the meat department room and made his way to the front of the store. He was assisted by the store manager who applied pressure to the injured right arm to control bleeding. One of the store cashiers called 911. EMS responded within 10 minutes to the site and the victim was transported to a local hospital.

Photo 4. Grinder Housing, Auger, and Feed-Throat

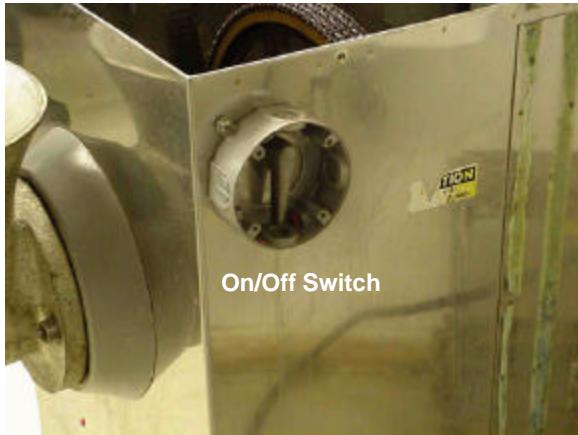
Photo 5. On/Off Switch Protected by Open-Faced Enclosure

After the incident, the employer implemented a hazardous energy control policy that required relocating the switch to a readily accessible wall location near the grinder's work location and procedures to lock out and tag the flexible cord plug at the end of each working day or when servicing or repairing the equipment. Additionally, the grinder's on/off switch lever was protected from inadvertent activation by an open-faced enclosure.
