FACE Report Number: 2000-12

May 22, 2000

***Carpenter Dies After Being Struck by Uncontrolled Concrete Bucket When Crane Tips Over - Ohio*****SUMMARY**

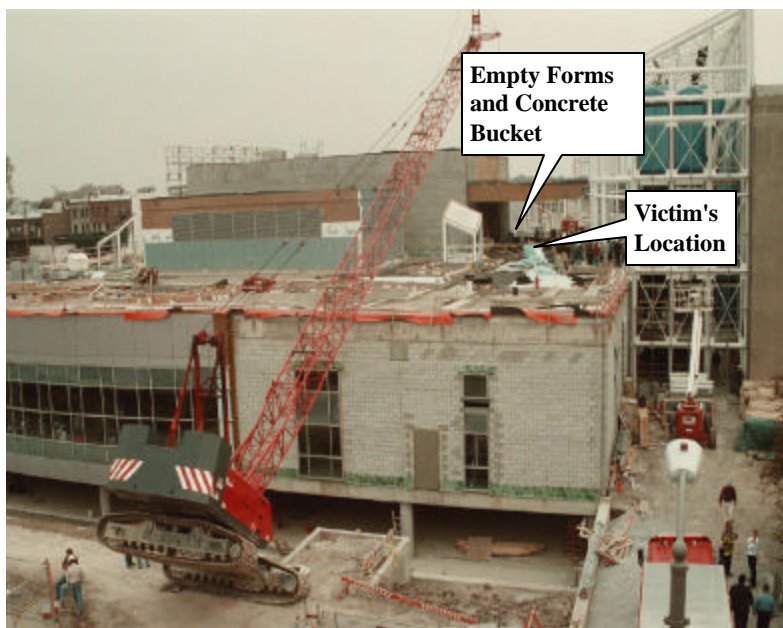
**Photo.** Crane Tip-Over at Library Expansion Project  
(Photo courtesy of The Blade/Toledo, Ohio)

At the time of incident, the bulk of the new structure had been completed and workers were engaged in adding electrical and mechanical systems, finishing the building's interior and constructing a rooftop green space on the new addition. At about 8:30 a.m. on the day of the incident, a concrete-finishing crew including a radio-equipped spotter, 3 concrete finishers, and a laborer, began pouring concrete into empty forms on the rooftop green space located approximately 25 feet above street level. Several loads of concrete were successfully hoisted and poured into forms located near the southwest face of the building between 80 and 106 feet from the crane's center pin (see Figure). According to the concrete truck driver, the bucket was filled to maximum capacity for the first load. Then he had been directed to fill the next three buckets only half-full. After pouring these three loads, the concrete crew moved away from the southwest face to begin filling forms which were a little over 130 feet from the crane's center pin. The crane operator lowered the empty bucket to street level and the concrete truck driver filled it to half capacity. The crane operator signaled the driver to fill the bucket to full capacity and after the bucket was full, the crane operator hoisted it, swung it over the roof and toward the empty forms at the direction of the spotter. At some point during the lift, the victim arrived on the rooftop after a work break and began stripping forms from a completed wall about 15 feet away from the concrete crew's location. As the crane operator moved the bucket toward the empty forms by lowering the boom (i.e., increasing swing radius), witnesses at street level observed the crane start to wobble and then slowly tip forward toward the building. The crane operator, realizing that the crane had lost stability and was tipping over toward the workers, radioed to the spotter to clear the area. He attempted to recover the crane by booming in (i.e., decreasing swing radius) but was unsuccessful. The finishing crew cleared the area, calling warnings to other roof-top workers located nearby. The victim apparently heard the warnings and was attempting to move when the bucket, swinging out of control, struck his head and shoulder. Workers notified emergency personnel who responded within 6 minutes. The victim was pronounced dead at the scene. Evaluation of the crane configuration, the distance of the intended landing site from the crane's center pin, and the manufacturer's load chart indicate that the crane's recommended capacity had been exceeded.

Discussion: Measurements conducted after the incident indicate that the intended landing site for the loaded concrete bucket was approximately 132 feet from the crane's center pin. The manufacturer's load chart lists a capacity of 3,620 lbs. for this radius (see Appendix). The hoisted load at the time of the incident including the headache ball, 50 feet of load line, rigging fixtures, and the loaded concrete bucket was estimated to be 5110 lbs., 1,490 lbs. above the recommended load chart capacity (see Appendix for a complete tally of hoisted weights).

***Recommendation No. 1: Employers, crane owners, and operators should ensure that cranes are operated within their safe capacities as recommended by the crane manufacturer's load chart.***

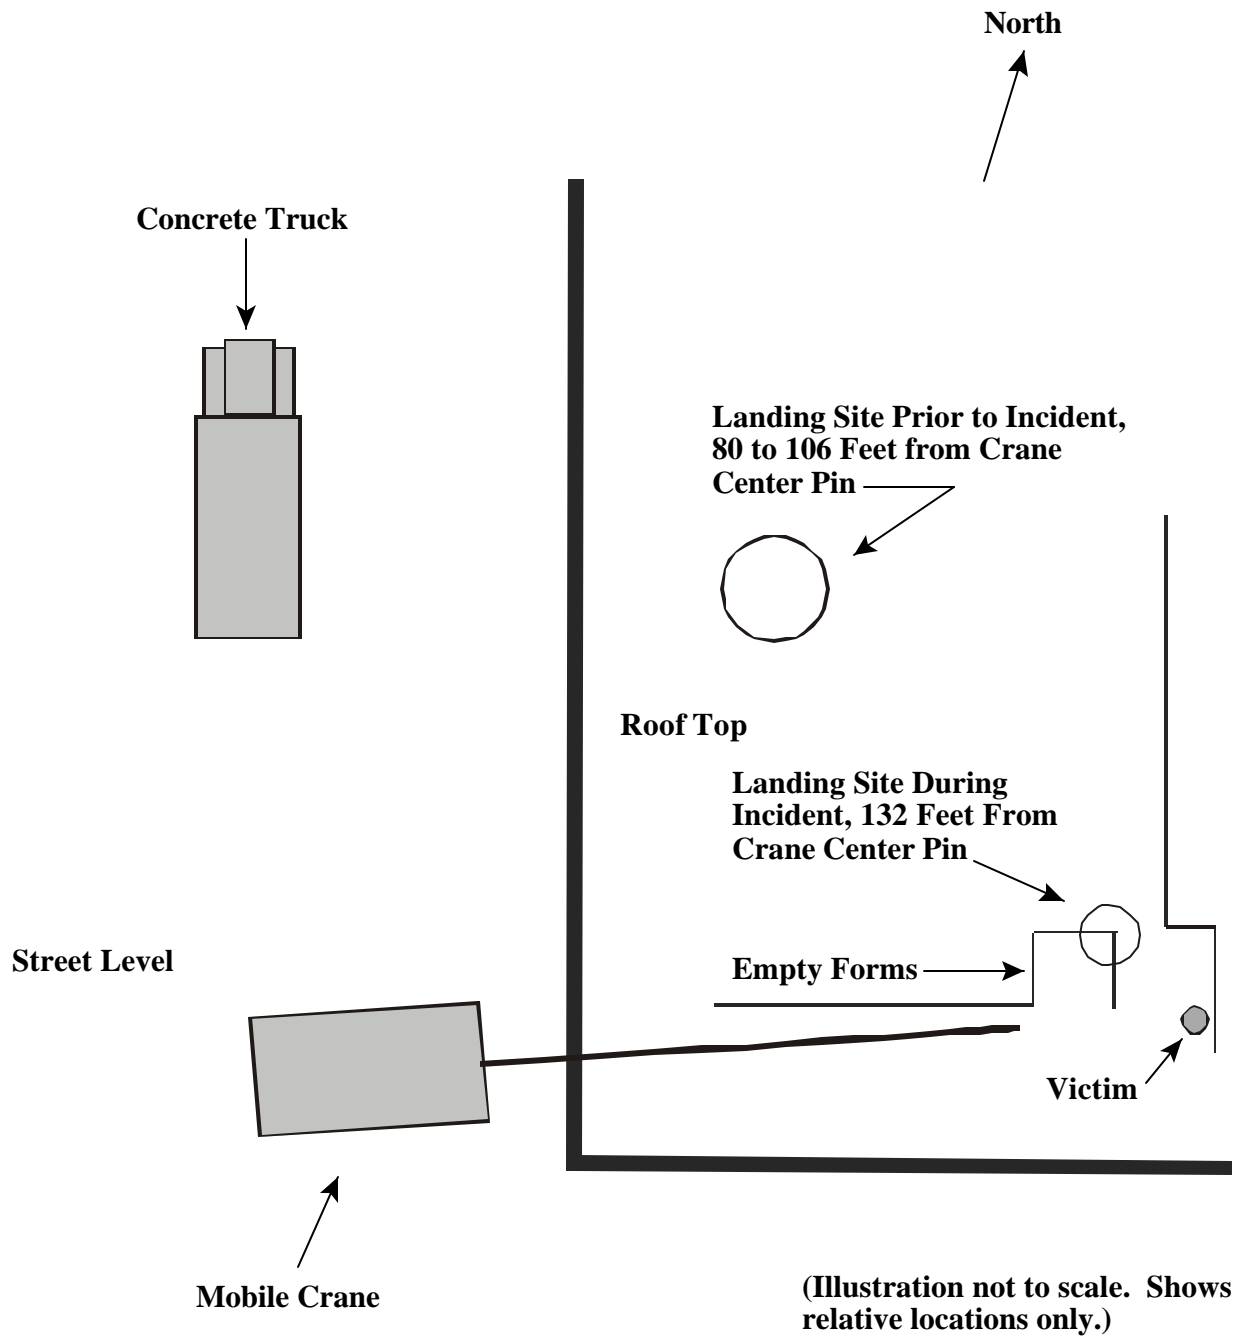
*Figure. Southwest Corner of Library*

The operator could not see the landing spot; the earlier lifts had been landed near the center of the building (see Figure). Although the concrete crew moved away from the roof edge when they relocated, they also moved to the south. From the crane operator's perspective at street level, this new location may have appeared to be closer to the crane (i.e., shorter radius). After the incident, the crane operator stated that he had been "working back toward the crane" at the time of the tip over (i.e., the landing locations getting closer to the crane's center pin as work continued). Because of these circumstances, the crane operator may have believed that the crane would be operating at a shorter radius where the crane would have greater lifting capacity. As mentioned previously, the crane was equipped with a computerized LMI designed to interrupt the hoist operation when hoisted loads reached 100% of manufacturer's rating. After the incident, the operator stated that the LMI had been indicating about 2700 lbs. during the morning's lifts. The LMI was examined and tested by manufacturer's representatives and found to be indicating false readings. Load-moment indicators and similar instruments may offer protection against injury and loss from crane overloads by providing information of load parameters to guide the judgement of a competent operator. However, their use cannot be substituted for the judgement of a qualified operator with knowledge of the hoisted loads, swing radius, and load chart information.

Discussion: As previously mentioned, the new landing location may have appeared to the crane operator to be closer to the crane's center pin than it was. When landing locations are not visible to crane operators and they must rely on signals or radio communications from spotters, extra care should be exercised to ensure that the lift conditions are fully understood by all workers controlling or directing the lift. This could be accomplished at pre-lift meetings during which the day's hoisting work, including the swing radius for the intended work areas, would be planned. When switching landing locations crane operators and spotters should verify that hoisting parameters, such as swing radius, are completely understood.

***Recommendation #4: Employers should develop and implement safe work procedures to ensure that workers and crane operators have a clear and complete understanding of the landing locations before loads are hoisted.***
