FACE Report Number: 2000-10

June 1, 2000

***Construction Laborer Dies After Being Pinned Between the Bucket of a Mini-Excavator and an Air Compressor - North Carolina*****SUMMARY**

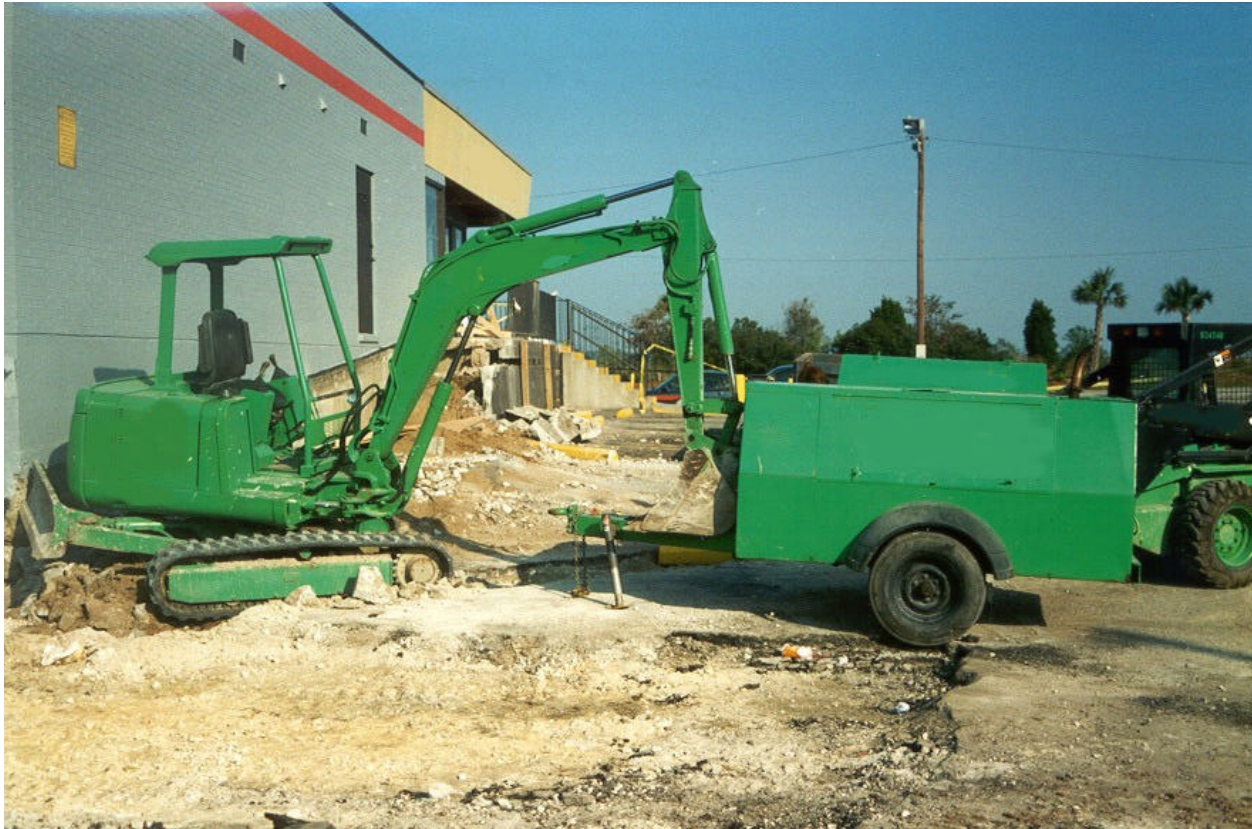
**Photo 1. Mini-Excavator.** The mini-excavator used in the incident had a 23-inch-wide bucket attached. A bystander was stuck by the bucket and then the bystander and the victim were pushed against an air compressor.

The track-mounted mini-excavator used in the incident had a 10-foot, 9-inch digging depth and had a 23-inch-wide bucket attached (Photo 1). It was located between the restaurant and a towable air compressor. The left track of the excavator was approximately 12 feet from the side of the restaurant and the right track was approximately 6 feet from the body of the air compressor. The top of the air compressor, positioned on its cart, stood approximately 5 feet from the ground (chest height). It was approximately 3 feet wide and 6 feet long. Two air lines were connected to the air compressor and ran through the area in which the excavator was operating. One air line extended from the air compressor over the asphalt parking lot to the jackhammer used at the end of the building. The other airline ran to a jackhammer used near the side of the building where the wheel chair ramp was being replaced. The incident site layout is shown in Photo 2.

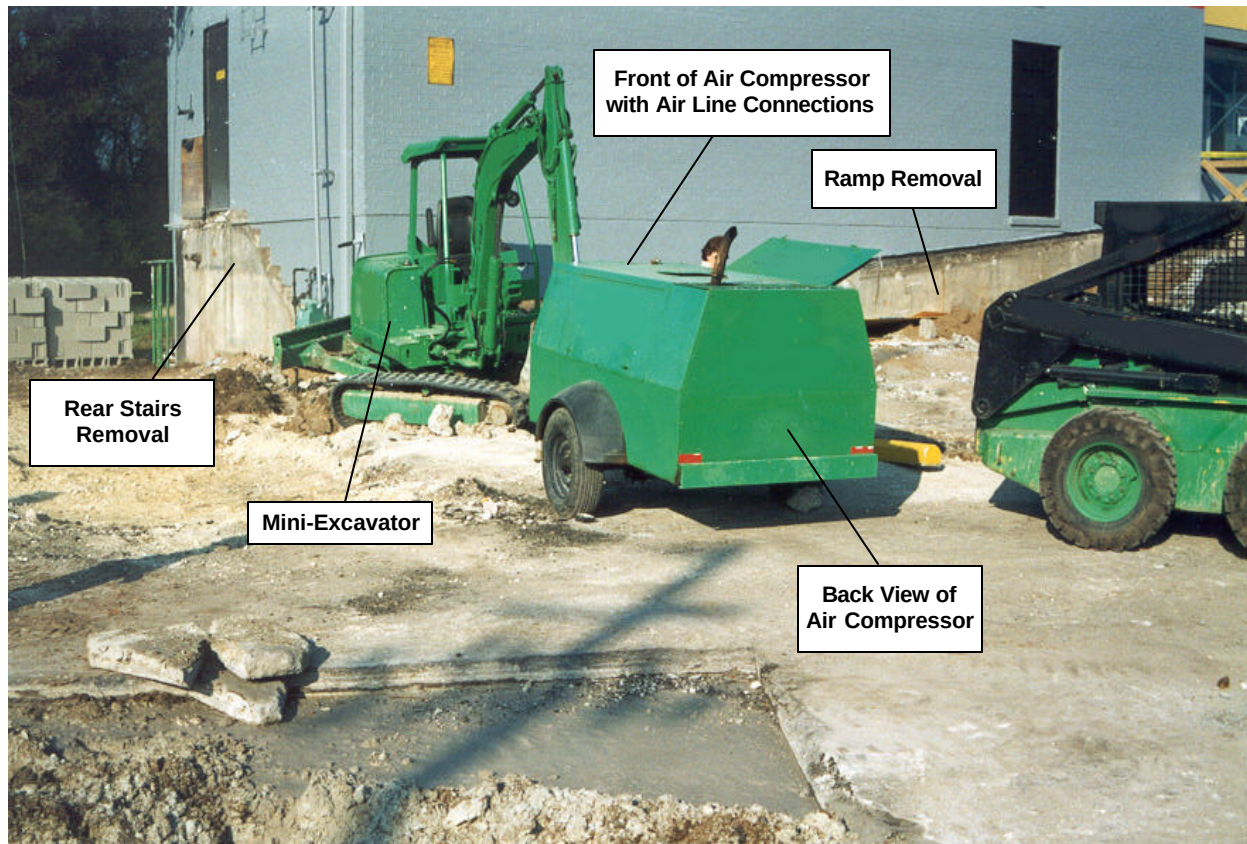
**Photo 2.** *Incident Site Layout.* Two air lines were removed before this photograph was taken. One air line extended from the front of the air compressor to end of building (rear stairs removal area), and another extended from the front of the air compressor to the side of the building (ramp removal area).

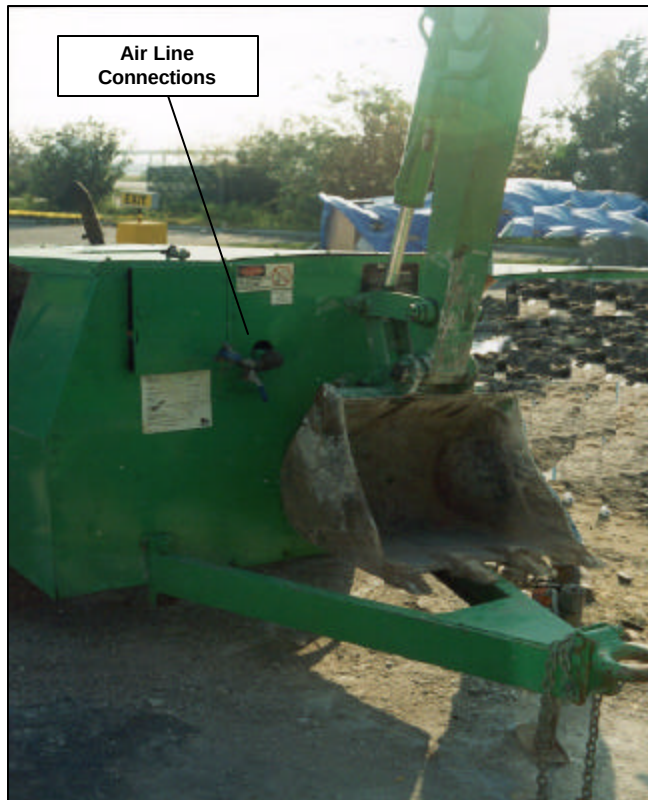
According to the coroner's report, the operator swung the excavator around, and the excavator bucket struck an air line on the air compressor. The air line broke loose and tangled around the bucket. The victim, his coworker, and the bystander entered the area between the excavator and the air compressor to see what had happened. The bucket suddenly became disentangled and started to swing to the right. The operator moved the controls and the bucket moved back to the left, toward the air compressor pinning the bystander and then the victim between the bucket and the compressor (Photo 3). The excavator operator moved the bucket away to release them. The coworker, who had gone with them into the swing path but who had not been hurt, helped the victim walk to his truck and sit down. The victim was alert and told his coworker that his ribs hurt. The general contractor, who was in the restaurant, called 911 at 2:55 p.m. According to the police report, police and emergency medical services (EMS) personnel arrived at 2:59 p.m. EMS personnel attended immediately to the bystander, who had a scalp laceration, and then attended to the victim, who was sitting in his truck. EMS transported both individuals to a local hospital. While in the EMS truck, the victim became unresponsive, diaphoretic, and hemodynamically unstable. The victim was admitted and emergency surgery was performed but internal bleeding caused by compression injuries could not be stopped. He died the following morning at 12:26 a.m., approximately 9 1/2 hours after the incident. The bystander was treated in the emergency room for a scalp laceration and released.

**Photo 3.** *Bucket of Mini-Excavator and Air Compressor.* One of the air lines was pulled free of its connection to the air compressor. When the bystander and the victim entered the area to investigate, they were momentarily pinned between the mini-excavator bucket and the air compressor.

bucket. Training all workers to stay clear of all moving machinery and particularly out of the swing path of excavators, can help prevent workers from becoming injured or killed in machine-related incidents.
