FACE Report Number: 2000-02

April 14, 2000

Flagger Struck From Behind and Killed by a Truck Intruding Into a Highway Construction Work Zone - Wisconsin**SUMMARY**

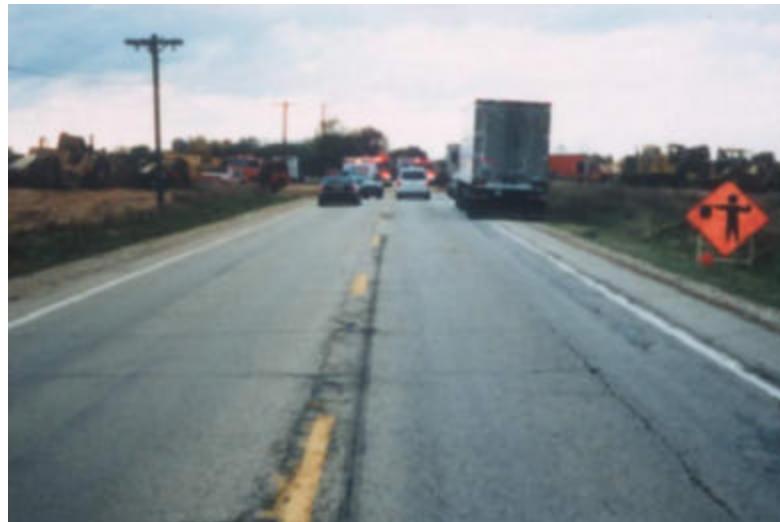
*Incident Scene***Fatality Assessment and Control Evaluation (FACE) Project**

On October 18, 1999, a 33-year-old female highway construction laborer (the victim), was struck and killed by a truck while flagging traffic. The victim was struck from behind by a 10-ton straight-side produce truck. Prior to the incident, the victim (Flagger 1) was on the south side of the highway facing west with her flag, preparing to stop all eastbound traffic on the highway. Another flagger (Flagger 2) was on the north side of the highway, approximately 50 feet east of the victim, and was stopping westbound traffic. Flagger 2 signaled the westbound produce truck to stop and the truck had almost come to a complete stop when a westbound tractor trailer approached at approximately 55 miles per hour and struck the produce truck in the right rear. The produce truck was struck with such force that it was momentarily airborne and the driver could not control his vehicle; the produce truck was propelled across the eastbound lane directly into the path of the victim, who was still facing

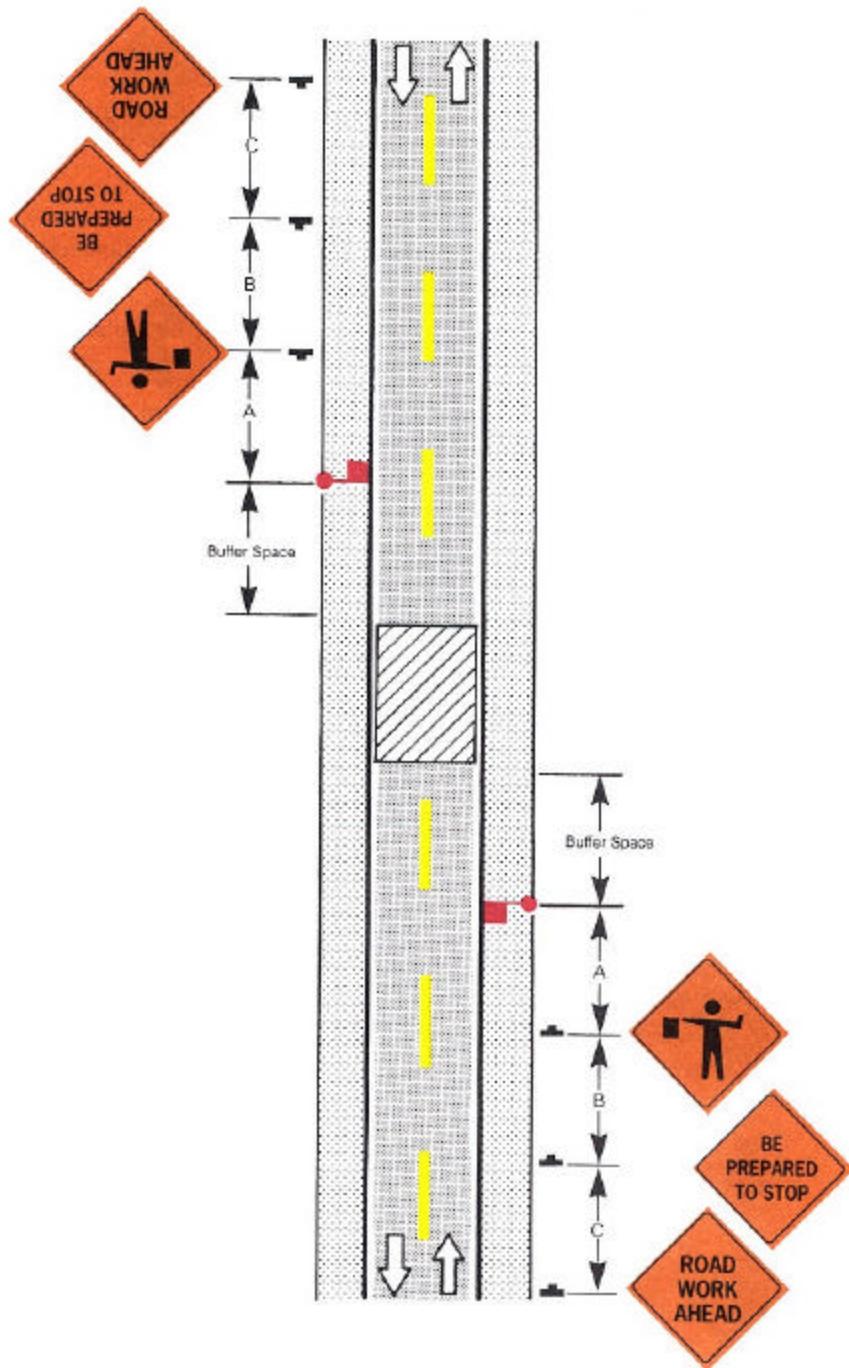
Figure 1. Part VI of the (MUTCD) Standards and Guidelines for a Two-Lane Highway With a Haul-Crossing, Using Flagging as the Method for Temporary Traffic Control

Discussion: The MUTCD sets forth the basic principles that govern the design and usage of traffic control signs and devices. The signs in use throughout the highway construction work zone met the minimum standards and guidelines recommended in the MUTCD for a two-lane work zone with a haul crossing.

Recommendation #1: Employers/highway construction contractors should consider the use of additional warning signs and traffic control devices to supplement the minimum signs recommended by the Manual on Uniform Traffic Control Devices (MUTCD).¹

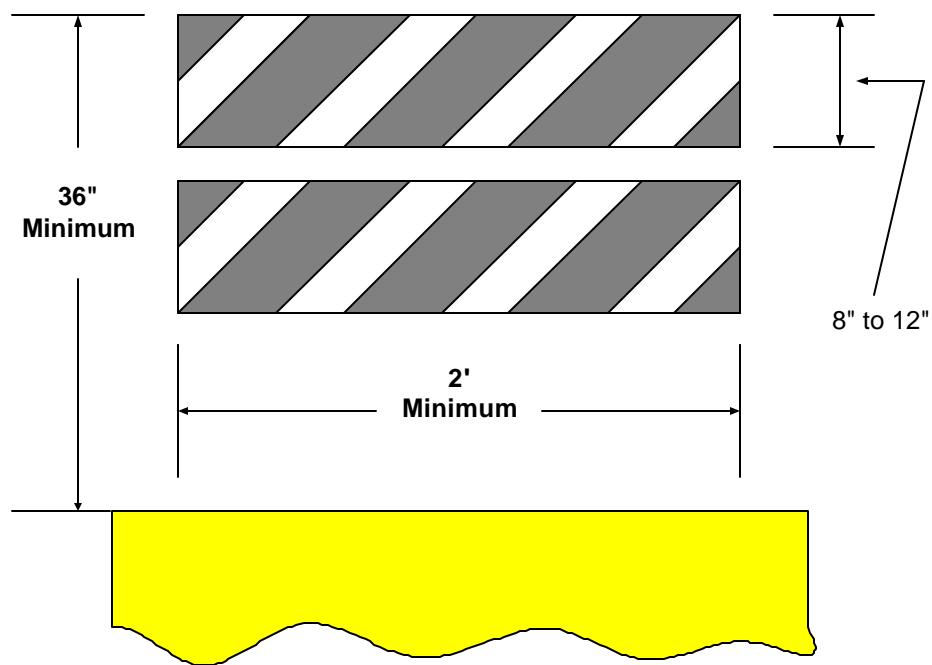
Figure 2. Type II Baricade Mounted on a Sawhorse Stand

The victim was facing west, preparing to stop eastbound traffic. Another flagger (Flagger 2) was positioned on the north side of the highway directing the westbound traffic to stop. The visibility was good and the crossing could easily be seen by vehicular traffic approaching from both east and west. Flagger personnel were wearing reflective vests and hard hats. They were using flag/stop/slow signs and were communicating verbally and by visual signals. There was a barrier (type II, 36 inches high by 2 feet wide, having 2 orange and white striped boards mounted horizontally on a saw horse type stand) located at the victim's location (Figure 2).

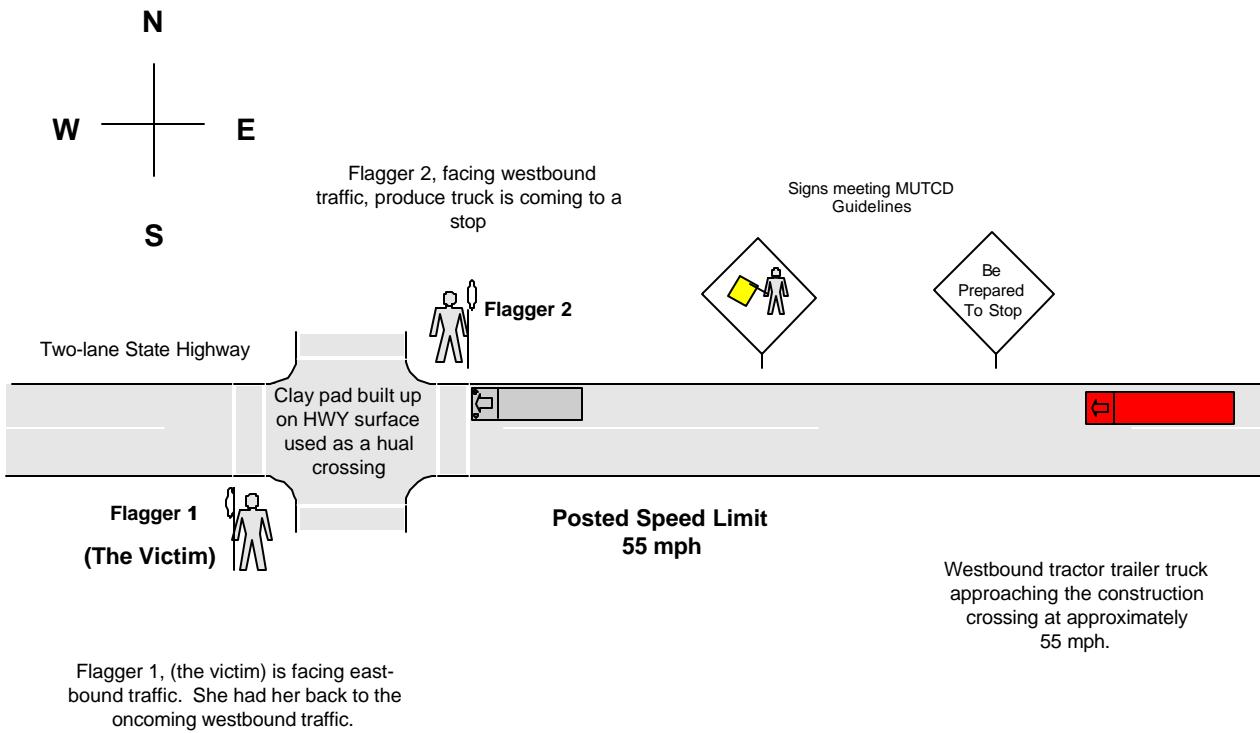
Figure 3. Pre-Event

On the day of the incident the flaggers had been stopping traffic as necessary to allow the earth movers to use the crossing, starting at approximately 8:00 a.m. At approximately 2:15 p.m., a straight-side produce truck (Photo 2) was moving westbound, slowing to a stop as directed by Flagger 2. The victim was facing west, away from this traffic, preparing to stop eastbound traffic. A westbound vehicle, a tractor trailer (Photo 3), was approaching the crossing at an estimated 55 miles per hour (Figure 3).

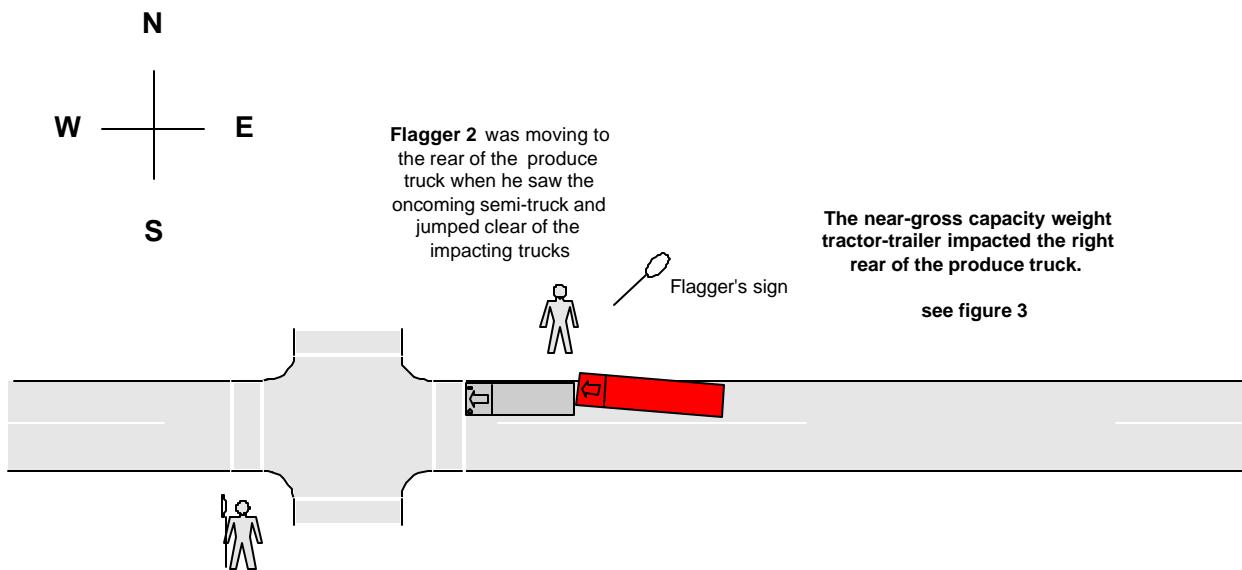
Figure 4. Event 1

The tractor trailer, weighing approximately 22 tons, struck the produce truck, weighing approximately 10 tons, in the right rear. Flagger 2 was jumping clear and could not see or warn Flagger 1 (Figure 4).

Flagger 1, the victim, is facing east-bound traffic. She had her back to the oncoming westbound traffic.

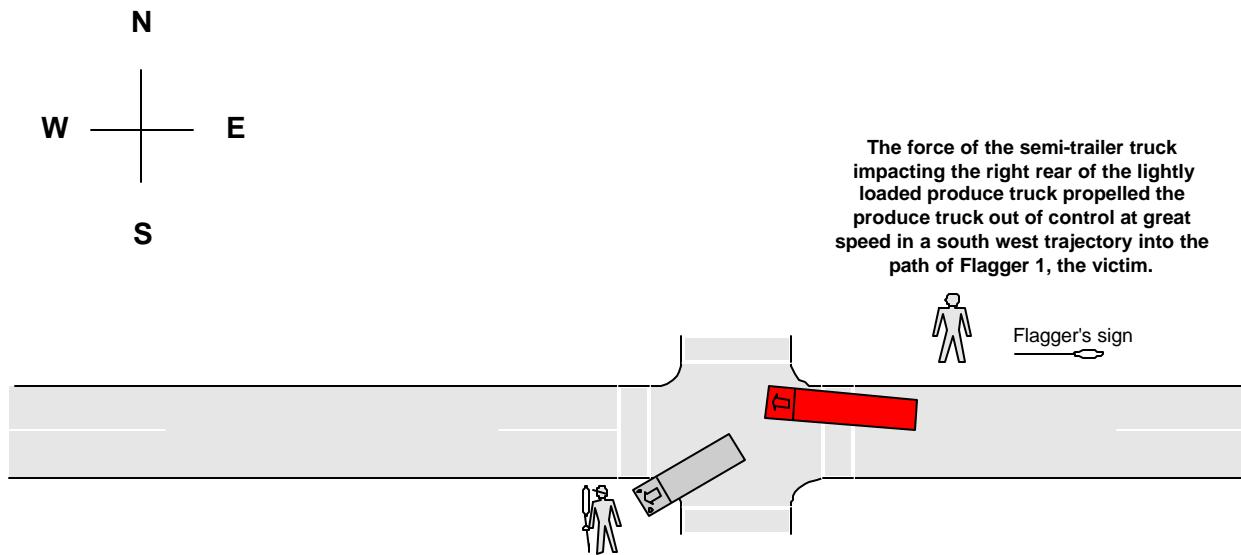
Figure 5. Event 2

The produce truck was struck with great force and it was propelled over the clay pad at the crossing; the produce truck momentarily became airborne and out of control, moving southwest across the eastbound lane of the highway (Figure 5). This vehicle hit the victim in the back, dragging her approximately 30 feet in a westerly direction along the south side of the highway.

Flagger 1, the victim, was still facing eastbound traffic with her back to the oncoming truck.

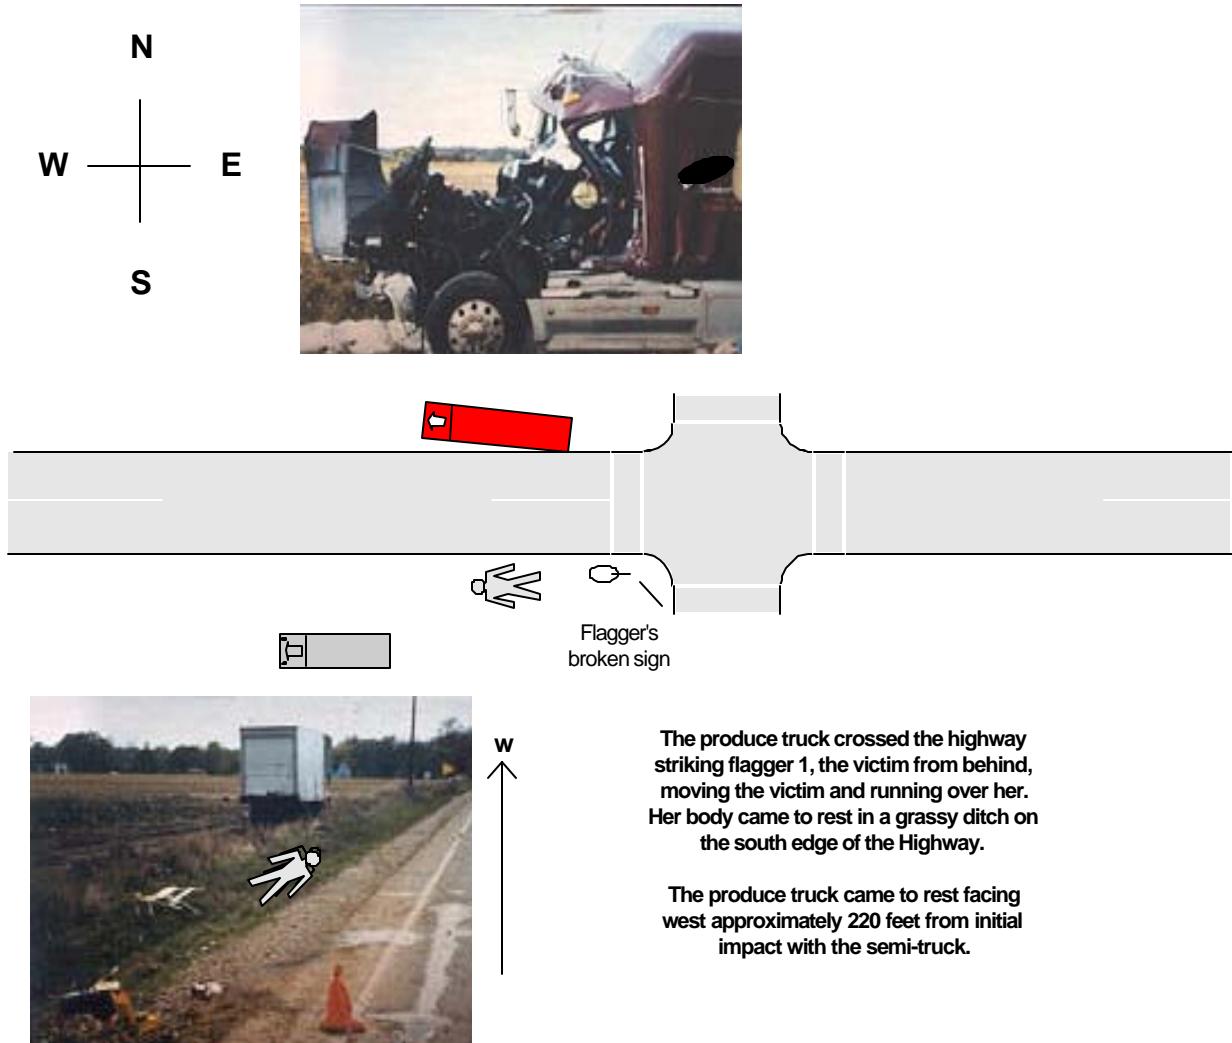
Figure 6. Post-Event

The impact with the tractor trailer moved the produce truck approximately 202 feet across the highway where it came to rest in a field in a westward direction parallel to the highway. The tractor trailer moved approximately 100 feet after impact and came to rest in a westward position in a ditch along the north side of the highway (Figure 6).

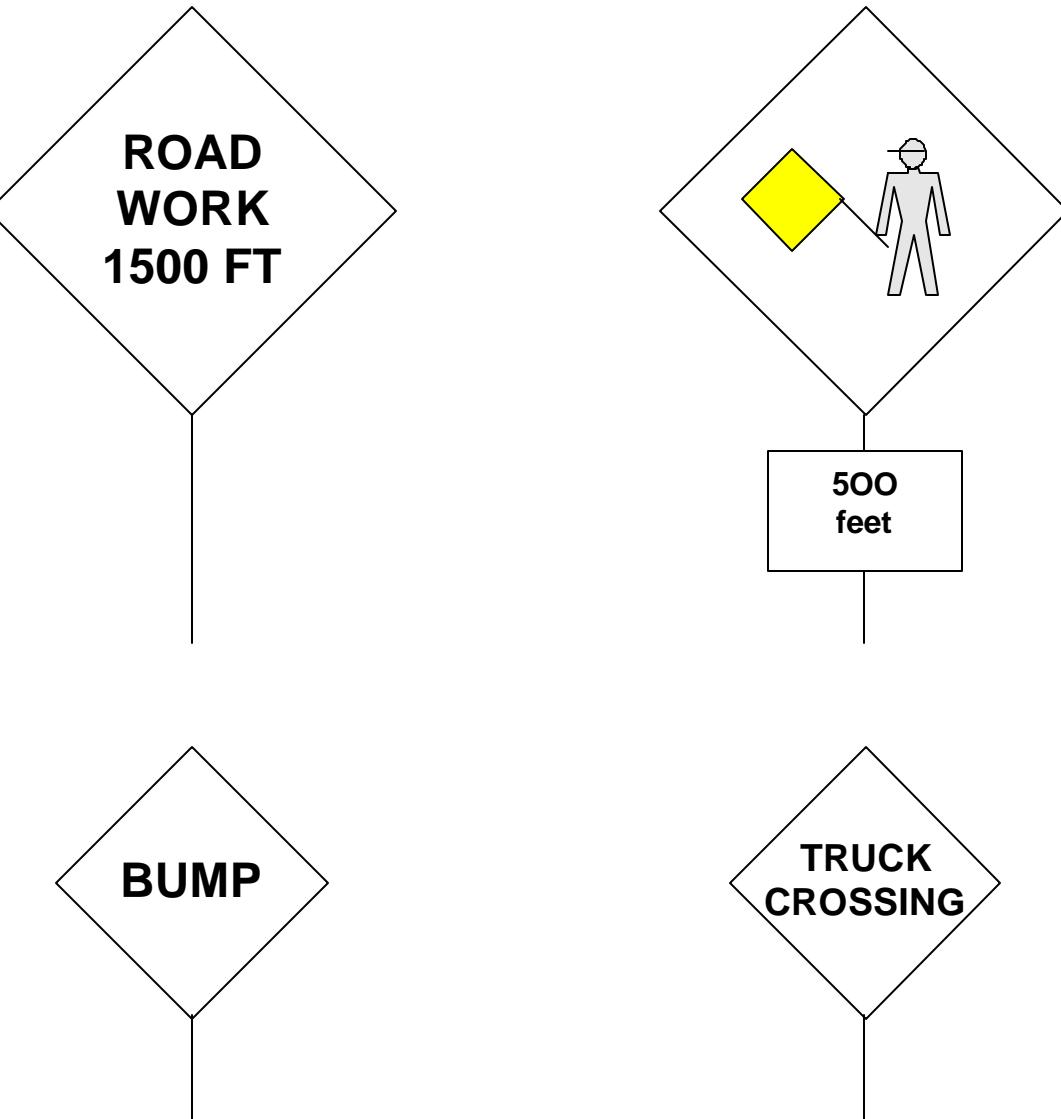
Figure 7. Supplemental Signs and Warning Devices Recommended in the MUTCD

ahead. As outlined in the MUTCD, rumble strips provide a vibratory and an audible warning that augment visual stimuli. The first rumble strip should be placed before the other advanced warning signs and devices. Rumble strips may be fixed permanent or portable devices. Supplemental signs showing distances in feet to the work zone ahead, distances in feet to the flagger's position, and a truck crossing sign may aid in keeping motorists aware of the potential hazards and of the need to stop if necessary. The clay pad at the crossing should have been seen as a bump hazard, especially for traffic moving at the posted speed limit of 55 mph. The addition of a bump sign, properly placed, may have acted as an added warning for motorists to slow down (Figure 7).

Use of supplemental signs and warning devices may have given motorists additional information regarding the crossing and flag operations ahead.

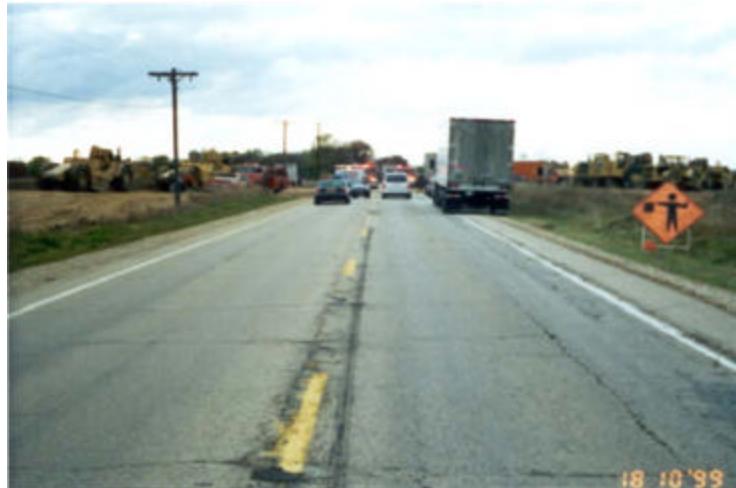
Flagger sign approximately 294 feet from the crossing

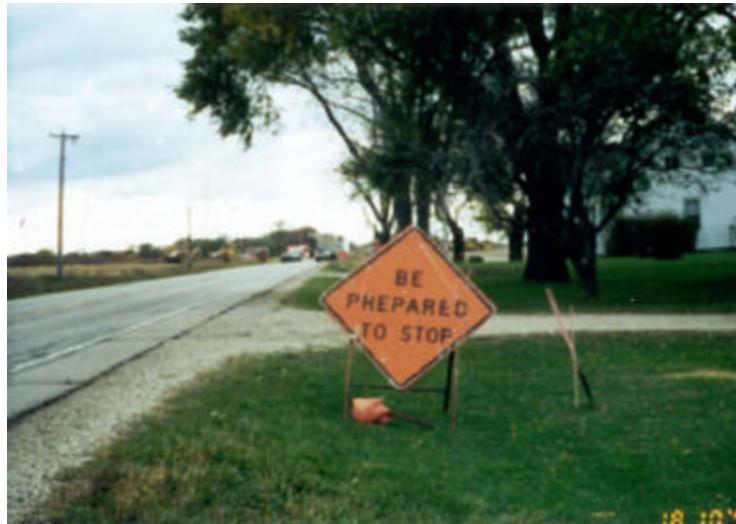
"Be prepared to stop" sign approximately 900 feet from the crossing

The highway warning signs as they were actually set up at the site, heading westbound toward the crossing.
