FACE Report Number: 2000-01

**Worker Dies From Crushing Injuries After Falling Into a Baling Machine - North Carolina****SUMMARY**

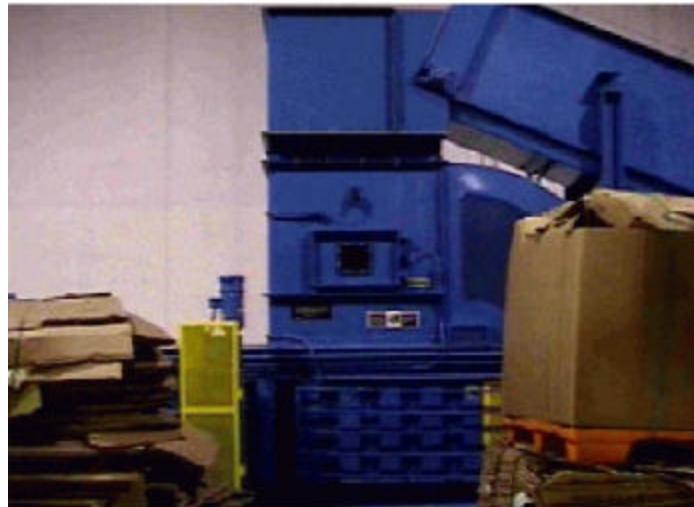
**Figure 1. Seglo Baler**

A 24-year-old male baler operator (the victim) died after he fell into a baling machine (Figure 1) and was crushed when the machine automatically cycled. The baling machine was used to compact and bale waste cardboard for recycling. Although the fall was unwitnessed, it is believed that the victim may have climbed up the outside of the conveyor to the top of the baler's loading chute to dislodge a cardboard jam. He may have lost his balance and fell 14 feet to the bottom of the baling chamber. Upon hitting the bottom, the victim's body broke the beam of a sensor light which sent a signal to the baler's

computer that the hopper was full, triggering the machine to automatically cycle, crushing the victim. At approximately 9:30 a.m. the next day, the victim was discovered by the first-shift baler operator, after he had processed a few bales of cardboard. After noticing what looked like a piece of company uniform sticking out from one of the bales of cardboard, he looked closer and discovered what he thought was a body. The day shift operator then went to the production supervisor's office to report his findings. After calling maintenance, they returned to the baler and after observing what looked like a body, the production supervisor called the police and the Emergency Medical Services (EMS). After the police determined there was no foul play involved, they allowed EMS and representatives from the Medical Examiner's office to remove the body from the bale.

- *ensure that workers are protected from the unexpected movement of machine parts by implementing and enforcing the use of lockout / tagout procedures*

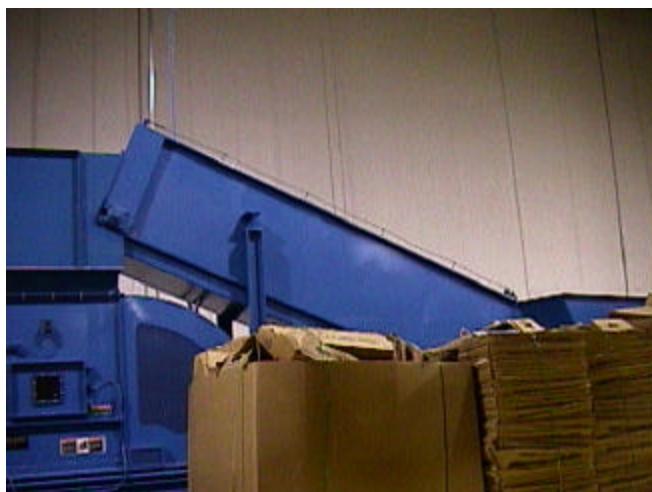
**Figure 3.** Conveyor and Chute

Discussion: Training in the safe operation of the baling machine is essential. In this case, the manufacturer of the baler provided initial training to one of the company's engineers, who in turn, was to serve as the trainer to employees. However, information collected indicated that another company engineer, not trained by the manufacturer, conducted the employee training. The American National Standards Institute (ANSI) has developed standards for compactor safety. The ANSI Standard Z245.2 - 1992, Stationary Compactors - Safety Requirements, provides guidance in safe design, operation, and maintenance of stationary compactors. No specific procedure for clearing jams in the equipment existed. The practice of climbing the conveyor belt and kicking the jam clear exposed workers to the danger of falls and the mechanical

Discussion: The top part of the hopper just under the conveyor (an area that measures 28 inches by 8 inches) needs to be evaluated and possibly redesigned to prevent jamming. In this incident, that area may have been jammed with cardboard or nylon mail bags which wrapped around the tip of the conveyor. A possible fix to prevent this wrap around could be a deflector installed at the end of the conveyor. This deflector would discharge away from the end of the conveyor and prevent materials from wrapping around the conveyor.

hazards of the baling machine. After conducting a hazard analysis, a written policy should be established including enforcement procedures on the proper operation of the baling machine and procedures for clearing jams. All baler employees, as well as maintenance employees, should be instructed in its use.

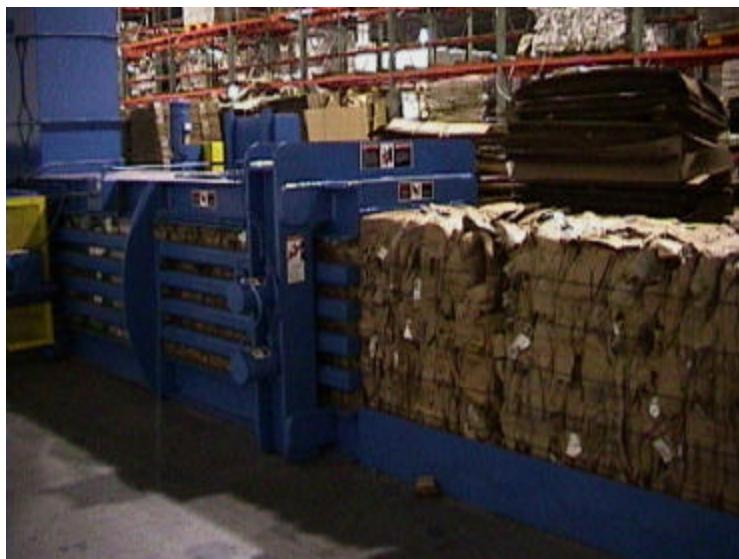
*Figure 4. Processed Cardboard Bale*

It was not until the next day that the victim was discovered in a processed bale, similar to Figure 4, by the first- shift baler operator. At approximately 9:30 a.m., while processing the third bale of the morning, the operator noticed something in a bale that looked like a piece of company work clothing. He then went to the production office and notified the production supervisor, who in turn notified maintenance of the finding. They all returned to the baler, and realizing that a body was in the middle of a bale, called the police and 911 for assistance. Both police and emergency medical services responded, and on seeing the condition of the body, notified the medical examiner's office to assist with removal. After the police determined there
