FACE Report Number: 00-07

March 16, 2000

***Three Tower Painters Die After Falling 1,200 Feet When Riding the Hoist Line – North Carolina***

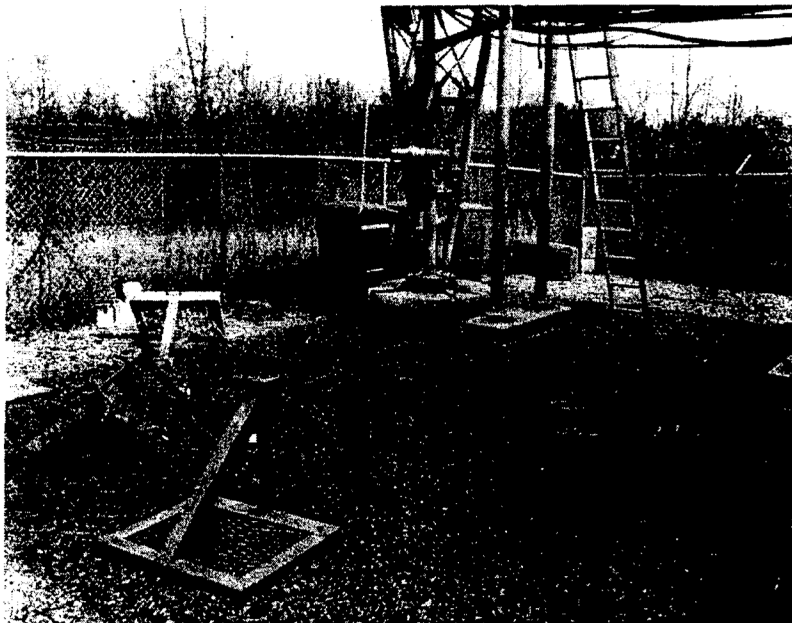
*Incident Site*

A 40-year-old tower-painting-company owner, his 16-year-old stepson, and a 19-year-old employee died after falling 1,200 feet when the hoist line on a portable capstan hoist used to raise them up the side of a 1,500-foot-high radio tower began slipping around the capstan, causing the hoist operator to lose control of the hoist line. The company had been at the site for 2 weeks to repair the beacon light at the top of the tower, paint the tower, and install rest platforms

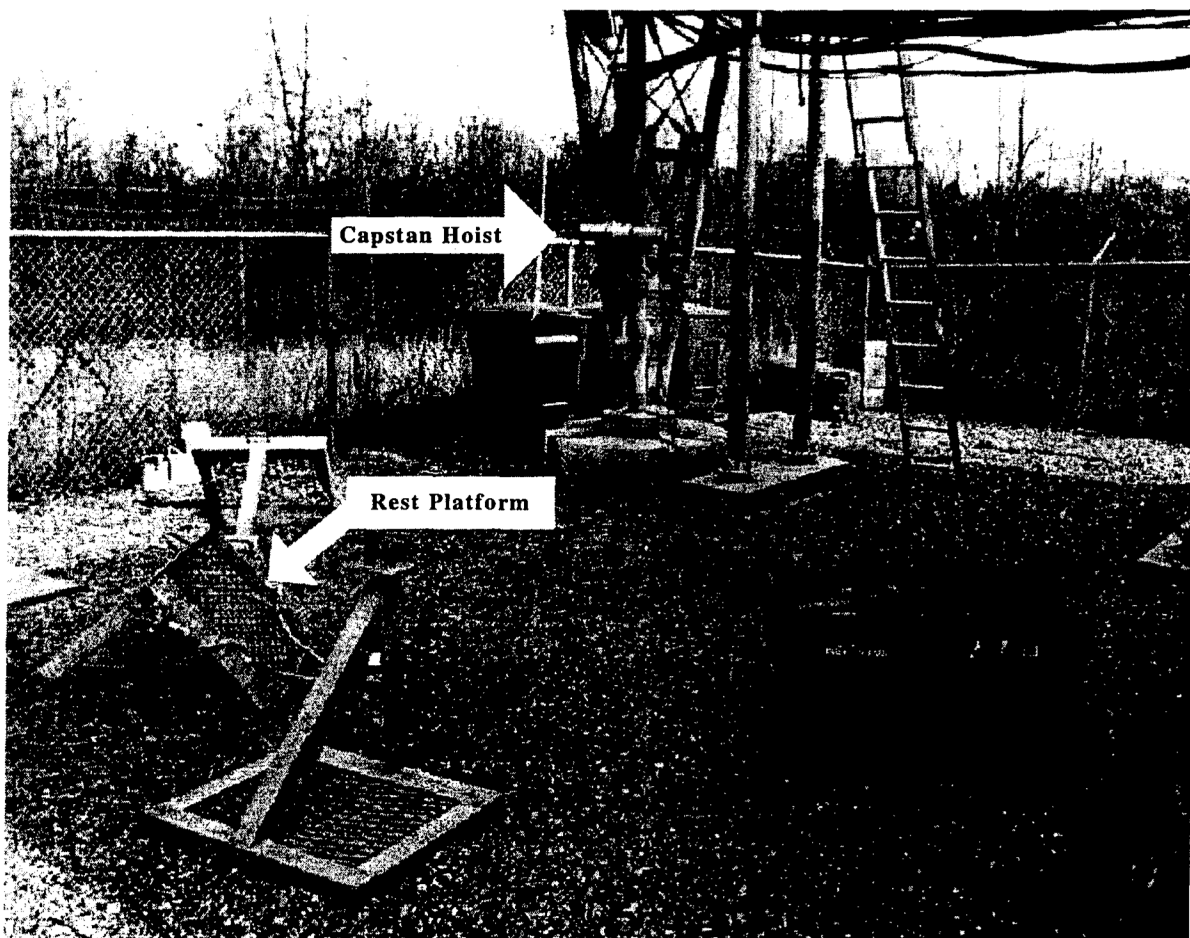
*Figure 1. Incident Site*

When the cable had been installed by the second contractor, the company began to paint the tower. The owner attached a portable electric capstan hoist to the tower approximately 6 feet above ground level (Figure 1). An extension cord was plugged into a 115-volt outlet in the tower's adjacent

service building to power the hoist. Power to the hoist was controlled by a foot switch that was activated by stepping on the switch. The portable electric capstan hoist had a lifting capacity of 1,000 pounds and was not manufactured or rated for lifting people.

As previously mentioned, the hoist was not rated for lifting personnel. It is also possible that the hoist was being used in an overload condition. The weights of the 3 victims, as obtained from the county coroner were 190, 200, and 210 pounds. The weight of the rest platform was 175 pounds. The hoist manufacturer's braided rope, similar to that used in this incident, weighs 14 pounds per 100 feet in length.<sup>2</sup> The weight of at least 2,000 feet of rope was against the hoist at the beginning of the lift. This would have added an additional weight of 280 pounds ( $2,000 \times .14 \text{ lb/ft} = 280 \text{ lb}$ ). The total of these weights would be 1,055 pounds. An additional load on the hoist would have been the friction added by the pulley at the top of the tower. A manufacturer's engineer stated that it is usual to add a minimum of 10% (105 lbs) additional load for this friction. It is possible that the capstan could have seen a total load of 1160 pounds, exceeding its 1,000 pound capacity.<sup>2</sup>

Discussion: The hoist used in this incident was not rated for the transport of personnel, and warning labels on the hoist stated that the hoist was not intended for use in the lifting or moving of persons. Equipment should only be used as rated by the manufacturer. OSHA Compliance Directive CPL 2-1.29, *Interim Inspection Procedures During Communication Tower Construction Activities*, requires that hoists used to lift personnel must be designed to use power lowering;<sup>4</sup> the hoist in this incident was not. Additionally, CPL 2-1.29 requires that hoists used to lift personnel be equipped with a primary brake connected directly to the drive train of the hoisting machine and a secondary automatic emergency-type

brake that, if actuated, would be able to hold the rated load within a vertical distance of 24 inches.<sup>4</sup> The hoist involved in this incident was not equipped with a braking system.

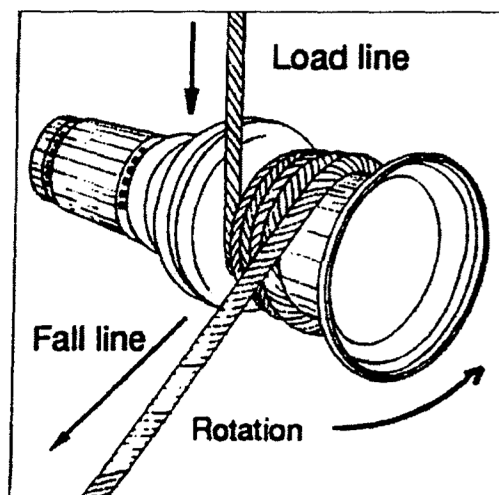
*Figure 2. Proper method for wrapping the hoist rope around the capstan for optimum rope action*

For safe operation and positive control of the load being lifted the capstan is designed to turn in only one direction. The proper method of wrapping the hoist rope around the capstan will place the "load wrap" (the end of the rope attached to the load) on the inboard end of the capstan where the diameter is the smallest (Figure 2).<sup>1</sup> This allows the rope to feed smoothly over the capstan without jumping or changing position. The number of rope wraps around the capstan is determined by many variables including the load to be lifted. The final determination is made by "feel." "Feel" is defined by the manufacturer as the amount of force required to keep the rope just tight enough around the capstan to raise or lower a load. With the proper number of wraps, an approximate 20-pound pull should raise or lower a load. Adding wraps of rope around the capstan decreases the amount of pull required to control the load. Removing wraps increases the amount of pull required.<sup>1</sup>

It could not be determined why the rope began to slip around the capstan. The fact that it slipped indicates that not enough force was being applied to keep the rope tight around the capstan. The owner's wife stated that she had operated the hoist a few times in the past but never with men on the line. She also said she thought the capstan was full of rope wraps. The hoist manufacturer's literature indicated that, under tension, 8 complete wraps of 3/4-inch braided rope could be placed on the hoist drum and would completely fill the drum.<sup>2</sup> As a general rule, 3 or 4 wraps would allow an operator to lift the rated load of 1,000 pounds with 20 to 40 pounds of pull on the fall line. -Figure 4 contains the manufacturer's chart used to calculate the required fall line pull for a load with 1 to 5 wraps of rope on the hoist drum.<sup>3</sup> Following the line to the right of the number 4 (number of wraps located on the left side of the chart) to the intersection of the curve, then down to the bottom shows that 4 wraps yield an approximate 44:1 mechanical advantage. In this case, a 44:1 advantage is  $1,160 \text{ lb}/44 = 26.26$  pounds of pull required on the fall line to lift the load. Using the same procedure, it can be seen that 5 wraps yield an approximate 115:1 mechanical advantage. In this case, a 115:1 advantage is  $1,160 \text{ lb}/115 = 10.08$  pounds of pull required on the fall line. If the hoist drum was full of 8 rope wraps, the pull required would be less.

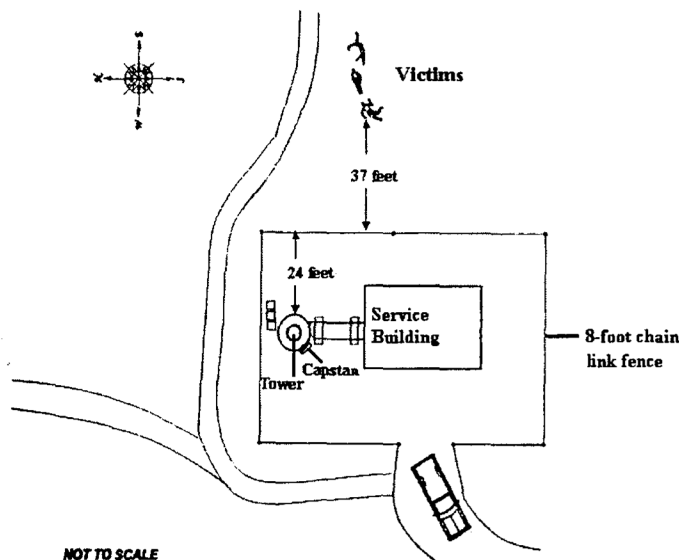
*Figure 3. Overhead view of the incident site*

The male workers were raised without incident until they reached approximately the 1,200-foot level. At that time, the rope began to slip around the capstan and the wife lost control of the hoist line. She tried to hold the line but could not. She looked up to see the three male workers falling. They fell to the ground, landing approximately 60 feet from the tower (Figure 3). The wife ran to the tower's service building and called the radio station that owned the tower. The station personnel

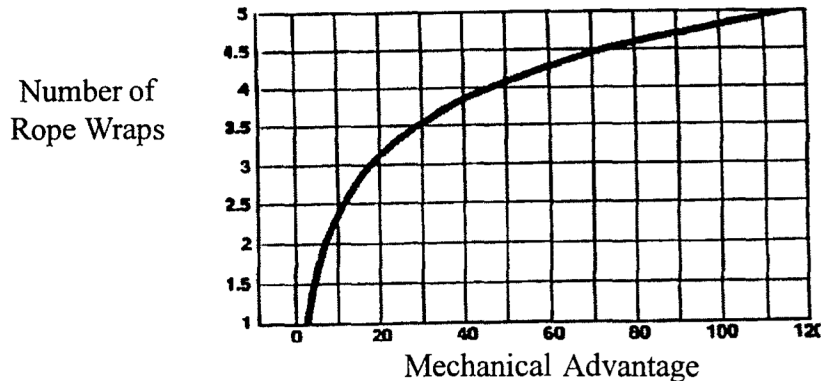
*Figure 4. Mechanical Advantage of Series 90 Hoists*

portable capstan hoist. As previously mentioned, the six 500-foot sections of rope were spliced together. The diameter of one of the spliced areas was approximately 1 $\frac{3}{8}$  inch. It is not known if the difference in diameter of the rope wraps on the capstan could have been a factor in the incident. Correspondence with one of the hoist manufacturer's engineers indicates that most splices, although larger in diameter than the rope, will move across the capstan smoothly. However, unusually large splices may tend to "over wrap" the rope already on the capstan. This "over wrapping" would require the hoist operator to momentarily reduce the pull on the fall line rope to allow the splice to seat on the capstan.<sup>2</sup>
