**ADMINISTRATIVE REPORT
PUBLIC HEALTH SERVICE/CDC/NIOSH/DSR
FACE 99 - 06**

**SUBJECT: 16 Year-Old Ride Attendant Dies After Being Caught and Dragged By
Amusement Park Ride – Connecticut**

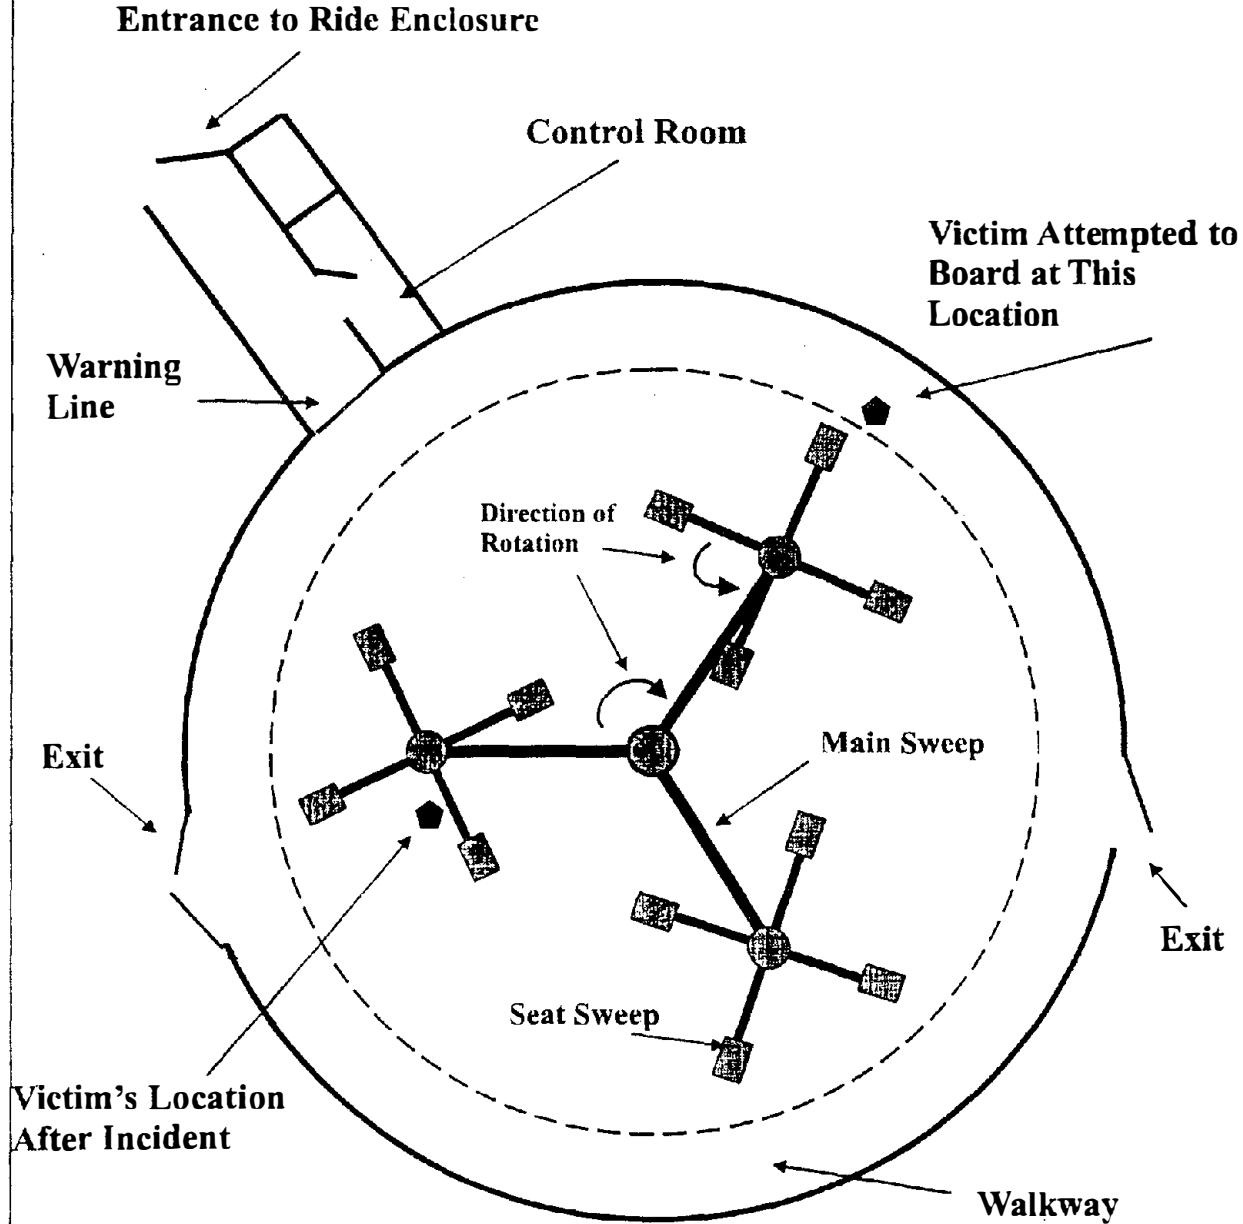
Fig. 1 - FACE 99-06: Amusement Park Ride

The Tornado is a flat ride which rotates around a center pole (see figure 1). The 1960's-vintage machine, originally designed and built as a portable ride for traveling carnival operations, had been permanently installed on a concrete pad. A year before the incident, the ride had been upgraded with the addition of a computer-controlled audio-visual effects system and covered with an igloo-like enclosure. Extending from the center pole are three arms, or main sweeps. A set of four shorter seat sweeps is mounted on the end of each main sweep. A three-passenger seat is mounted at the end of each of the shorter sweeps. Power for the ride is furnished by an electric motor mounted outside the enclosure and connected to a gearset on the ride's center pole by a shaft running in a covered trough in the concrete floor. Each set of seat sweeps is driven by another gearset mounted at the end of each main sweep and connected to the center-pole by a shaft mounted on the main sweep. During operation, the main sweeps rotate clockwise while the seat sweeps rotate counterclockwise. This counter-rotation causes each seat to trace a star-shaped pattern back and forth across the ride's operating circle. The counter-rotation also causes the speed of the seat's movement to constantly change. The seat accelerates from zero at the outside of the circle to a speed of about 25 mph by the time it crosses the main sweep near the center of the circle. As the ride continues to rotate and the seat moves outward, its speed decelerates reaching zero at the circle's outside edge. This instantaneous stopping of the seat's movement at the outside of the circle is clearly visible. During the 90-second ride cycle, the enclosure is darkened and flashing lights, music, and fog are combined with the ride's motion to mimic the effect of an actual tornado. The effects are synchronized with the operating cycle of the ride so that certain effects occur during startup, full speed, and slow down.

On the day of the incident, the victim worked the 12:00 p.m. to 8 p.m. shift. He performed as ride attendant at a small roller coaster for about 45 minutes and then worked at the Tornado. The victim worked several other rides throughout the afternoon and returned to the Tornado at about 4:00 p.m. Shortly before 4:45 p.m., two co-workers who were on break arrived at the Tornado and discussed work assignments for the rest of the evening with the victim. While there, the coworkers decided to go for a ride. They boarded one of the seats and the ride was started. At this time, the victim, acting as ride attendant, had entered the control room and was standing next to the ride operator as the ride cycle continued. As the ride was nearing the end of its cycle and was about to begin slowing down, the victim left the room, entered the walkway around the circle, and walked clockwise to a location about 30 feet from the control room. The ride operator and both of the riding coworkers observed the victim attempt to board one of the seats as it instantaneously stopped at the outside of the circle.

As he grabbed the side of the seat and placed his foot on the seat step he lost his balance and fell. He was caught by the seat and dragged across the concrete floor. The ride operator immediately activated the emergency-stop button and applied the manual emergency brake. However, the victim, caught under the seat sweep and between the seat-unit pedestal shaft and the floor, was dragged about half-way around the ride circle before the ride stopped. Once the ride had stopped, the ride operator called the park's emergency number to request assistance, turned on the lights in the enclosure, and went to the victim while the riding coworkers dismounted their seat and evacuated the guests from the enclosure. Park emergency personnel responded in under a minute. Local fire and emergency personnel were notified and arrived within 4 minutes. The victim was recovered by firefighters and removed from the ride enclosure by the EMS. By this time, a helicopter from the local hospital had responded to the park, and the victim was air lifted to a local hospital emergency room. He died the next day from his injuries.

- An interlocked gate, swinging in the egress direction, could be installed across the ride entrance before the yellow floor warning (see figure 1). To allow for quick exit in case of emergency, this gate would not be latched, but would be held closed by springs or gravity.^[3]

A switch mounted on the gate would be positioned such that it would be activated by opening the gate. The switch would be connected to the ride's control circuitry so that when activated, the ride would be automatically shut down and an audible or visible alarm would be activated.
