ADMINISTRATIVE REPORT  
SEPTEMBER 25, 1998  
PUBLIC HEALTH SERVICE/CDC/NIOSH/DSR  
FACE 98-21

SUBJECT: Tower Painter Dies and a Second Painter Injured After Falling 900 Feet While inside a Man Basket-South Carolina

**FACE 98-21**

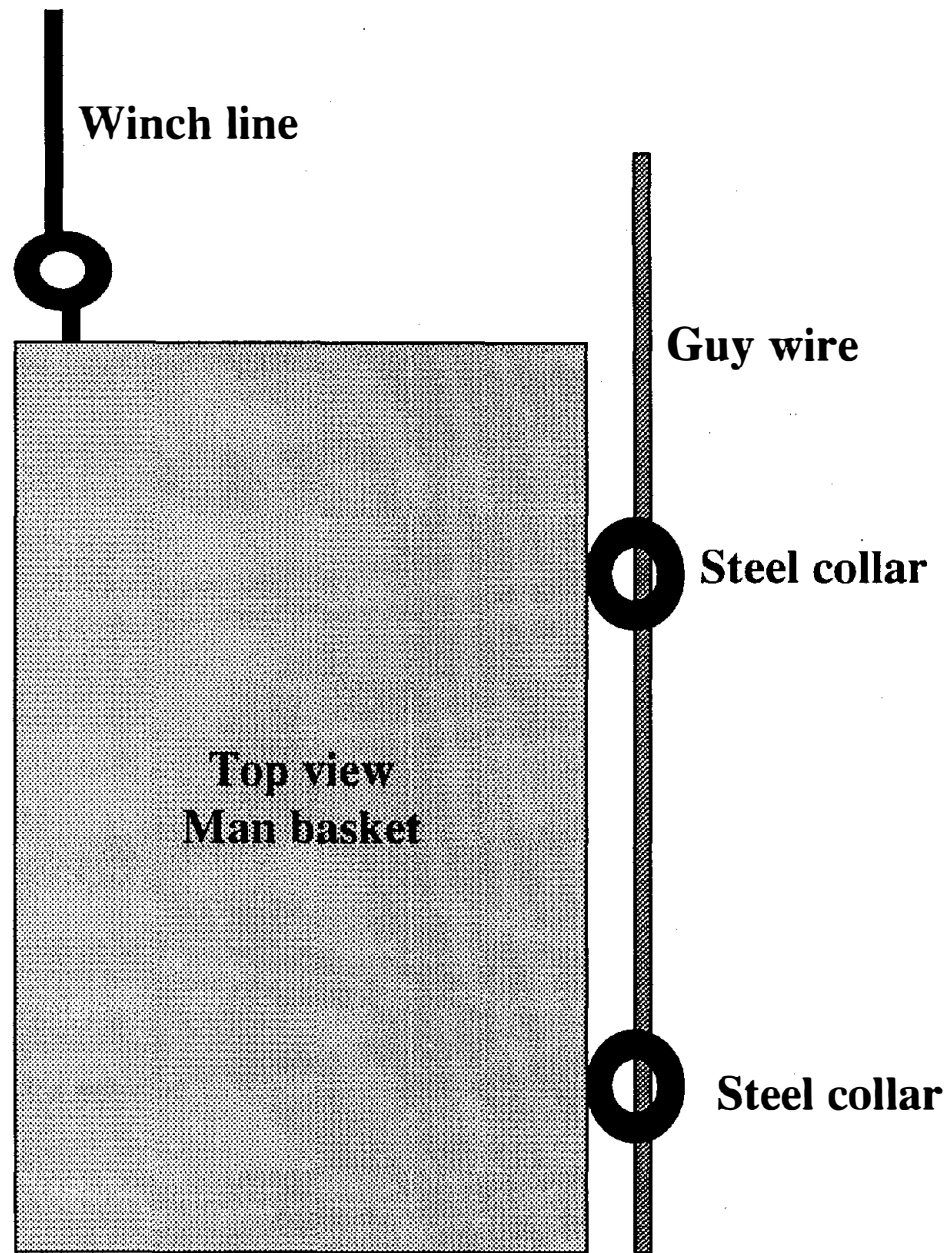
**Figure 1**

On the day of the incident, the victim rode the tower's elevator to the sixth guy wire from the ground, approximately 1,200 feet above ground, and rigged pulleys on the tower. The winch cable was then run through the pulleys and attached to a 4-foot-wide by 5-foot-long steel man basket that had been fabricated by the company owner. It was standard operating procedure for the victim to rig and test the pulleys and cables before lifting personnel. The man basket was attached to the guy wires by two steel collars which were welded to the top right rail of the man basket and were clamped around the guy wires. The winch cable was attached to the upper left rail of the man basket, allowing the basket to remain level while the men were inside (Figure 1).
