**ADMINISTRATIVE REPORT
PUBLIC HEALTH SERVICE/CDC/NIOSH/DSR
FACE 98-19**

**SUBJECT: Laborer Run Over by Dump Truck at Roadway
Resurfacing Operation -- Virginia**

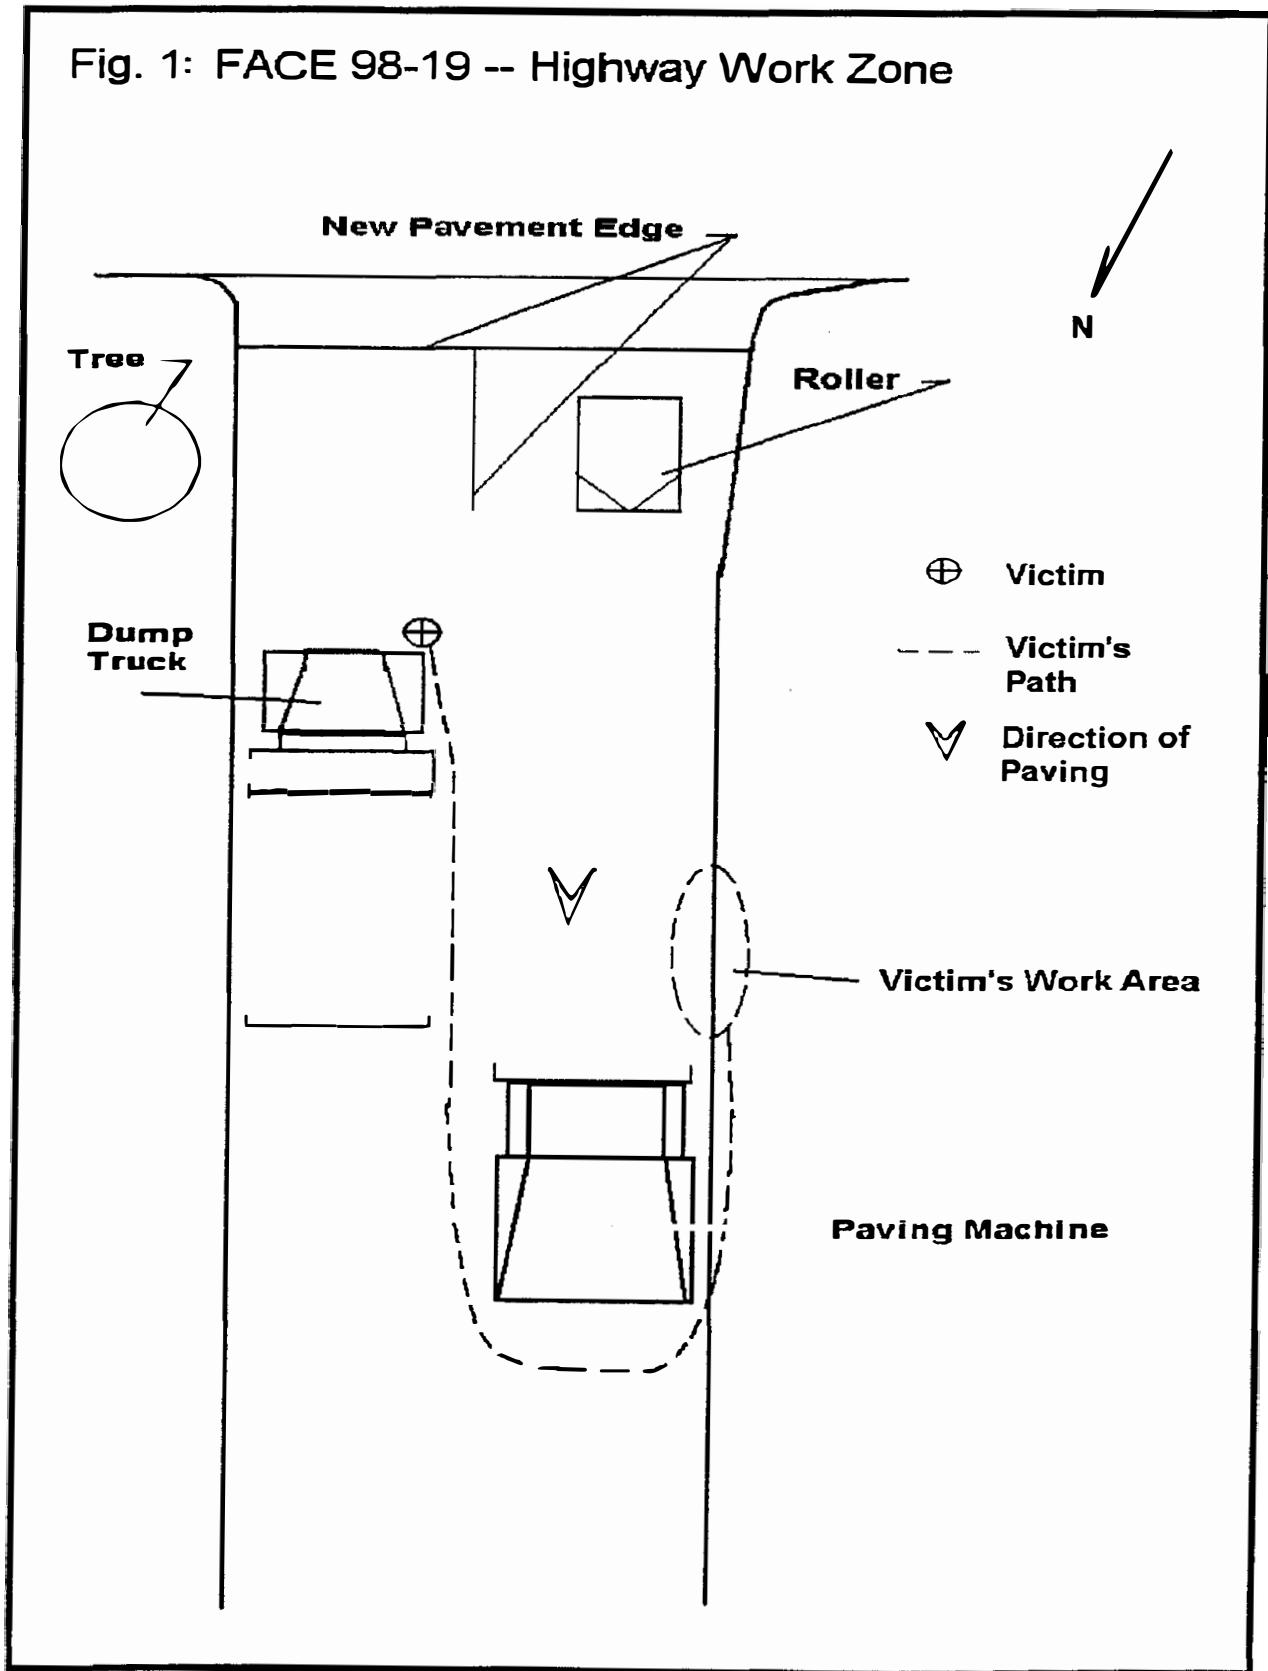
Fig. 1: FACE 98-19 -- Highway Work Zone

On the day of the incident, the crew arrived at the job site shortly before noon, having spent the morning hours paving a tennis court at another location. The road surface had been milled the day before. The eight person crew began resurfacing where the two-lane and four-lane road intersected (see Figure 1). The operation began with the placing of a new asphalt apron across the mouth of the intersection. The apron was then rolled while the paving machine proceeded to lay down a new "mat" (asphalt layer) in the northbound lane of the two-lane road. The victim had been assigned to rake and finish the edge of the pavement where it abutted and joined with the existing concrete curb. Shortly before 3 p.m., as paving operations were proceeding northward, the victim finished the pavement edge up to the back of the paving machine, which had stopped to await reloading of asphalt mix. The victim went around the front of the paving machine and continued walking south in the unpaved lane toward the intersection along the center-line edge of the new mat. At about the same time, a 1983 Mack tandem axle dump truck, leaving the work zone at about 5 mph, was also traveling south in the unpaved lane behind the victim. As the victim walked along the center line of the road, the truck passed the paving machine and the driver glanced in the right side rear view mirror to make sure that he had cleared the paving machine. At this time, the victim was slightly ahead of and adjacent to the truck's right front bumper. The roller operator who was working behind the paver near the intersection saw the victim walk in front of the truck. The truck struck and ran over the victim. The roller operator and the superintendent shouted to the truck driver to stop; however, the driver did not hear the warnings until the truck's right front wheel had passed over the victim and the lead wheel of the truck's rear tandem axles had started to run over the victim's foot. The driver stopped the truck and was directed to reverse a short distance to free the victim's foot. Co-workers notified 911, and emergency medical personnel responded within 12 minutes. CPR and first aid procedures were started by the local fire rescue squad and continued while the victim was transported to a local hospital, about four miles from the site. The victim died at the hospital approximately $\frac{1}{2}$ hour after the incident.

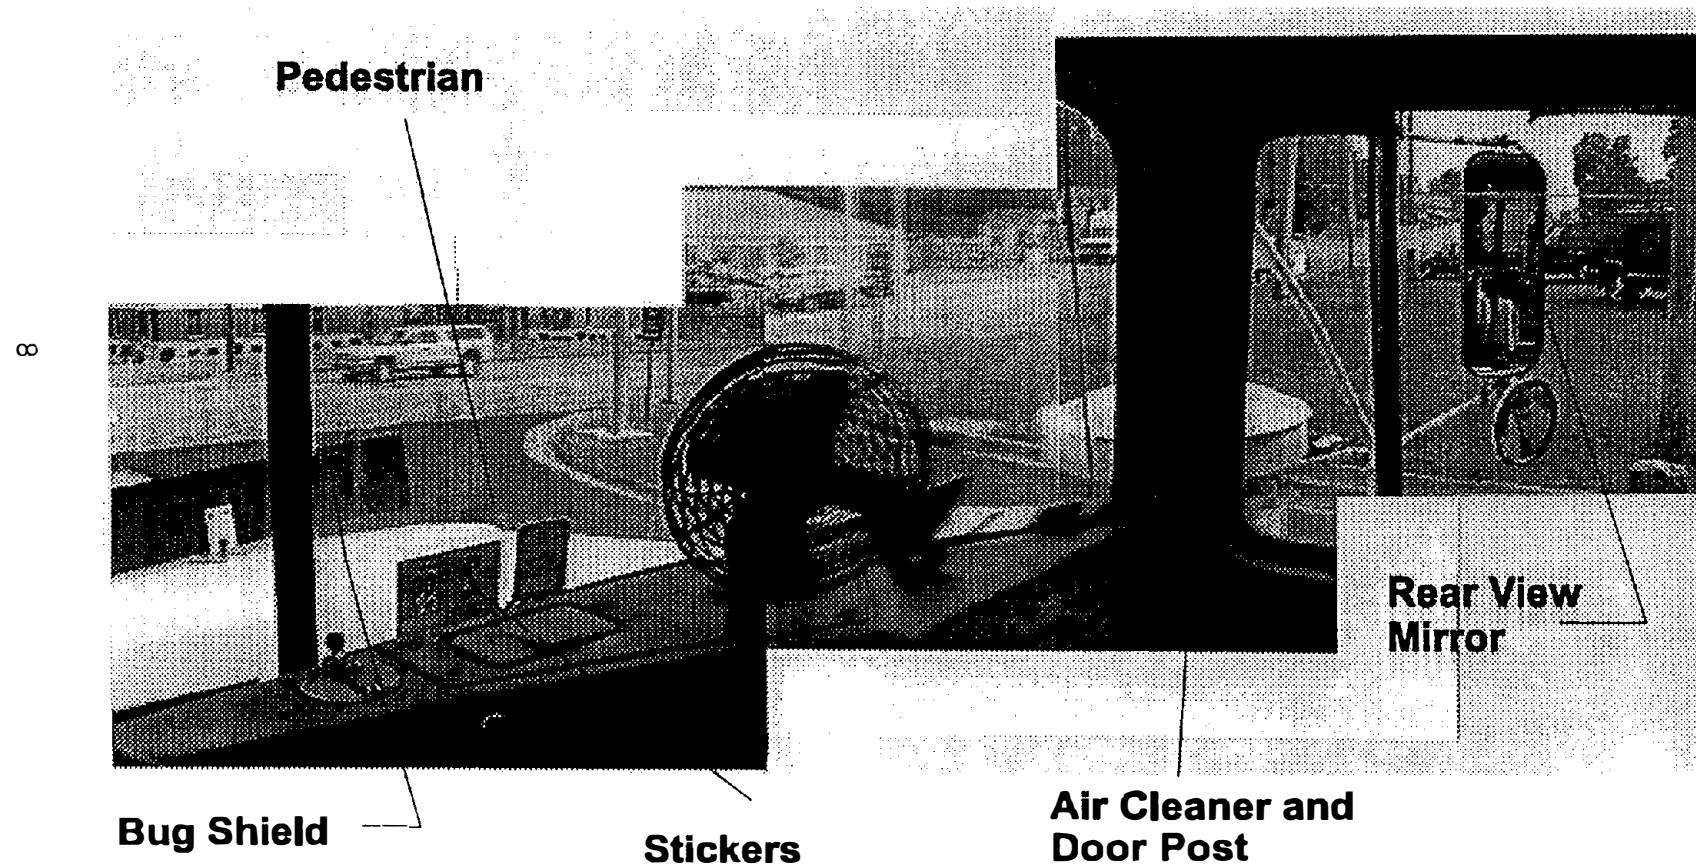
Fig. 2; FACE 98-19 -- Visibility From Driver's Seat

- When scanning from the right rear view mirror to the front of the truck, several objects are present in the plane of vision which may have caused visual distractions to a driver (see Figure 2). These objects are (1) the top of the air cleaner (white in color) and the windshield/door post frame; (2) a fan mounted on the truck's dash board; (3) two regulatory stickers affixed to the inside of the windshield directly in line with the corner of the truck hood and the driver; (4) a red translucent bug shield mounted across the front of the hood.

Discussion: As noted in the discussion for recommendation #2, the placement of auxiliary equipment on the truck and in the cab may affect a driver's ability to detect the presence of a pedestrian near the truck (see figure 2). Some of these objects, such as the dash-mounted fan could block a driver's vision. Other objects such as the inspection stickers may not block vision, but could pose a visual distraction. All the objects noted serve useful purposes, and help to provide a safe and efficient working environment for the driver. However, alternative mounting locations may be available which increase visibility while still preserving the intended function of the device in question. Inspection and permit stickers could be re-located to other positions on the truck's body or fixed on metal plates mounted on the bumper near the license tag. It may be possible to mount fans used for ventilation and windshield defrosting on the cab ceiling near the passenger side window post or a centrifugal fan of lower profile could be used.

Recommendation #4 Employers, manufacturers, and regulators, should carefully evaluate the placement of auxiliary equipment in vehicle cabs.
