ADMINISTRATIVE REPORT
PUBLIC HEALTH SERVICE/CDC/NIOSH/DSR
FACE 97-11

SUBJECT: Construction Laborer Dies After Being Struck by a Front End Loader at a Construction Site - Pennsylvania

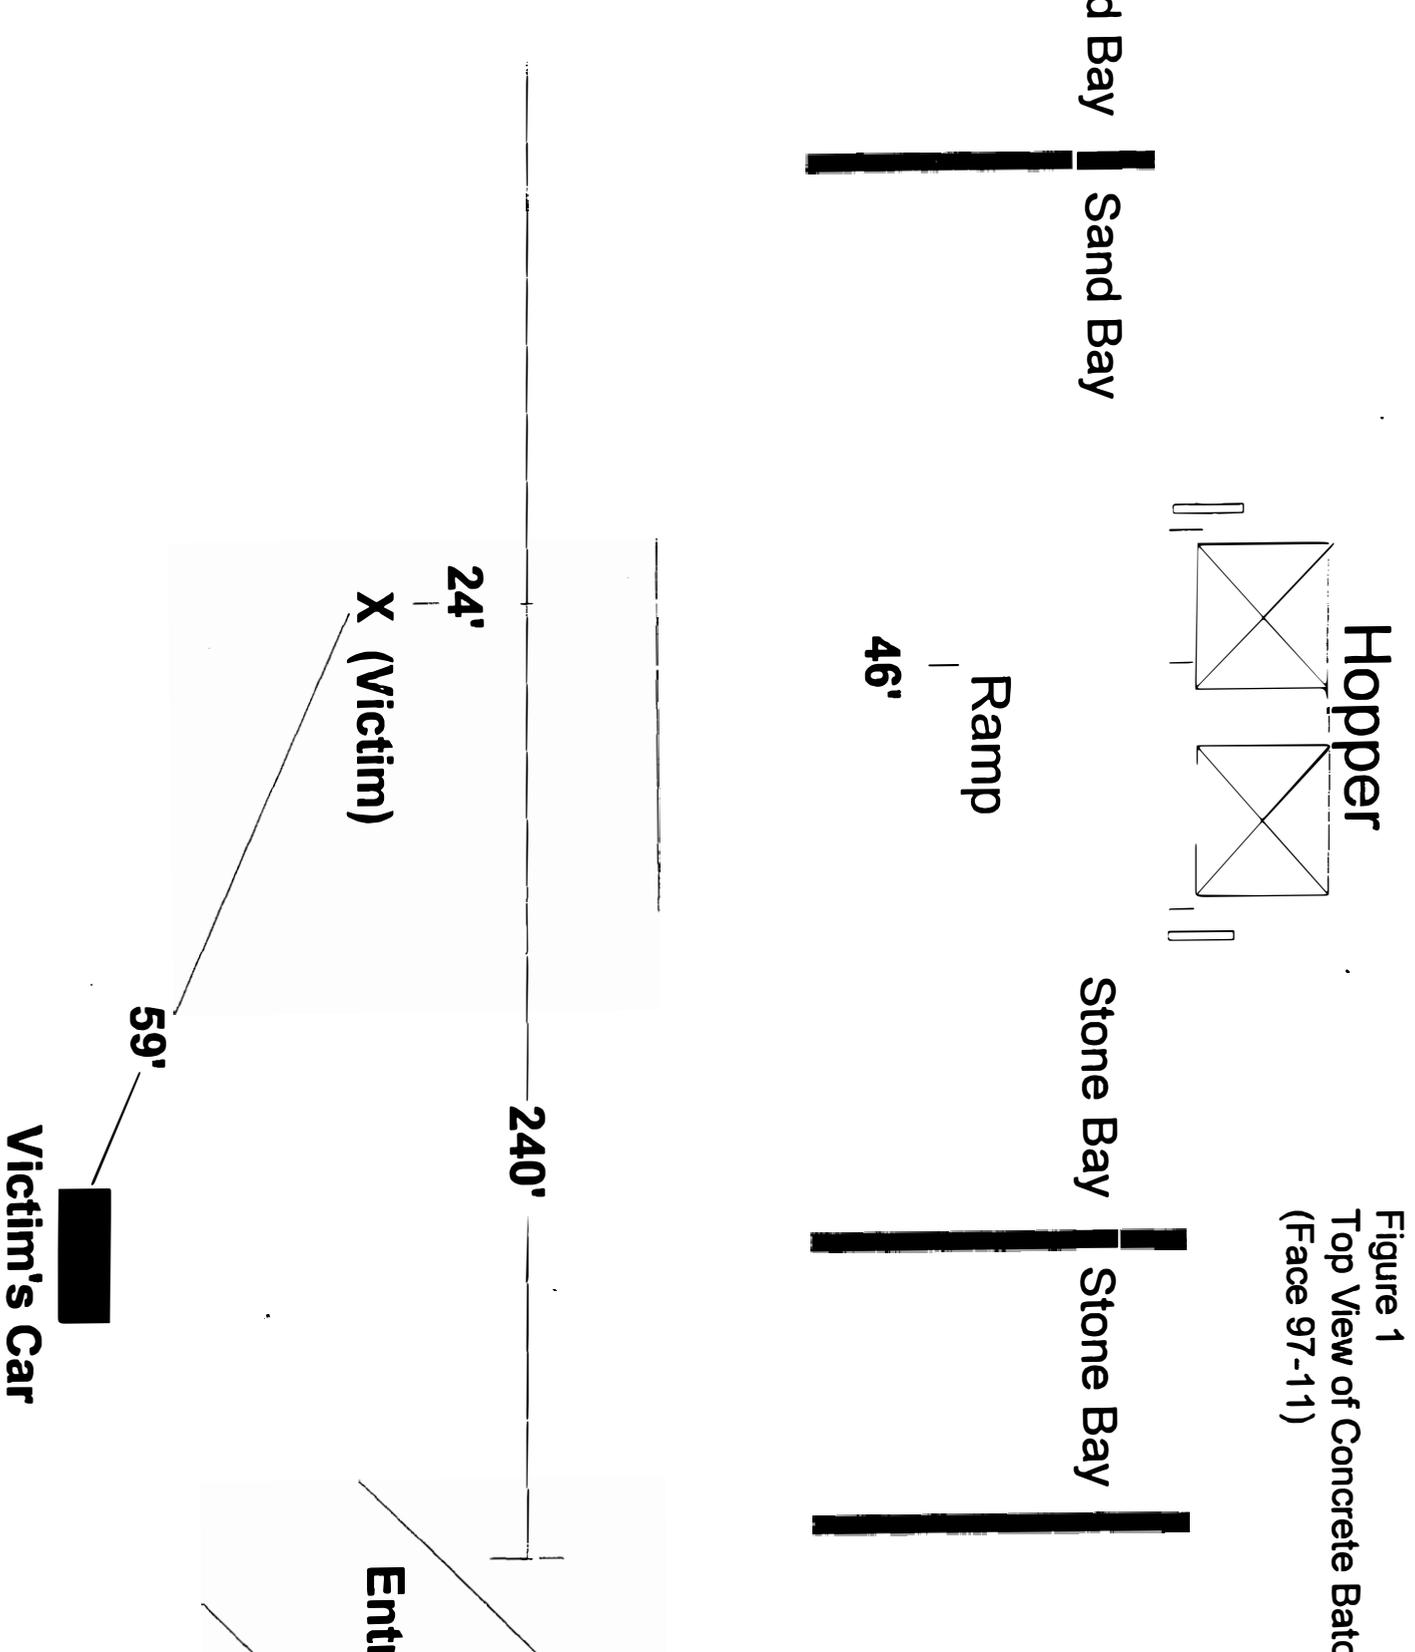
Figure 1
 Top View of Concrete Batch
 (Face 97-11)

The area of the facility used for incoming shipments consisted of a 100 foot by 110 foot sand bay and a 130 foot by 130 foot stone bay separated by a 25-foot wide mixing hopper. The maneuvering area in front of the hopper and raw material bays was approximately 240-foot wide by 130-foot deep. An employee was stationed at the entrance to the facility to collect the shipping manifests from each incoming truck. The employee then directed each truck to a raw material bay to dump its load of either sand or stone. A front end loader was used to move the raw material from the bays to the mixing hopper. A 40-foot wide by 48-foot deep earthen ramp was constructed in front of the hopper for use by the front end loader. The remaining area, for the incoming trucks to maneuver, was approximately 240-foot wide by 60-foot deep.

On the day of the incident, the victim started work at approximately 7:00 a.m. and was assigned to collect shipping manifests and direct incoming trucks to dump their loads in the sand and stone bays. At approximately 11:30 a.m., the victim directed a truck into the sand bay, located to the left of the mixing hopper. The truck was dumping its load of sand into the bay when the victim walked behind the toe (bottom) of the earthen ramp, which was located in front of the mixing hopper. A Model 966D Caterpillar front end loader was backing down the earthen ramp and struck the victim approximately 24 feet from the toe of the ramp with the left rear tire, and backed over the victim. The victim was wearing an orange reflective safety vest at the time of the incident. A Pennsylvania Department of Transportation official (PennDot), who was standing near the victim's car (reference figure) witnessed the incident and motioned to the operator of the front end loader. With the exception of the front end loader operator, other site personnel were not in the immediate area. Emergency Medical Service personnel (EMS) were contacted and arrived on the scene within minutes and administered first aid. The victim died approximately 13 hours later in an area hospital.

Recommendation #2: Employees should ensure that construction workers who are directing traffic flow are placed in a location where they are visible to equipment and vehicle operators. The site layout should be designed for efficient and orderly traffic flow, and with personnel safety in mind. Site-specific traffic control procedures should be designed and implemented to allow for construction-site traffic and safe personnel mobility.

at the site was also inadequate for the number and size of vehicles which used the area, which further exacerbated the problem of safe pedestrian mobility. Since the batch plant is only a temporary site, installation of sophisticated traffic control equipment such as electrical lights and directional signals is not economically prudent. Traffic flow at a construction site should be designed prior to the start of operations, if possible, to minimize vehicular and pedestrian traffic interface. Personnel should be placed in a visible and stationary position, if possible, to direct traffic and conduct other duties. After the incident, the new person assigned to collect manifests was moved to the site exit ramp which was decided by site management to be a safer and more stationary location . If personnel mobility is necessary, then safe avenues (roped off areas, etc.) for pedestrian traffic should be provided, which do not interact with vehicular traffic.
