**ADMINISTRATIVE REPORT
PUBLIC HEALTH SERVICE/CDC/NIOSH/DSR
FACE 97-14**

SUBJECT: Maintenance Worker Dies After Overhead Crane Collides With Aerial Platform At Construction Equipment Plant - North Carolina

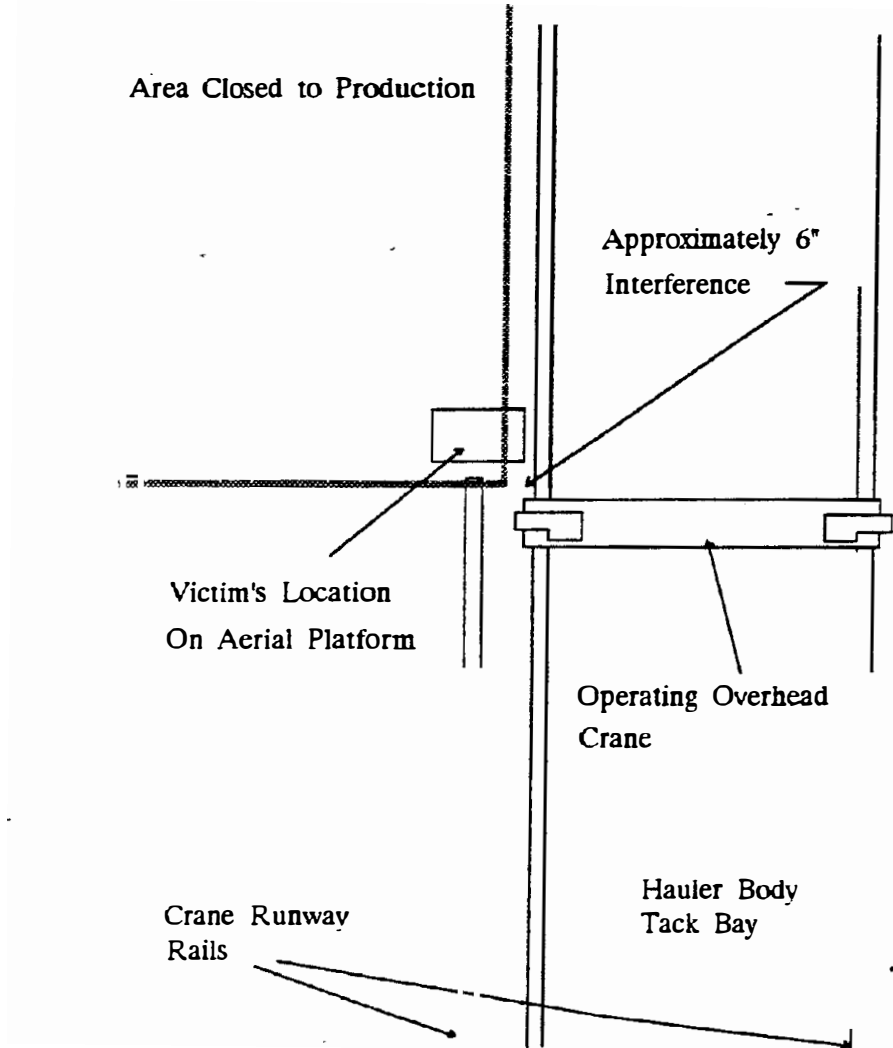
Figure: FACE 97-14, Overhead View of Crane Runways

Discussion: The cranes which operated on the rails being re-routed had been locked out and blocked against motion to protect workers during the modification. However, the crane operating in the adjacent bay remained in use without restriction. During the morning, the aerial platform had been located between 1 and 1½ feet of the operating crane and the crane had passed by several times. Later, the victim repositioned the platform, presumably for better access to the cut rail. In this location the platform was 4 to 6 inches inside the crane's zone of movement because the drive mechanism of the crane extended slightly beyond the rails. This distance would have been difficult to detect visually, especially by an individual at floor level. Had the crane been located near the end of the adjacent cut-off rail when the platform was positioned, the clearance could more accurately have been judged. Better yet, stops could have been fixed to the rail to limit the movement of the crane, or the crane could have been de-energized and tagged out of service.

Discussion: Although the bay in which the modifications were taking place had been designated as non-production and no movement of equipment was taking place, another crane was operational on an adjacent runway. Additionally, no barricades, warning lines, or signs were used. The controls for the crane were suspended from an umbilical which allowed the operator to work the crane while standing at floor level. The crane operated on rails which were about 20 feet off the floor. The operator's attention would normally be focused on the load or load-handling device rather than on the rail above, and the load would be lifted no higher than necessary for movement above floor obstacles. Additionally, since the crane had passed beside the platform without incident during the morning hours, it may not have occurred to any of the workers that the platform had been repositioned within the crane's zone of movement. Where workers are exposed to hazard from movement of overhead cranes, a safe zone of operation should be marked by signal devices such as blinking lights or marker cones placed at floor level, where they are easily seen.

Recommendation #1: Employers should ensure that a hazard assessment of work areas is conducted prior to work being performed.

Recommendation #2: Employers should ensure that adequate zones of safety, marked by readily discernible warning devices, are established around maintenance areas in production facilities.
