**ADMINISTRATIVE REPORT
PUBLIC HEALTH SERVICE/CDC/NIOSH/DSR
FACE 98-13**

SUBJECT: Groundsman On Tree Trimming Crew Caught In Wood Chipper - North Carolina

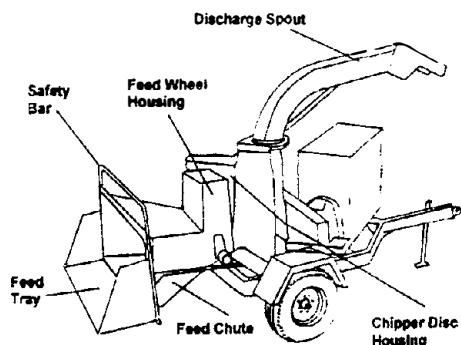
Figure 1 Wood Chipper

The machine in the incident (figure 1) was a Bandit Model 250 wood chipper. This is a mobile machine designed to be towed by a truck which is also used to transport the chipped material from the jobsite. The machine consists of a feed mechanism, a rotating chipper disc and a power plant. Tree trimmings and trunk sections are fed into the machine through the feed chute. At the end of the feed chute, are two hydraulically driven feed wheels arranged one above the other on parallel axes. The feed wheels grab the branches fed through the

chute and force them into the knives mounted on the rotating chipper disc. The chipper disc operates at high rpm and propels the wood chips through the discharge spout which directs them into the transport vehicle. Power for the machine is supplied by an internal combustion engine.

The crew had been engaged in cleaning up branches of $\frac{1}{2}$ to 1-inch diameter, 3 to 5-feet long and it is conceivable that the victim may have pushed an armload of twigs or short branches into the machine and lost his balance, falling forward and into the feed wheels.

Discussion: Every effort should be made at the job site to ensure that at least two people are present and within sight of each other while wood is being fed into the chipper. The chipper in this incident was equipped with a properly functioning safety bar located around the mouth of the feed chute which was mechanically linked to the hydraulic controls for the feed rollers. The bar was a three-position control: pulling the bar activated the feed wheel rotation for in-feed, pushing the bar to center was a neutral position, and pushing fully forward reversed the feed wheels to out-feed. The employees had been trained in the operation of the bar and to remain in position to activate it while feeding material into the chipper. However, because this bar surrounded the feed

chute, it could not have been activated by a worker after becoming caught by the feed wheels. Workers not actively feeding material into the hopper should remain a sufficient distance from the machine to minimize their exposure to flying chips and debris, becoming entangled in brush which is being fed into the machine by a co-worker or creating a tripping hazard for co-workers. However a second person in visual contact with the victim may have recognized the danger and been able to push the bar to the out-feed position in time to prevent or minimize the injury.

Recommendation No. 1: Employers should ensure that manufacturers recommended safe operating procedures are followed when operating machines.

Recommendation No. 2: Employers should ensure that at least two people trained to operate the safety bar are present and within sight of each other when material is being fed into a wood chipper.

Recommendation #3: Employers and manufacturers should evaluate the applicability of additional engineering controls to wood chippers.

Discussion: The chipper in this incident was equipped with several devices to increase the safety of operation. In addition to the previously mentioned safety bar located around the feed chute, the machine was equipped with a fold-down feed tray. When the tray is folded down the distance from the feed rollers to the edge of the feed chute increases from 31 to 49 inches. The tray can be folded up to facilitate transport of the machine from one jobsite to another. The fold-down tray was intended to make it difficult for machine operators to reach or kick into the feed wheels and to provide an area where small twigs and leaves could be placed and then fed into the chipper with a pushing tool or long branch. Additionally, there were three flexible rubber flaps located across the feed chute 32 inches away from the feed wheels. These flaps were intended to be a physical warning to employees to keep hands away from the feed wheels and to prevent material from flying back out of the chipper. An emergency shut-off device is available from the manufacturer for retro-fitting to existing machines and as original equipment on new machines. Two cables hang inside in front of the feed wheels. The cables are connected to the hydraulic controls so that pulling a cable reverses the feed wheels. Technology is emerging which may allow the use of electronic sensors to eliminate machine-related injury. In one example of this technology the worker would wear gloves made of metal impregnated material. The presence of a worker's hand near the feed chute would be sensed by a metal detector mounted at the opening. The signal could then be used to stop the feed wheels.
